# ANOKA RAMSEY JUDICIAL DITCH 1 REPAIR REPORT

Blaine/Mounds View, MN

July 14, 2026  
Blaine / Mounds View, MN

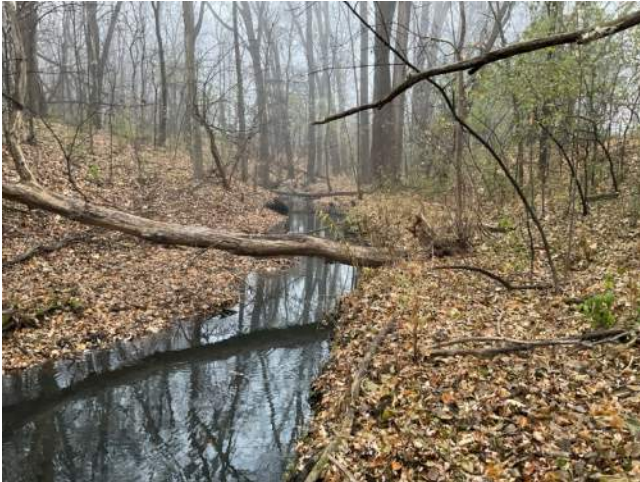
Photo #1: Heavy Vegetation near ditch, Main Trunk STA: 31+00

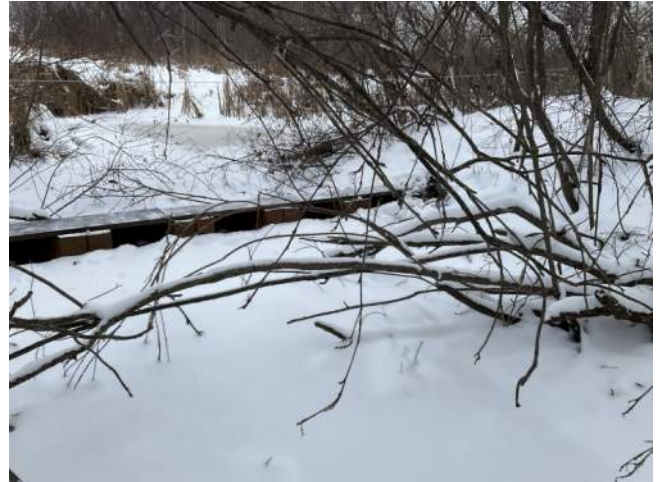
The weir located at Station 116+58 of the Main Trunk is obstructing the function of the drainage system and creates maintenance challenges (including an attractive nuisance for beaver). As such, we recommend removing this weir as a component of the repair. The sheet piling should be pulled and/or cut-off below the ditch grade, with the metal disposed of off-site. See 3.2.2 *Water Quality* for discussions on the effects of the weir removal.

Photo #3: Sheet pile weir with 2x12 board on top, Main Trunk STA: 116+58

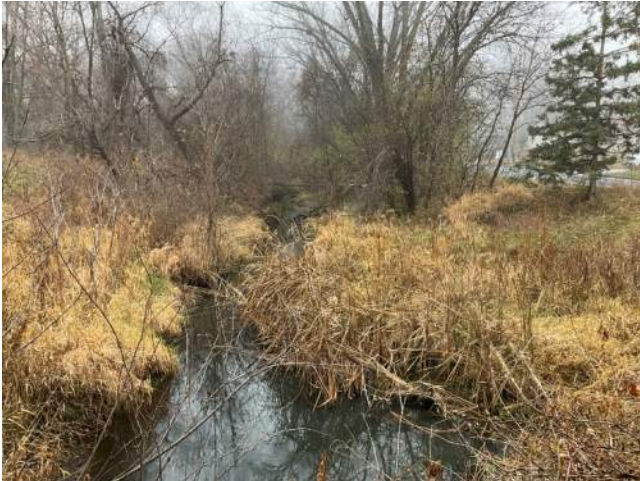
Photo #2: Heavy Vegetation in ditch, Main Trunk STA: 53+00

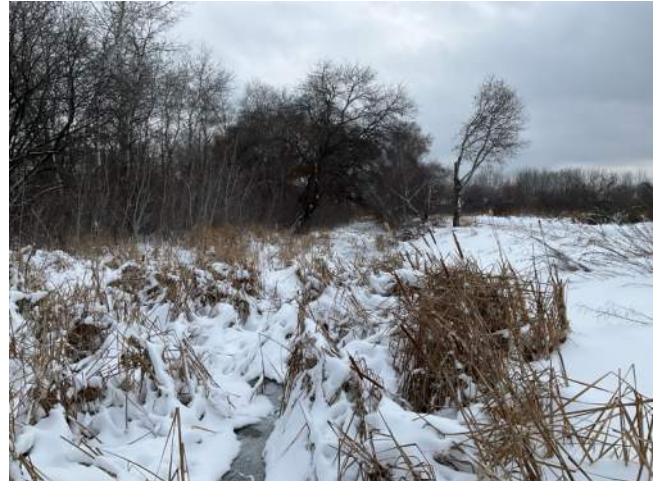
- Kane Meadows Open Space Trail is located adjacent to the Main Trunk and runs parallel to the ditch from approximately Station 94+00 to Station 152+00. The trail also parallels Branch 1 from approximately Station 0+00 to Station 9+00. The proximity of the trail increases the chance that it will be damaged during repairs. To the extent feasible, repair activities should be conducted on the side opposite of the trail to preserve its integrity. Coordination with the City of Blaine (as owner of the trail) will be necessary prior to any repair activities in this area.

Photo #4: Heavy in channel vegetation, trees on east side of ditch, Kane Meadows Open Space Trail on west side of ditch, Main Trunk STA: 137+00

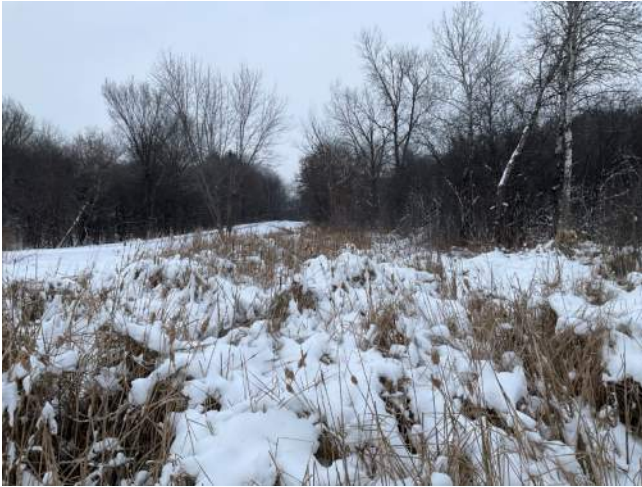
Photo #5: Heavy vegetation in ditch, trees to one side and Kane Meadows Open Space Trail on other side, looking upstream, Branch 1 STA: 1+00

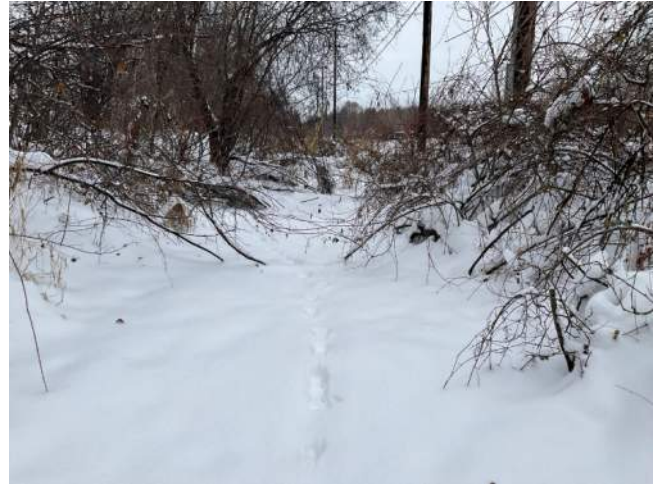
- Along Branch 2, several segments of the ditch run parallel to overhead power lines, specifically from approximately Station 33+00 to Station 36+00 and from Station 56+50 to Station 59+00. The proximity of these overhead lines will require caution when accessing the channel during construction to prevent damage and ensure safe operations.

Photo #7: Overhead Power Lines next to ditch, Branch 2 STA: 33+50

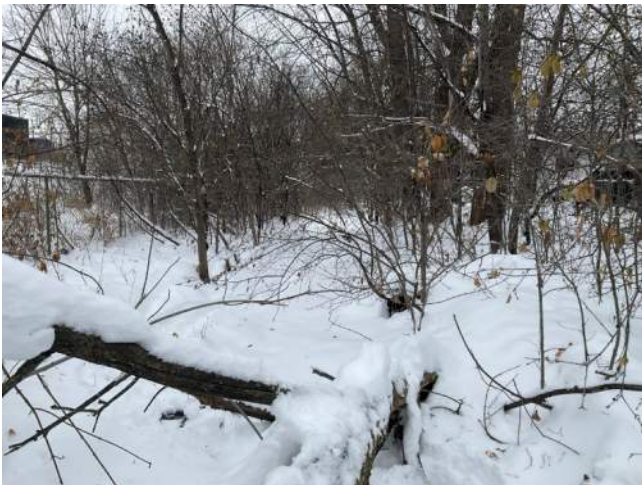
Photo #6: Heavy trees near ditch, chain link fence, Branch 2 STA: 29+00

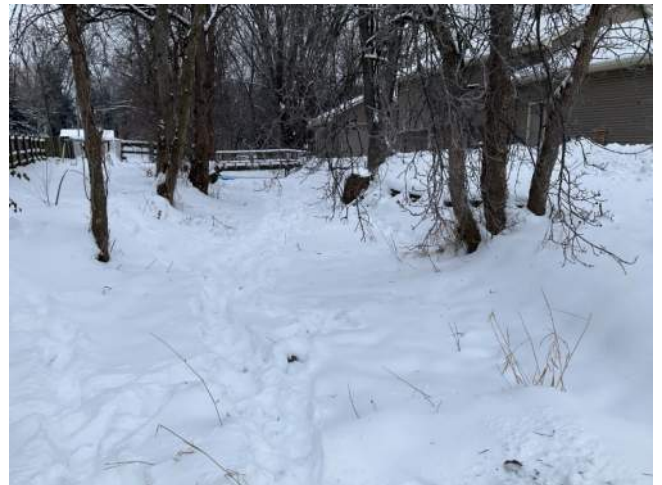
- Along Branch 2, from approximately Station 43+00 to Station 57+00 (from Flowerfield Road to Aaron Avenue), the ditch runs through a residential housing area. Access in this segment may require temporary removal of the fencing. In addition, the proximity of structures near ditch at the road intersections may limit available access points. Coordination with adjacent landowners will be required prior to performing a repair.

Photo #8: Block wall, buildings, and fence near ditch, Branch 2 STA: 56+00

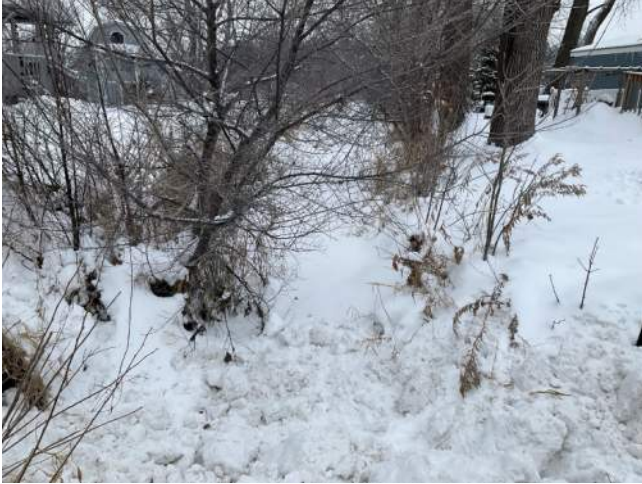
- Along Branch 2, from approximately Station 61+00 to Station 66+00 (from 91st Court NE to 92nd Avenue NE), the ditch runs through a mobile home park, where access is limited due to the proximity of the buildings to the ditch. This likely will require multiple mobilizations for the contractor to access on either side of the obstructing buildings. Coordination with landowners will be required prior to repair activities.

Photo #9: Ditch next to mobile homes, Branch 2 STA: 61+50

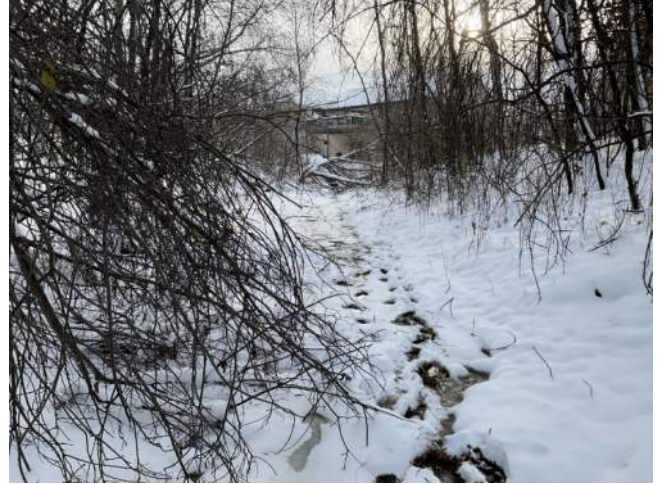
Photo #11: Deadfall in channel, Branch 3 STA: 1+00

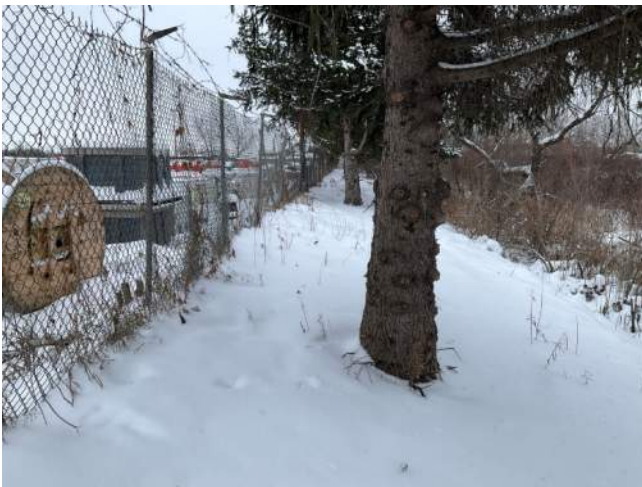
Photo #10: Chain Link Fence Next to Ditch, Branch 2 Lateral 1 STA: 16+00

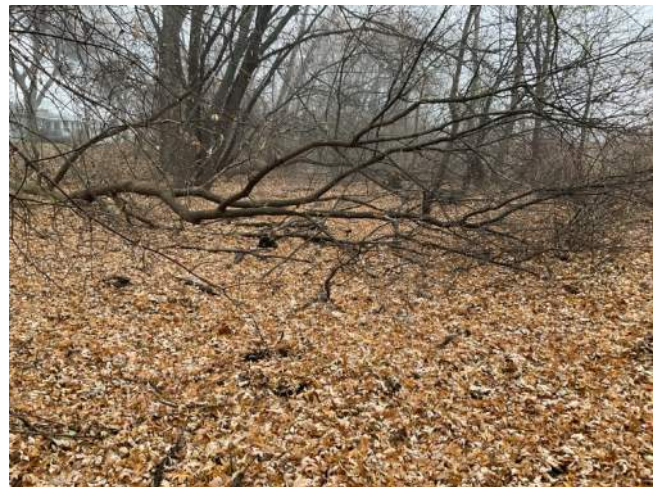
Photo #12: Deadfall in channel, Branch 5 STA: 17+00

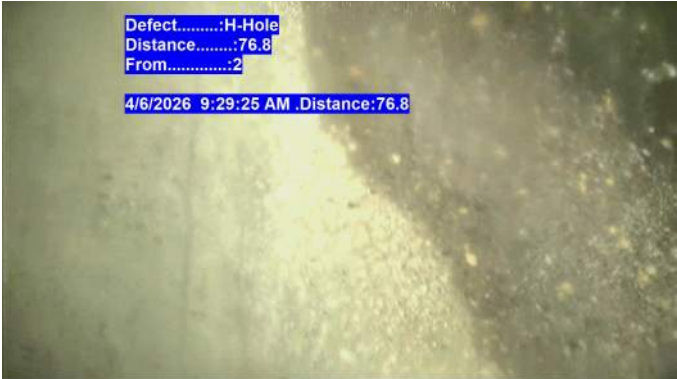
Img:1,Distance:76.8  
Hole,@:2,Rmk:

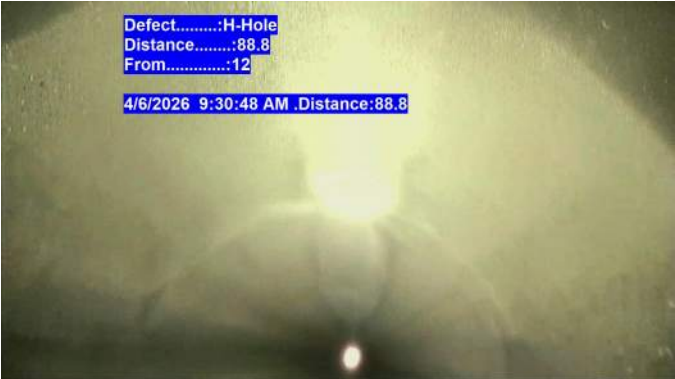
Img:2,Distance:88.8  
Hole,@:12,Rmk:
