# ANOKA RAMSEY JUDICIAL DITCH 1 REPAIR REPORT

# ANOKA RAMSEY JUDICIAL DITCH 1 (ARJD 1) REPAIR REPORT

Original issuance date: July 14, 2026

***Amended August 5, 2026***

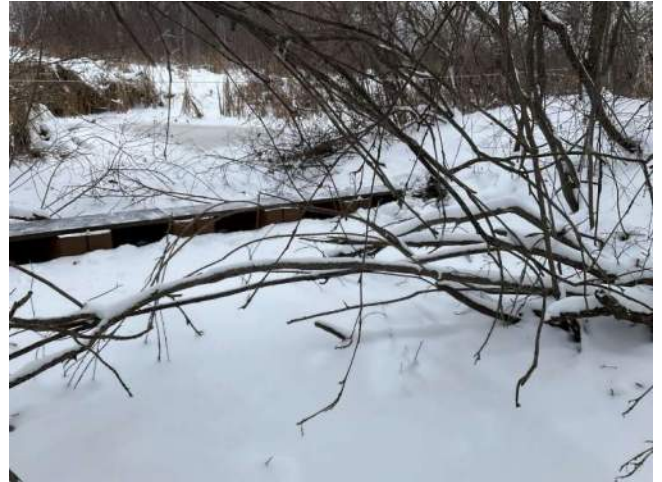
Photo #3: Sheet pile weir with 2x12 board on top,  
Main Trunk STA: 116+58

The weir located at Station 116+58 of the Main Trunk is obstructing the function of the drainage system and creates maintenance challenges (including an attractive nuisance for beaver). As such, we recommend removing this weir as a component of the repair. The sheet piling should be pulled and/or cut-off below the ditch grade, with the metal disposed of off-site. See 3.2.2 *Water Quality* for discussions on the effects of the weir removal.

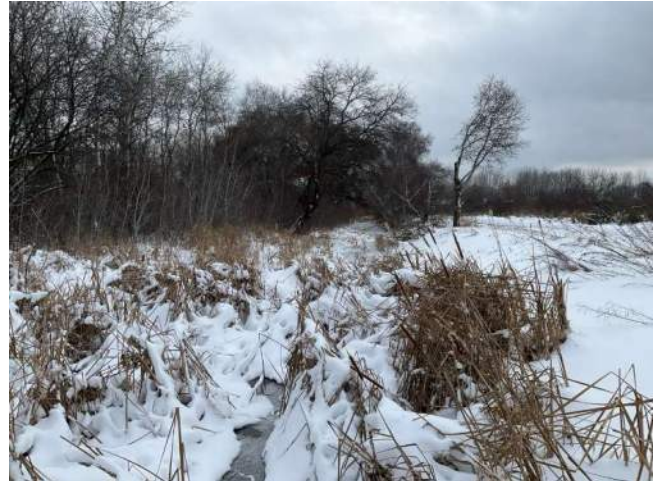
Photo #4: Heavy in channel vegetation, trees on east  
side of ditch, Kane Meadows Open Space Trail on  
west side of ditch, Main Trunk STA: 137+00

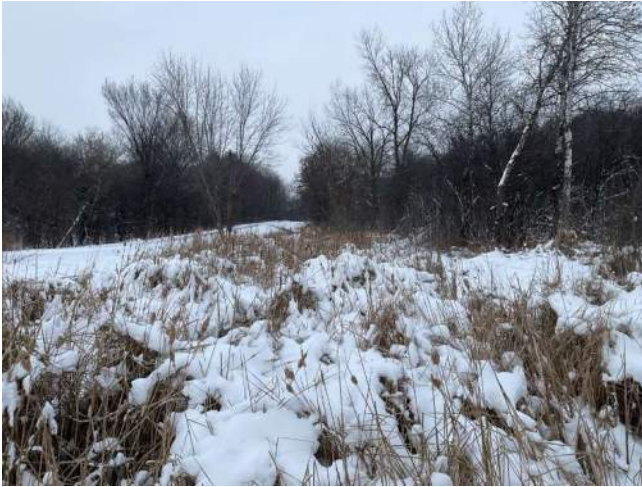
Photo #5: Heavy vegetation in ditch, trees to one side and Kane Meadows Open Space Trail on other side, looking upstream, Branch 1 STA: 1+00

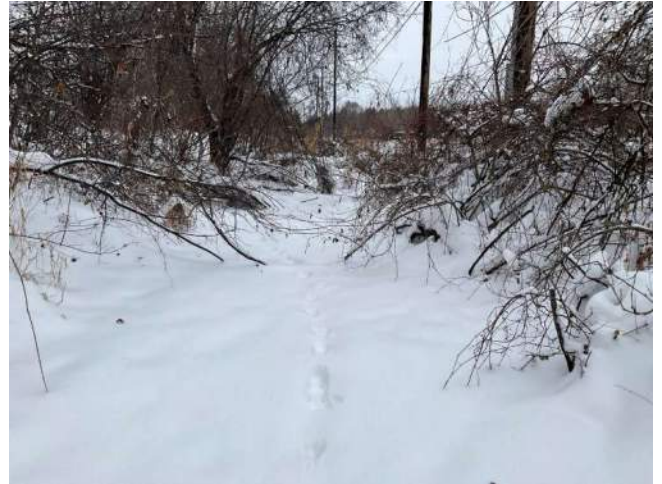
Photo #7: Overhead Power Lines next to ditch, Branch 2 STA: 33+50

- Along Branch 2, several segments of the ditch run parallel to overhead power lines, specifically from approximately Station 33+00 to Station 36+00 and from Station 56+50 to Station 59+00. The proximity of these overhead lines will require caution when accessing the channel during construction to prevent damage and ensure safe operations.

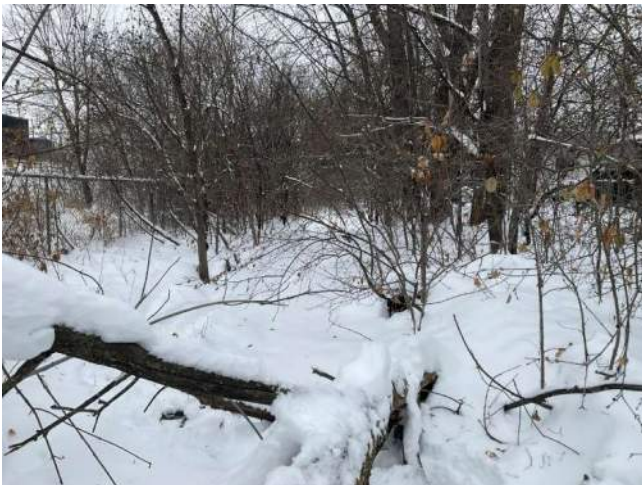
Photo #6: Heavy trees near ditch, chain link fence, Branch 2 STA: 29+00

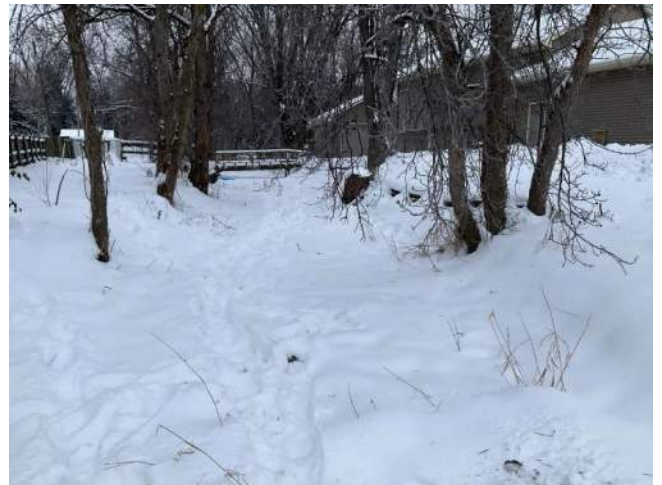
Photo #8: Block wall, buildings, and fence near ditch, Branch 2 STA: 56+00

- Along Branch 2, from approximately Station 43+00 to Station 57+00 (from Flowerfield Road to Aaron Avenue), the ditch runs through a residential housing area. Access in this segment may require temporary removal of the fencing. In addition, the proximity of structures near ditch at the road intersections may limit available access points. Coordination with adjacent landowners will be required prior to performing a repair.

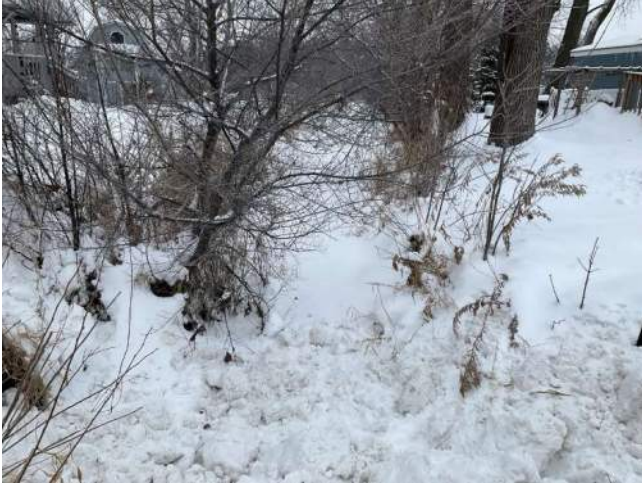
Photo #9: Ditch next to mobile homes, Branch 2 STA: 61+50

- Along Branch 2, from approximately Station 61+00 to Station 66+00 (from 91st Court NE to 92nd Avenue NE), the ditch runs through a mobile home park, where access is limited due to the proximity of the buildings to the ditch. This likely will require multiple mobilizations for the contractor to access on either side of the obstructing buildings. Coordination with landowners will be required prior to repair activities.

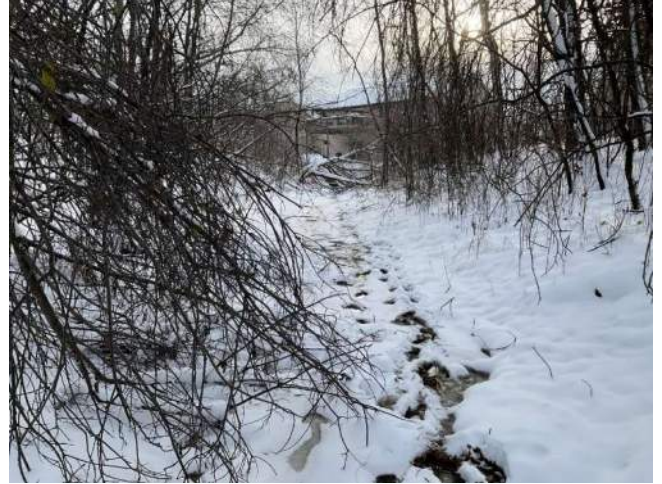
Photo #11: Deadfall in channel, Branch 3 STA: 1+00

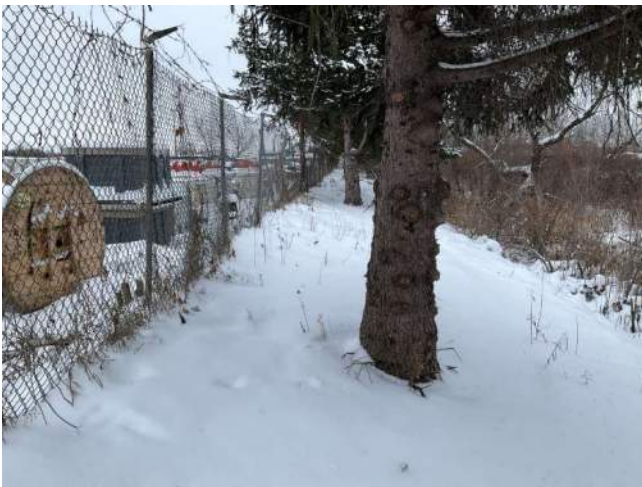
Photo #10: Chain Link Fence Next to Ditch, Branch 2 Lateral 1 STA: 16+00

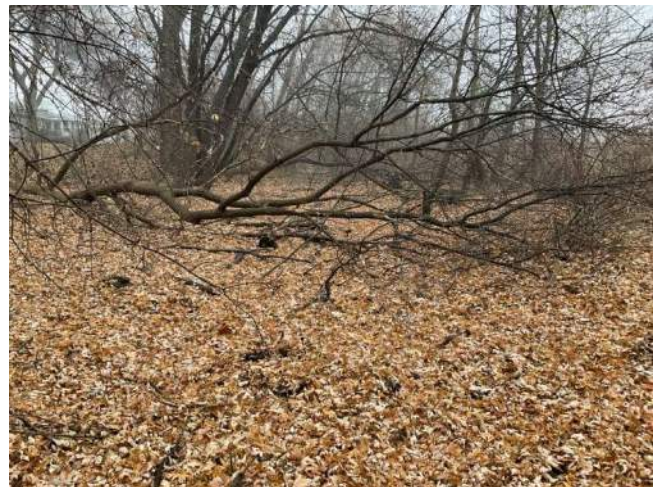
Photo #12: Deadfall in channel, Branch 5 STA: 17+00

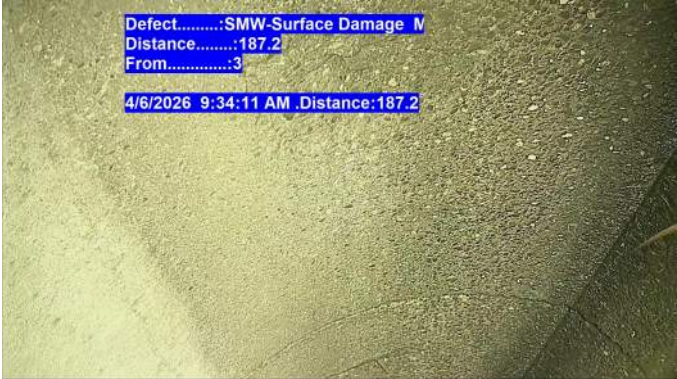
Img:3,Distance:187.2  
Surface Damage Missing Wall,@:3,Rmk:
