RCWD BOARD OF MANAGERS WORKSHOP

Date: June 29, 2026
To: RCWD Board of Managers
From: Matt Kocian, Lake and Stream Manager
Subject: Middle Rice Creek Repair and Feasibility

Regarding | 2022 Project Assessment

Project Name | Middle Rice Creek Restoration**Date** | 6/19/2026**To / Contact info** | Matt Kocian – Lake & Stream Manager**Cc / Contact info** | RCWD Board of Managers**From / Contact info** | Mike Majeski**Regarding** | Scope for Bank Repair of Meander A

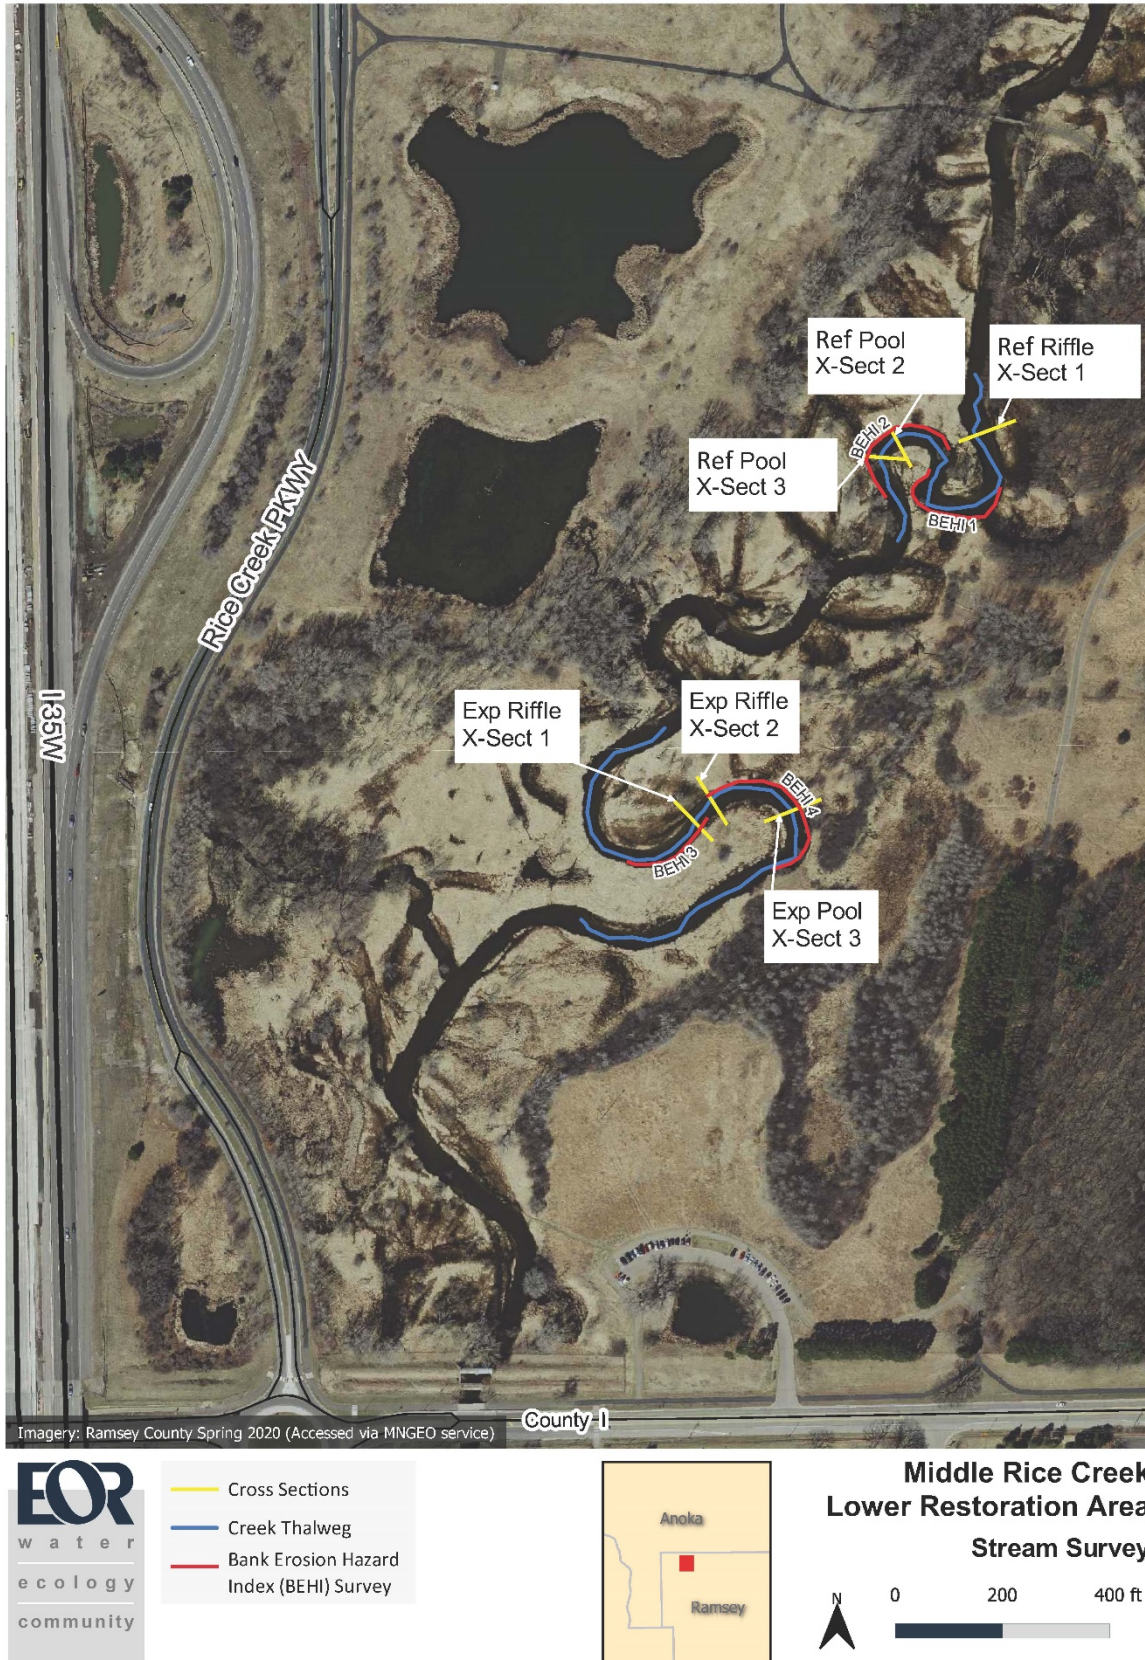
Figure 1. Location Map and Survey Extents for Middle Rice Creek 2022 Assessment

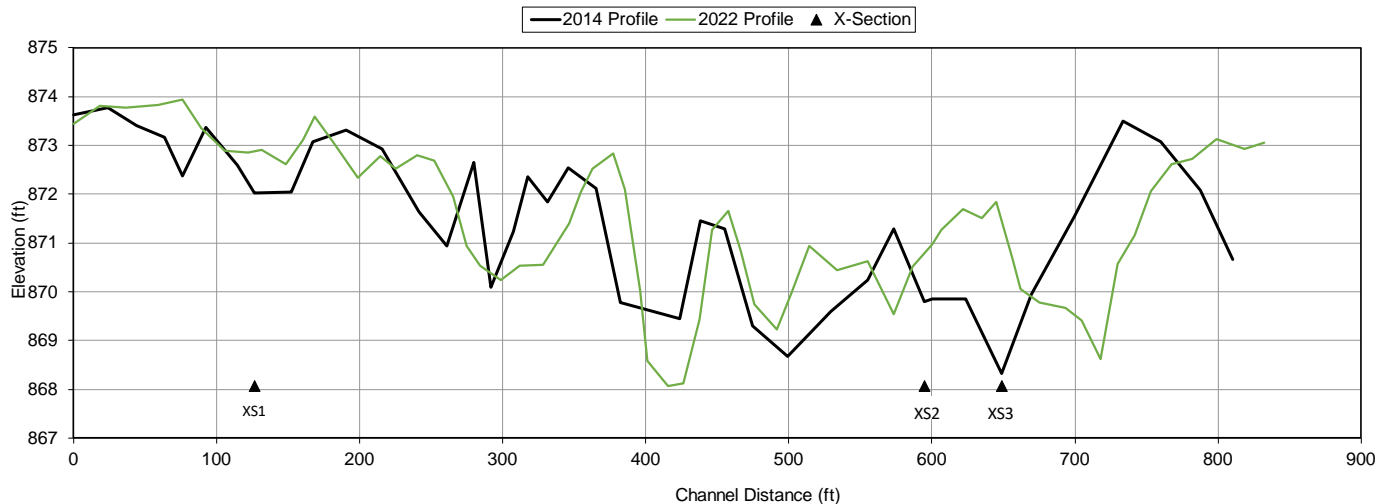
Middle Rice Creek Reference Profile Comparison

The thalweg profile slope (riffle to riffle slope) in 2014 was slightly steeper compared to the riffle slope measured in 2022 and is due to aggraded sediment in the channel since 2014 (Figure 2). Pool depths varied between the two surveys with some pools that maintained similar depths and others that filled in or scoured since 2014. Factors that likely influenced the channel bed elevations between the two surveys include stream flow and bank erosion. Extreme high and low flows have occurred since 2014, with record high flows in 2014 and 2019 and record low flows in 2021 and 2022 (Figure 3). The low flows during the 2021/2022 drought have resulted in less stream power and sediment carrying capacity within the channel and likely caused the accumulation of sediments that were surveyed in the channel in 2022.

Figure 2. Middle Rice Creek Reference Reach Thalweg Profile Comparisons, 2014 & 2022

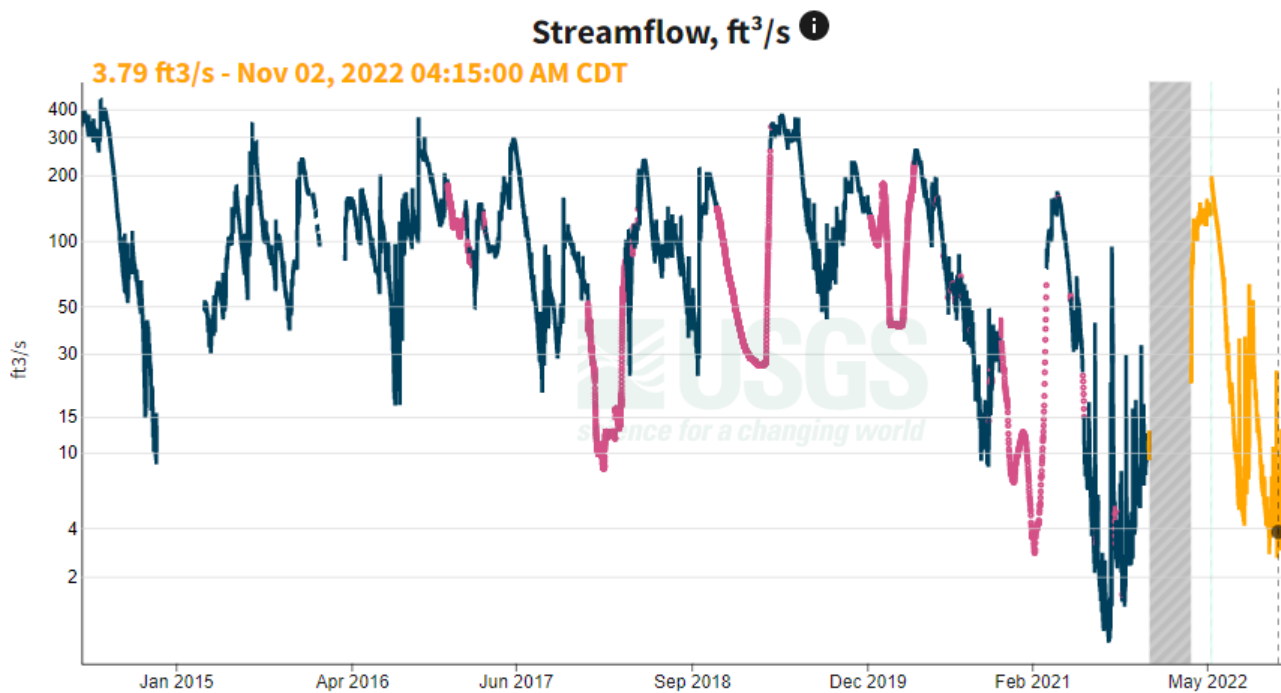
Figure 3. Rice Creek Streamflow Measured by the USGS at Old Highway 8

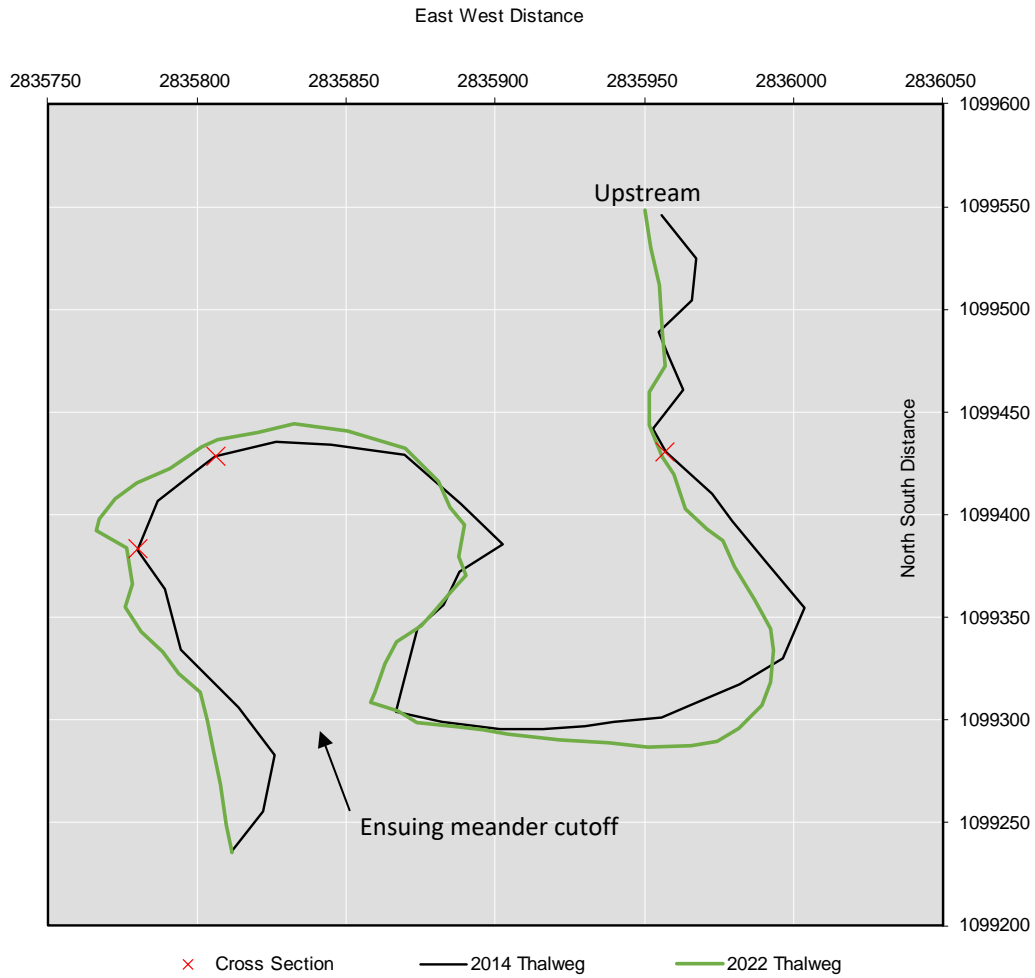
Lateral bank migration was documented at two outside bends within the reference reach. Based on cross section data measured between 2014 and 2022, the outside banks have migrated on average 1.13 feet per year (BEHI and NBS estimate was 1.4 feet/year, see Appendix A). As a result, the overall channel length of the reference reach between the start and end points has increased by approximately 22 feet since 2014 (Figure 2, Figure 4). It should be noted that part of the increase in channel length may also be due to changes in the thalweg location between the surveys, with greater thalweg meandering from right bank to left bank in the low flow channel caused by very low streamflow during the November 2022 survey. Consequently, the end point of the 2022 profile survey extends past the 2014 end point in Figure 2 despite both surveys ending at the same location in the channel. The increase in stream length as surveyed in 2022 results in a slight shift in the locations of the riffles and pools compared to the 2014 profile and becomes exaggerated with an increase in stream station from upstream to downstream.

Figure 4. Middle Rice Creek Plan View of 2014 & 2022 Reference Reach Thalweg Profile Surveys

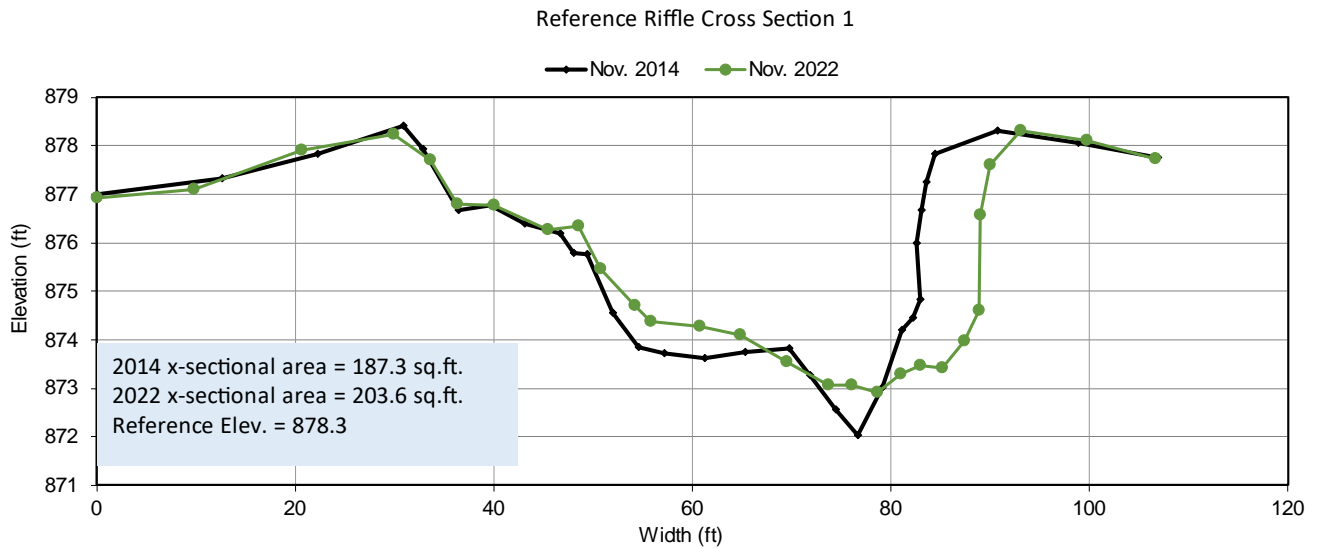
Three channel cross sections were surveyed in the reference reach including one riffle and two pool locations. The riffle cross section data indicated an increase in channel cross-sectional area by 16.3 square feet since 2014 (Figure 5). Conversely, the two pool cross sections indicated a decrease in channel cross-sectional area by 10.9 square feet at cross section 2 (Figure 6) and 2.7 square feet at cross section 3 (Figure 7). Although bank erosion has occurred along the outside bends of the surveyed pools (average of 9 feet of lateral migration since 2014), the point bars along the inside bends have built out at a similar rate such that the bankfull channel width of the reference pool between 2014 and 2022 was nearly the same (36.1 feet compared to 37.8 feet, respectively).

Figure 5. Reference Riffle Cross Section 1 (Looking Downstream)

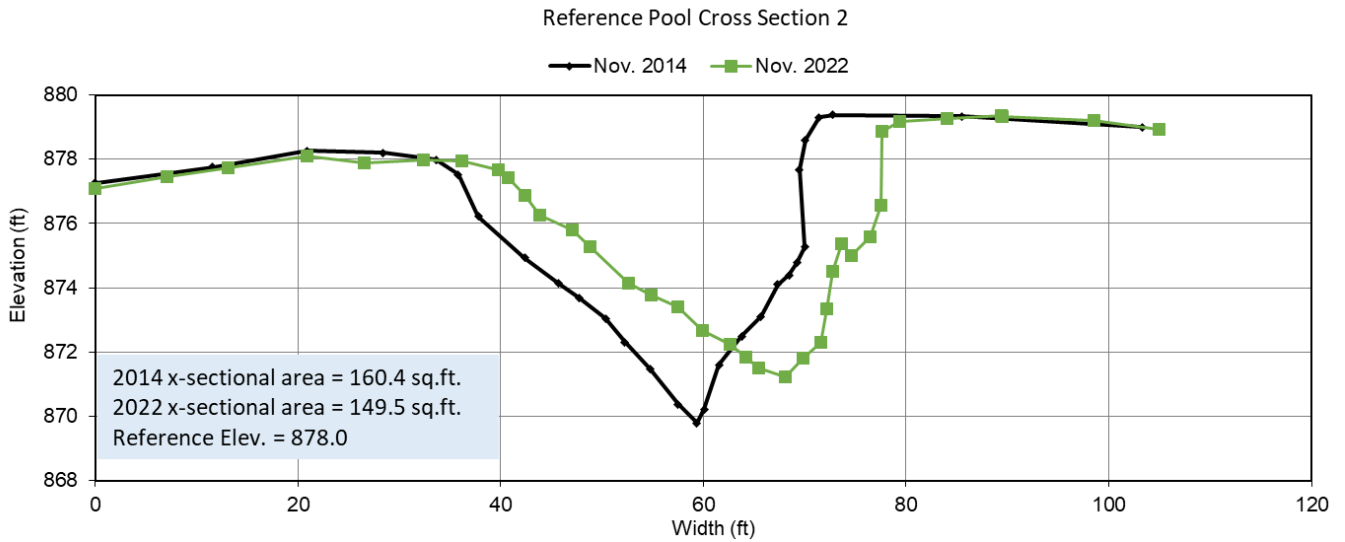
Figure 6. Reference Pool Cross Section 2 (Looking Downstream)

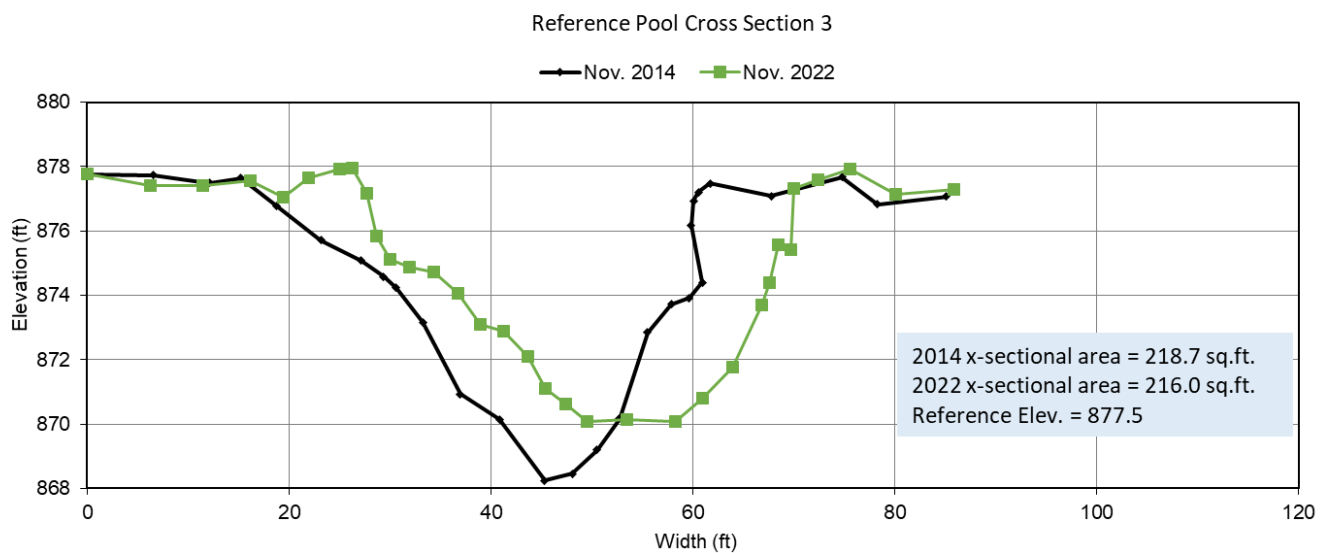
Figure 7. Reference Pool Cross Section 3 (Looking Downstream)

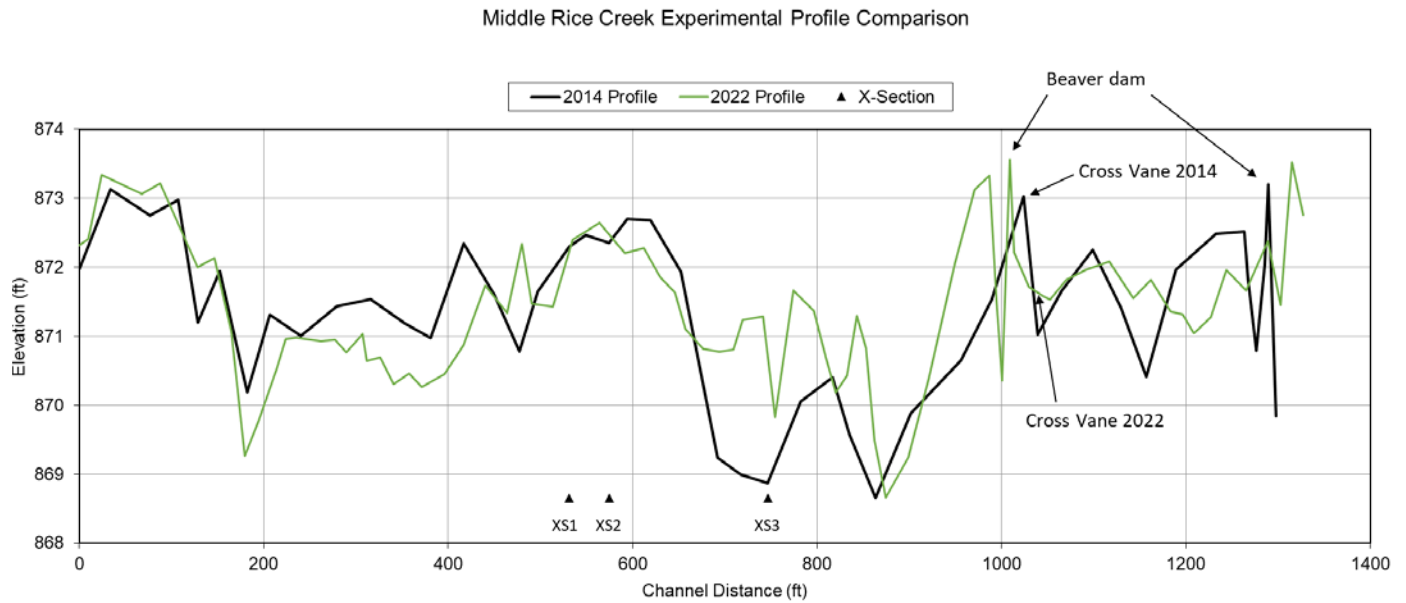
The overall thalweg profile slope (riffle to riffle slope) along the experimental reach remained relatively unchanged between 2014 and 2022, with riffle crest elevations varying only a few tenths of a foot between the two years (Figure 8). Pool depths varied between the two surveys with some pools that maintained similar depths and others that filled in or scoured since 2014. Persistent beaver dams occurred in the experimental reach and changed locations between the two years. The beaver dam in 2014 near station 1290 was not visible in 2022 and appeared to be buried in aggraded fine sand. The beaver dam observed in 2022 near station 1010 was not present in 2014. Although beaver dams have been present in this reach, sediment accumulations upstream of the dams have

Figure 8. Middle Rice Creek Experimental Reach Thalweg Profile Comparisons, 2014 & 2022

been minimal and likely flush out during high flow events.

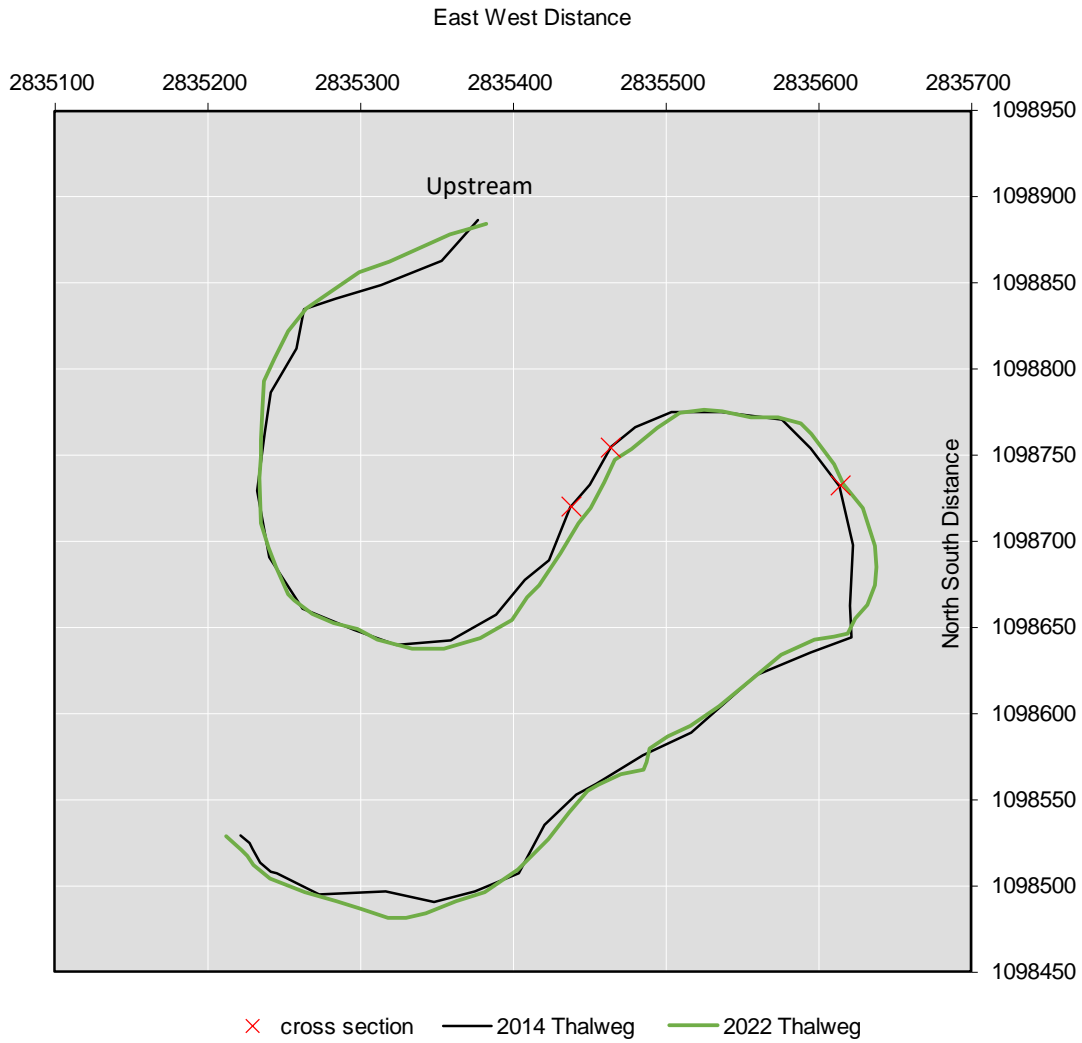
Lateral bank migration was documented at two outside bends within the experimental reach. Based on cross section data measured between 2014 and 2022, the outside banks have migrated on average 0.65 feet per year (BEHI and NBS estimate was 0.58 feet/year, see Appendix A). As a result, the overall channel length of the experimental reach between the start and end points has increased by approximately 30 feet since 2014 (Figure 8, Figure 9). As stated for reference reach, part of the increase in channel length may be due to changes in the thalweg location between the surveys, with greater thalweg meandering from right bank to left bank in the low flow channel caused by very low streamflow during the November 2022 survey. Similar to the reference reach, the end point of the 2022 profile survey extended past the 2014 end point in Figure 8 despite both surveys ending at the same location in the channel. The increase in stream length as surveyed in 2022 results in a slight shift in the locations of the riffles and pools compared to the 2014 profile and becomes exaggerated with an increase in stream station from upstream to downstream. This is the reason why the cross vane location plotted in Figure 8 does not line up on the graph between 2014 and 2022, even though the actual cross vane location has not moved between the two surveys. However, the cross vane elevation has decreased 1.45 feet since 2014 due to settling of the boulders in the fine sandy substrate.

Figure 9. Middle Rice Creek Plan View of 2014 & 2022 Experimental Reach Thalweg Profile Surveys

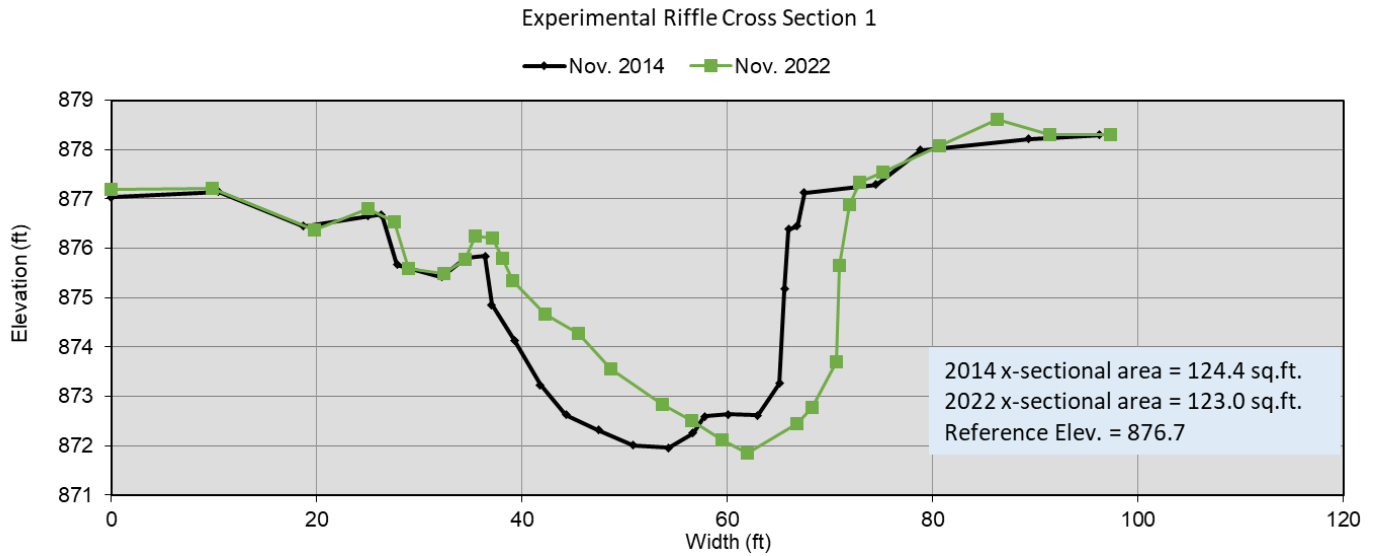
Three channel cross sections were surveyed in the experimental reach including two riffles and one pool. The two riffle cross sections were surveyed at the same riffle location, with cross section 1 occurring at the upstream end of the riffle and cross section 2 occurring at the downstream end of the riffle. The cross-sectional areas of the two measured riffles were very similar between 2014 and 2022 despite 5.5 feet of lateral bank migration measured at cross section 1 since 2014 (Figure 10). Little cross-sectional change was measured at cross section 2 where channel flow transitions from right bank to left bank across the riffle (Figure 11). The pool cross section indicated channel filling has occurred since 2014 with a decrease in cross-sectional area by 22.6 square feet despite 5.0 feet of lateral bank migration since 2014 (Figure 12). The bankfull channel width measured in 2022 was 3.4 feet wider than 2014 (41.4 feet compared to 38.0 feet, respectively).

Figure 10. Experimental Riffle Cross Section 1 (Looking Downstream)

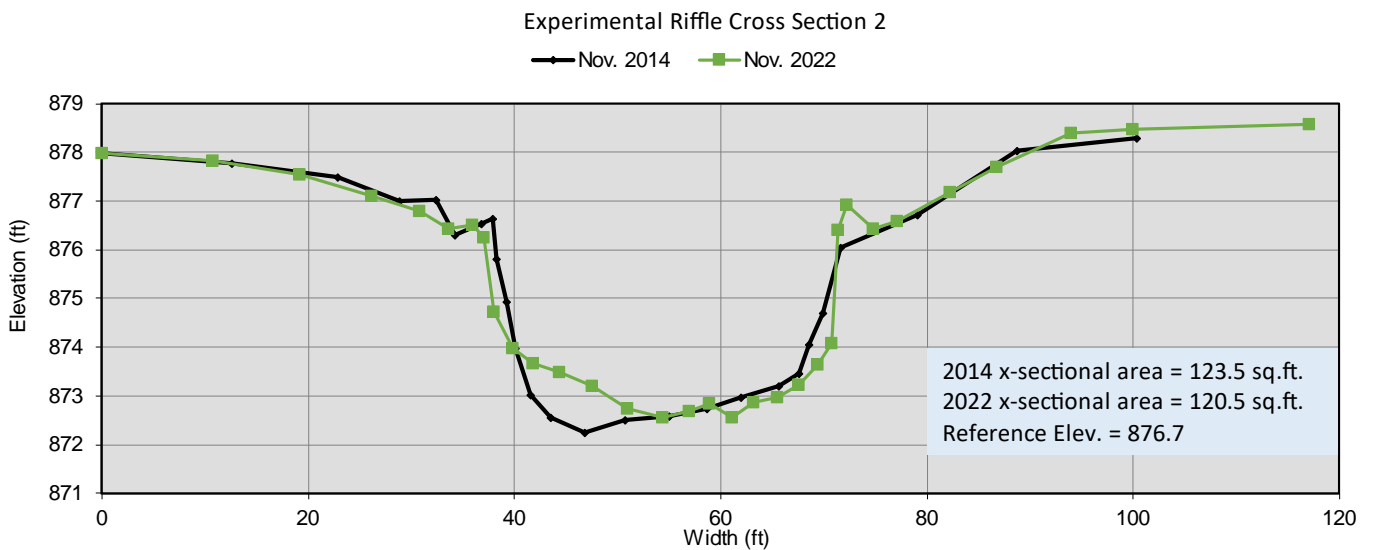
Figure 11. Experimental Riffle Cross Section 2 (Looking Downstream)

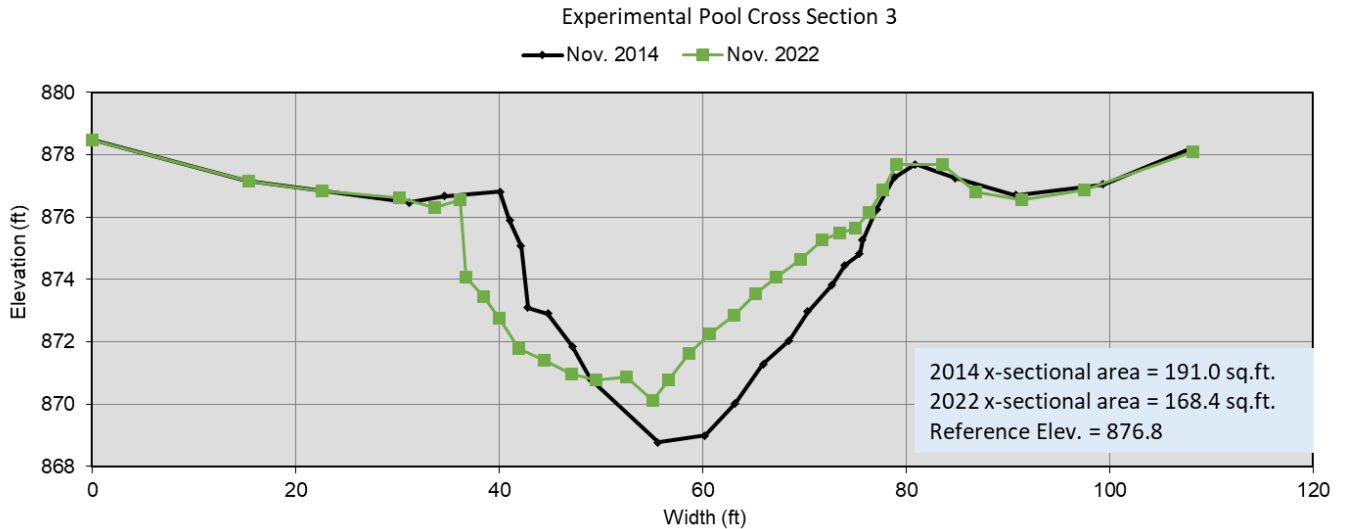
Figure 12. Experimental Pool Cross Section 3 (Looking Downstream)

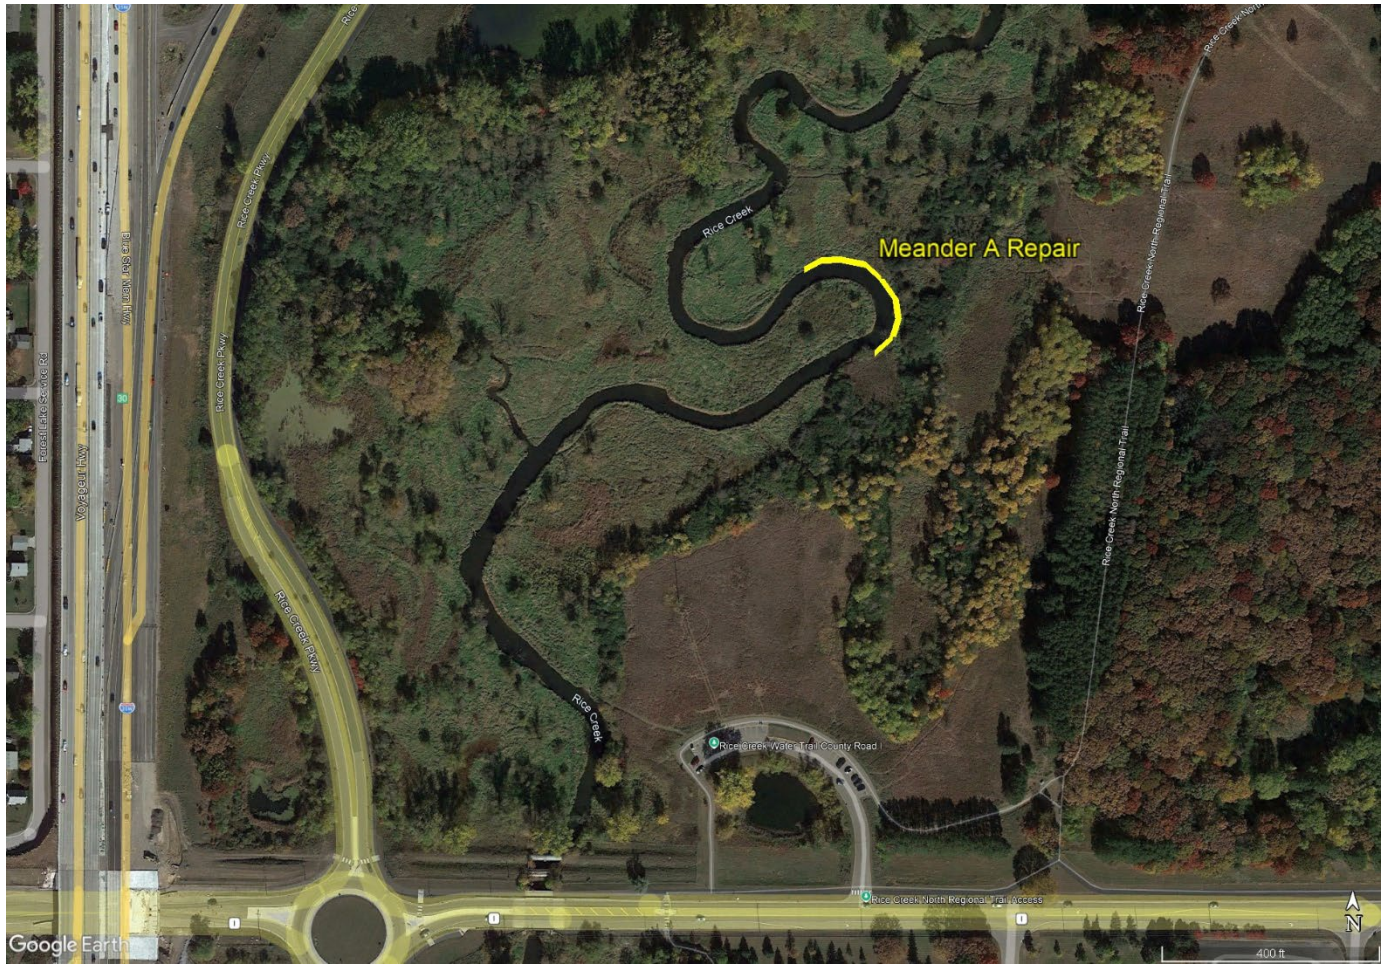
Following the 2022 site assessment of the Middle Rice Creek restoration project (originally constructed in 2006), EOR identified several banks within the project area that would benefit from maintenance repair. In May 2026, RCWD reached out to EOR to develop a design-build approach to advance the recommended bank repair of Meander A located upstream of County Road I (Figure 1). The 2022 site assessment recommended repair of Meander A by utilizing existing woody material near the creek to reduce costs to procure materials for the repair project. There are numerous aspen trees and buckthorn shrubs near Meander A that can be utilized for toewood/ tree revetments to stabilize the eroding bank.

Figure 1. Location of Meander A bank repair area north of County Road I.

EOR will utilize the original Middle Rice Creek Restoration construction drawings to develop a repair plan for Meander A. The original plan contains sufficient site information to guide the design-build approach and project access. Construction inputs will be developed based off the original plan dimensions and recommendations in the 2022 site assessment to determine quantities. The construction drawings and quantities will then be used to seek quotes from experienced stream construction contractors. Once a contractor is selected for the project, EOR will coordinate with RCWD staff to determine timing of construction. Construction oversight will be completed by EOR staff, and an as-built will be completed to document construction inputs. A simple record drawing of the bank repair site will be completed and submitted to RCWD as a final deliverable.

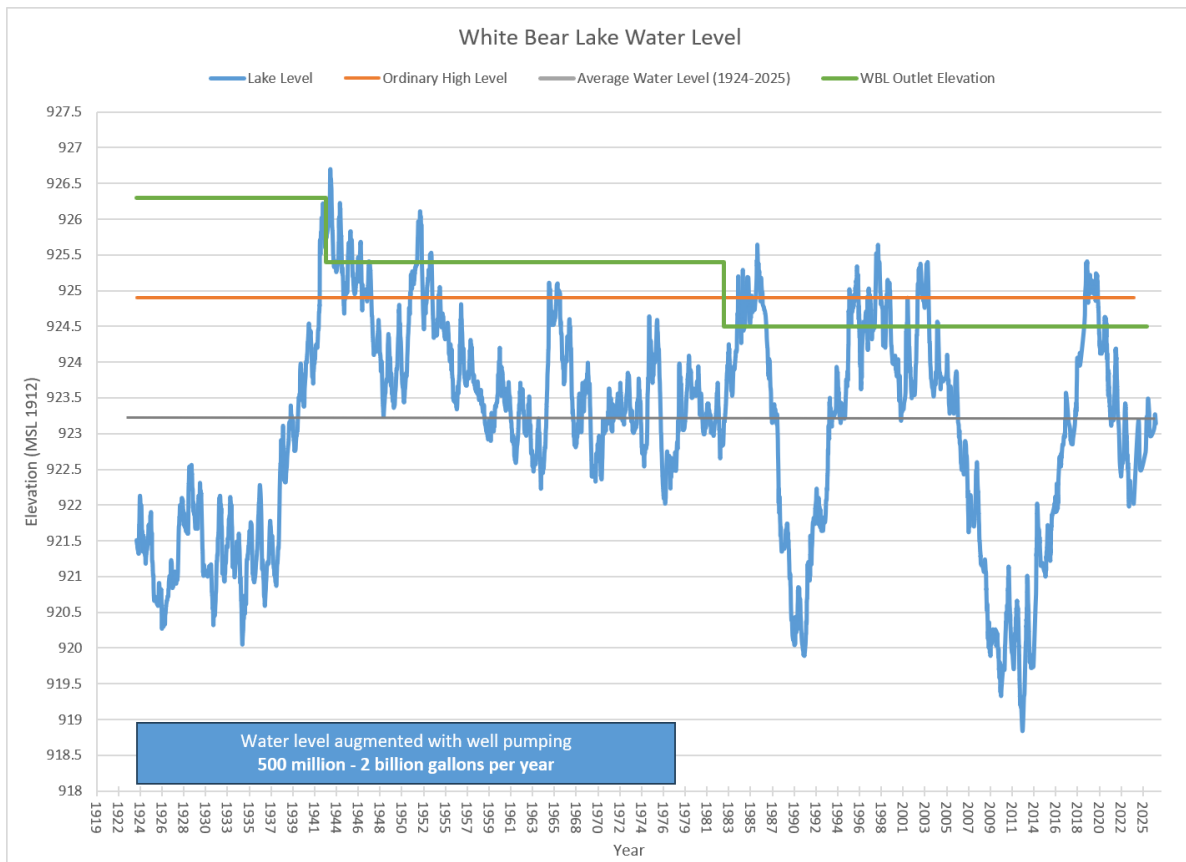
Water levels on White Bear Lake have long been highly variable. Over the long history of water level monitoring, levels have varied by more than 6 feet. Water level records dating back to 1924 are shown in Figure 1.

Figure 1: White Bear Lake water levels; the OHW is indicated by the orange line, lake outlet elevation by the green line, and the long-term average level is indicated by the grey line.
