## RCWD BOARD OF MANAGERS WORKSHOP

This agenda item provides for discussion of the erosion failure at the City of Circle Pines stormwater outfall into Anoka County Ditch 53-62 (ACD 53-62), provides background information and seeks Board consensus direction.

The City of Circle Pines has selected WSB to assess the failure of a stormwater outfall to Anoka County Ditch 53-62 (ACD 53-62). The existing storm sewer collects runoff on West Road and routes it approximately 375 feet northeast to the ditch. In 2023 Rice Creek Watershed District (RCWD) sought to extend and stabilize the outfall as part of their ACD 53-62 Main Trunk Repair project. The outlet has failed, resulting in broken storm sewer and slope failure.

# WEST ROAD OUTFALL REPAIRS

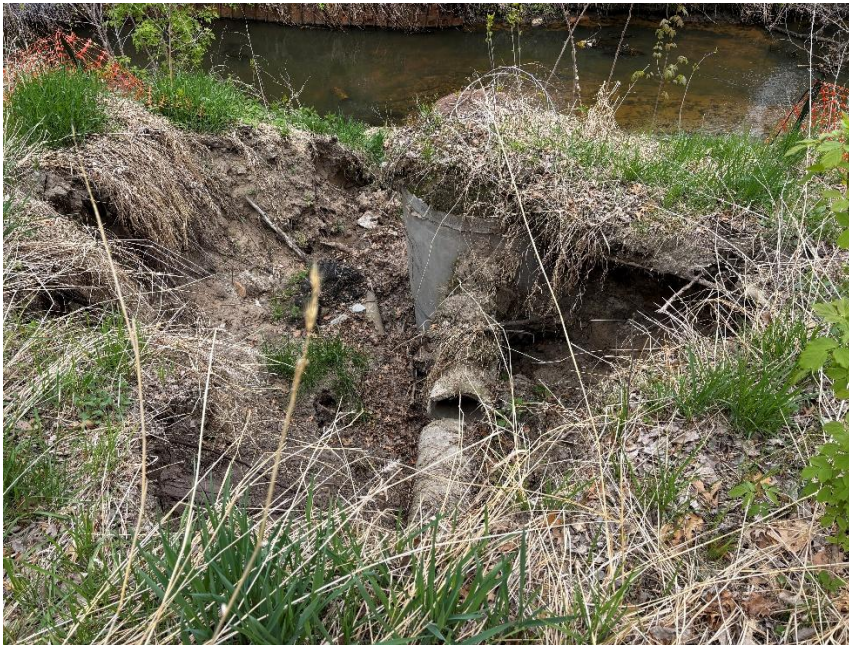
Figure 1. Stormwater Outfall Failure

WSB believes debris accumulation in the trash guard at the outlet caused the outlet pipe to silt in and created high pressures which caused the upstream pipe to separate behind the recently installed drop structure. It is believed that improper compaction and use of unsuitable soils for

backfill during the 2023 project left the slope vulnerable to washout and led to slope failure when the pipe separated.

At the failed outfall structure WSB recommends removing and replacing the damaged storm sewer. The 24 linear feet of storm sewer immediately upstream from the structure should be jetted clean and lined. Backfill operations will require appropriate material to be imported to the site and compacted properly. Slopes in this area will require erosion control blanket. Downstream ditch should be inspected and any additional material washed downstream should be collected and removed. This work should be prioritized to prevent further erosion of the ditch bank and damage to the structure.

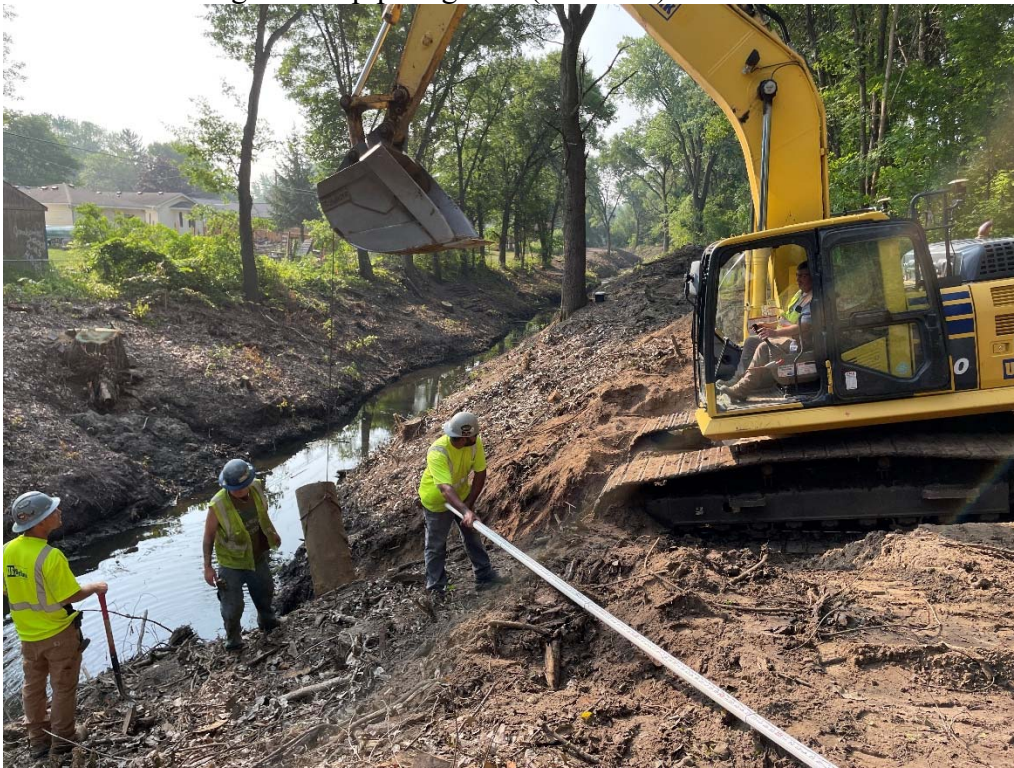
8:40 AM- Nate and Tom dug to see the condition of the second segment of pipe and after performing measurements they determined it needed to be reattached to fit current design (Pictures 8, 9, 10, & 11)

10. Nicholas removing second pipe segment (8:45 AM).

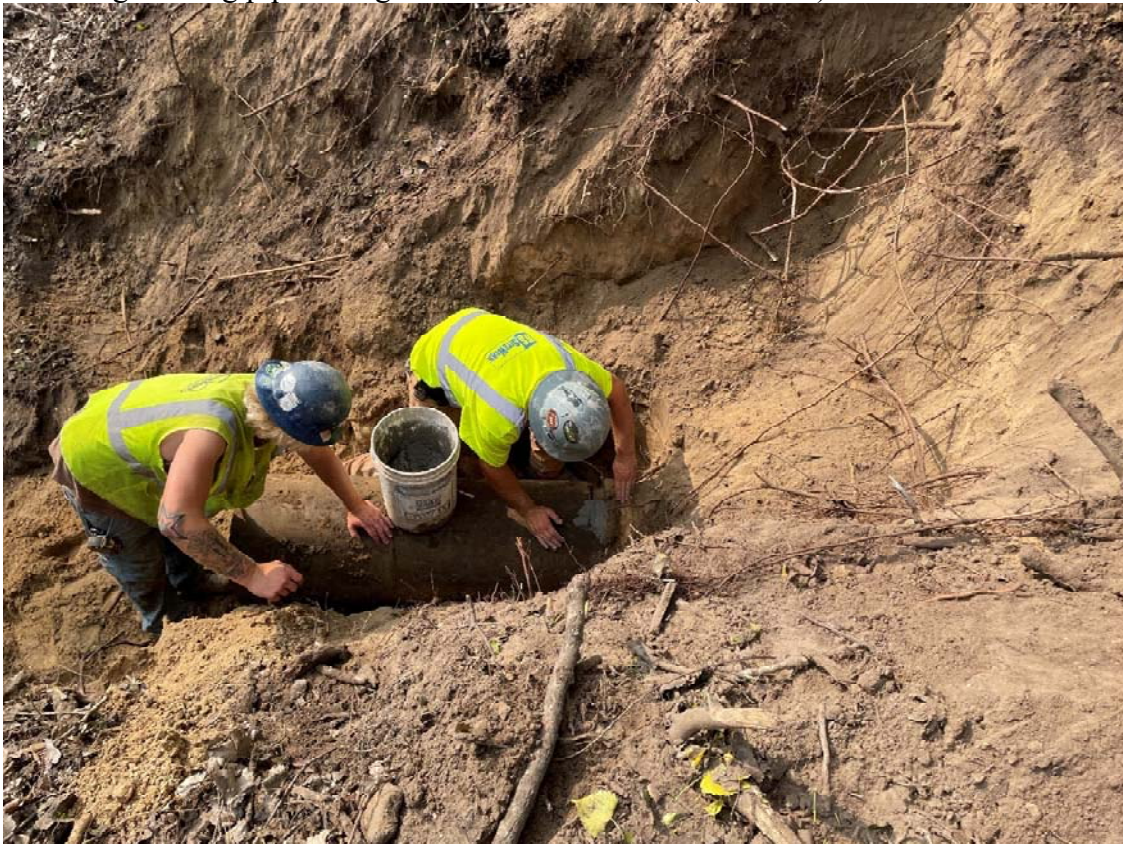
13. Attaching existing pipes using adhesive and concrete (9:00 AM).

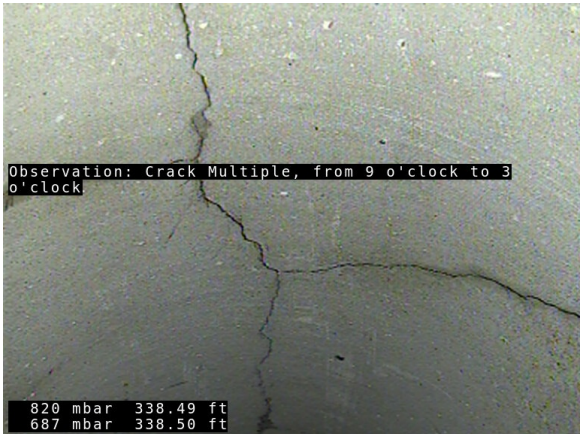
**MH-1 WEST RD-END OF PIPE\_0023.jpg**

**Crack Multiple, from 9 o'clock to 3 o'clock**

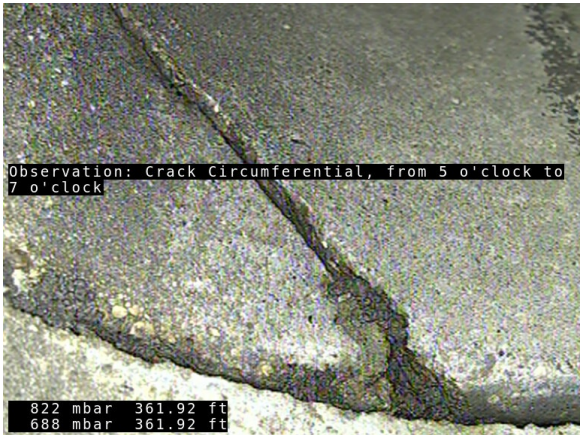
**MH-1 WEST RD-END OF PIPE\_0024.jpg**

**Crack Circumferential, from 5 o'clock to 7 o'clock**

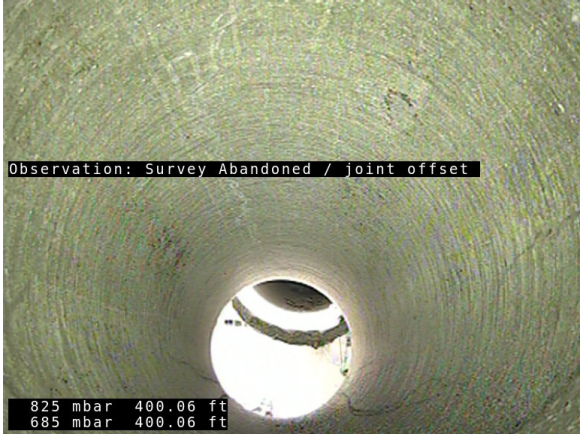
File name: **MH-1 WEST RD-END OF PIPE\_0032.jpg**  
Inspection date and time: **4/30/26 12:03 PM**  
Position: **400.05 ft**  
Code: **MSA**  
**Survey Abandoned / joint offset**

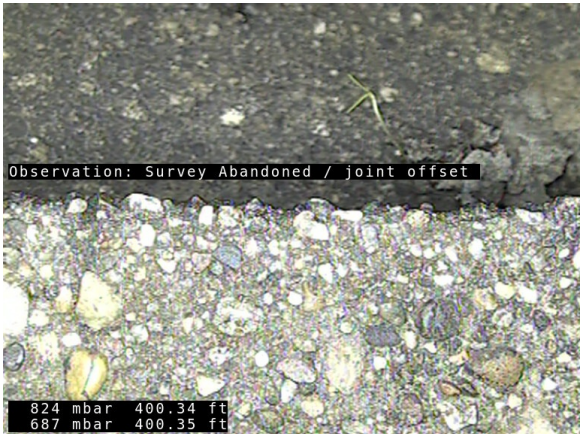
File name: **MH-1 WEST RD-END OF PIPE\_0031.jpg**  
Inspection date and time: **4/30/26 12:03 PM**  
Position: **400.34 ft**  
Code: **MSA**  
**Survey Abandoned / joint offset**

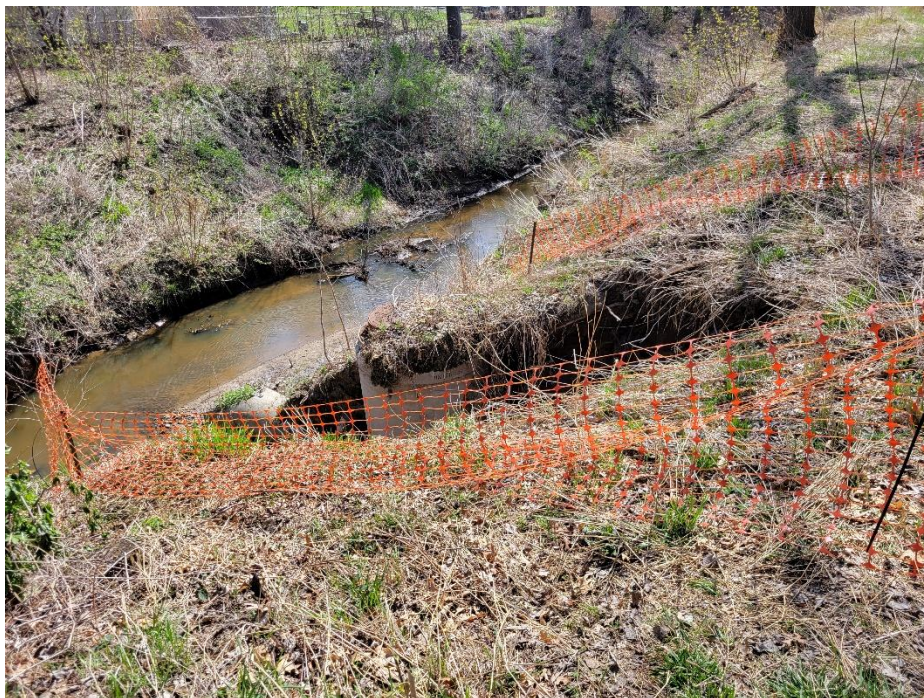
Photo 1: Scour/erosion area

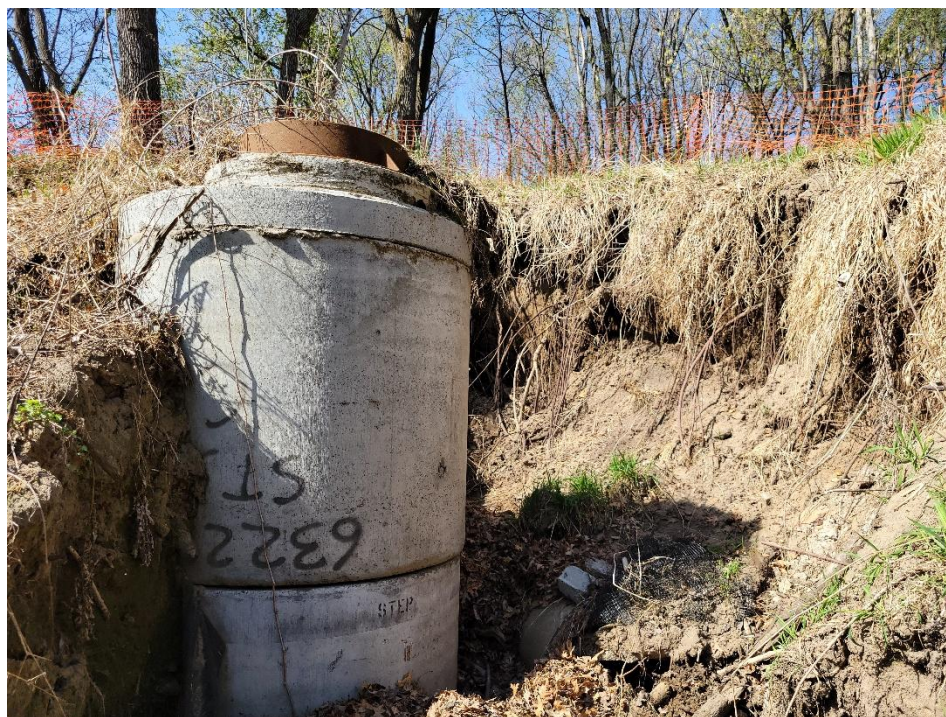
Photo 2: Scour/erosion area

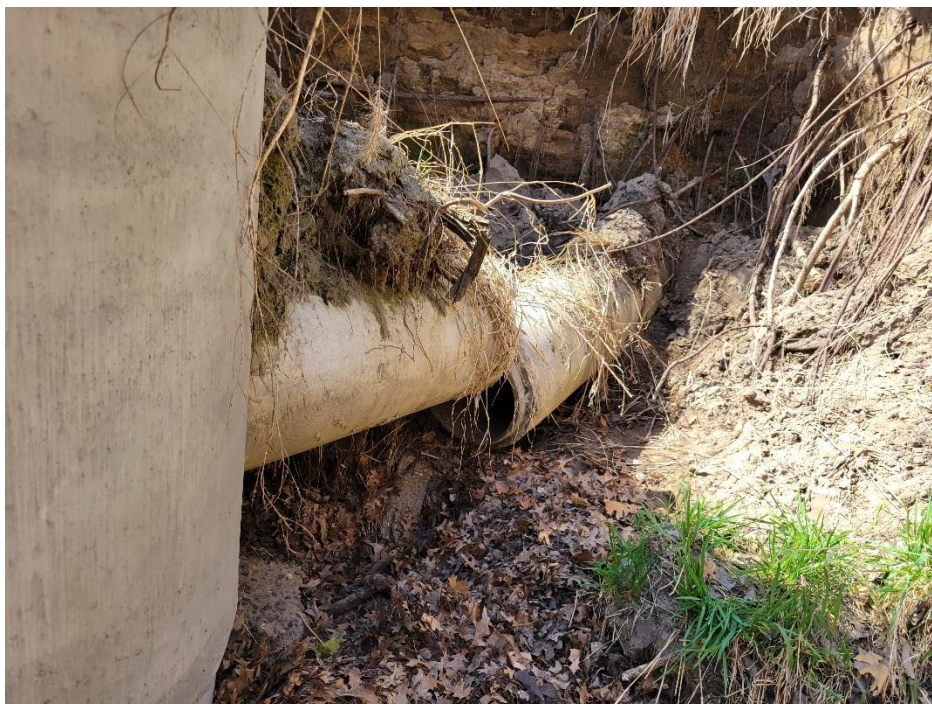
- The outfall manhole structure is intact and is not dislodged/disrupted. As well, the downstream pipe and the first upstream pipe are likewise in place. The second pipe upstream of the manhole has become separated and dislodged. In addition, the third pipe upstream of the structure has become dislodged and tipped. There is a near-vertical failure plane (wall of soil) at the upstream end of the third pipe. **See Photo 3 and 4 and Figure 1.**

Photo 3- Dislodged pipe. Note intact pipe segment connected to new structure.

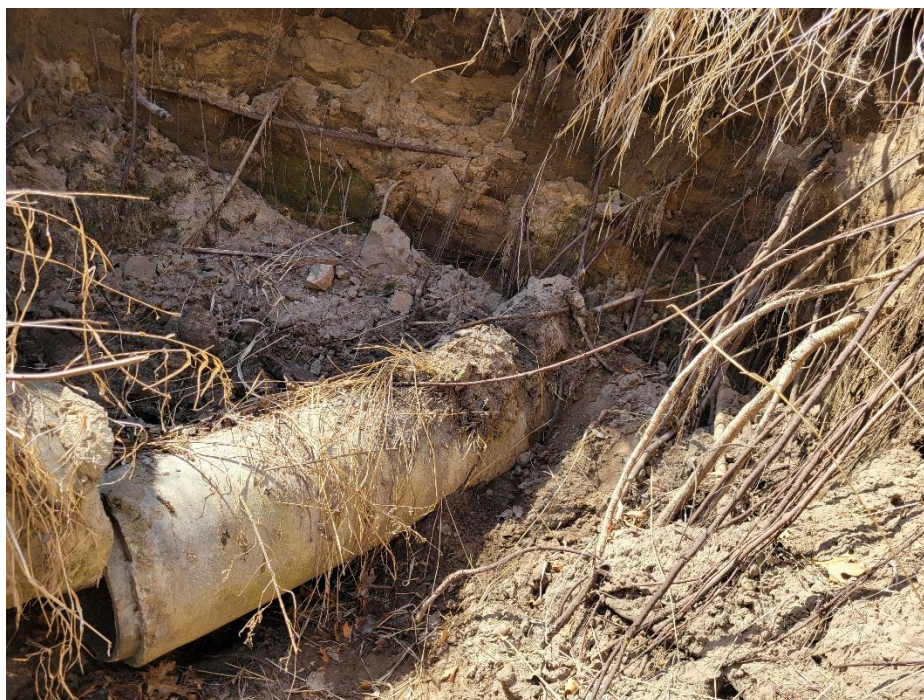
Photo 4- Dislodged pipe segments

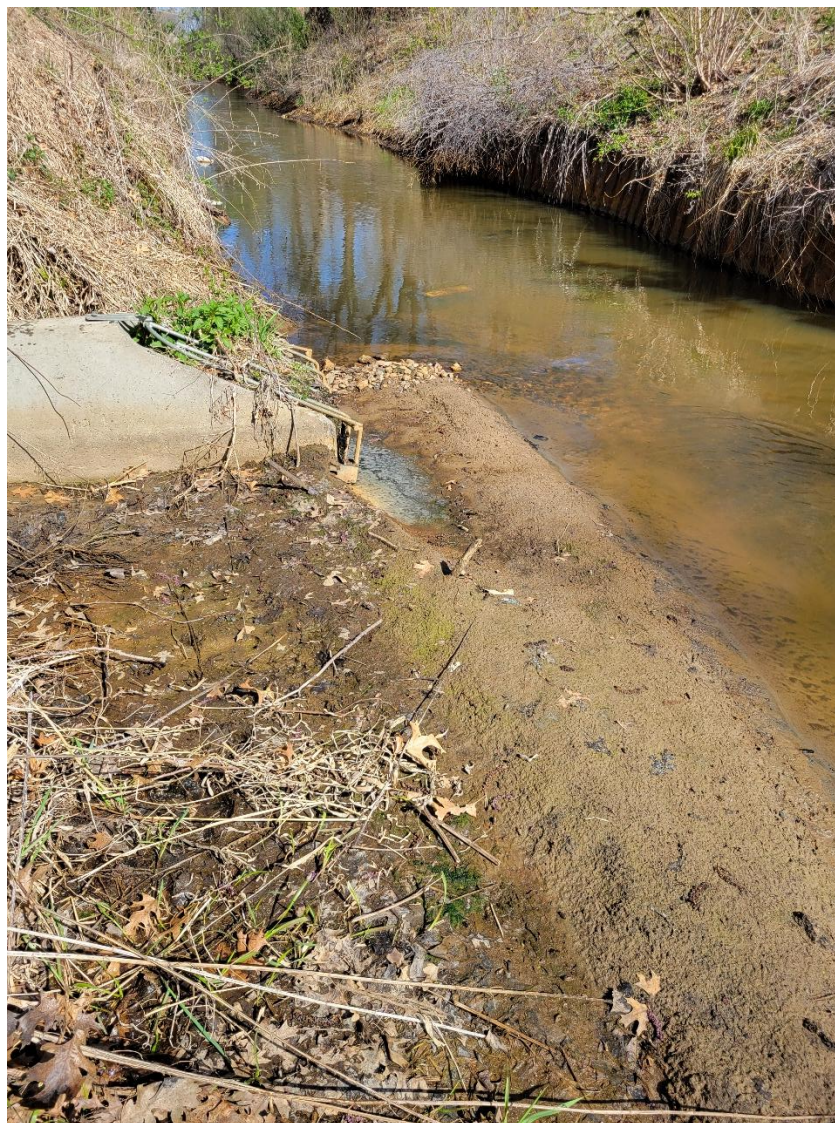
- Sediment in the outfall pipe apron originated upstream of the joint separation, which dropped into the outfall structure and eventually blocked up the pipe. Sediment accumulation likely was exacerbated by the presence of the apron trash guard.
- No evidence exists that contractor workmanship in the outfall structure replacement was a source or contributing factor in the erosion. This is evidenced by the undamaged outfall structure, which remains intact despite the erosion occurring upstream of it and along it.

Photo 5- Pipe apron sediment. Note plume of sediment on left side of ditch.

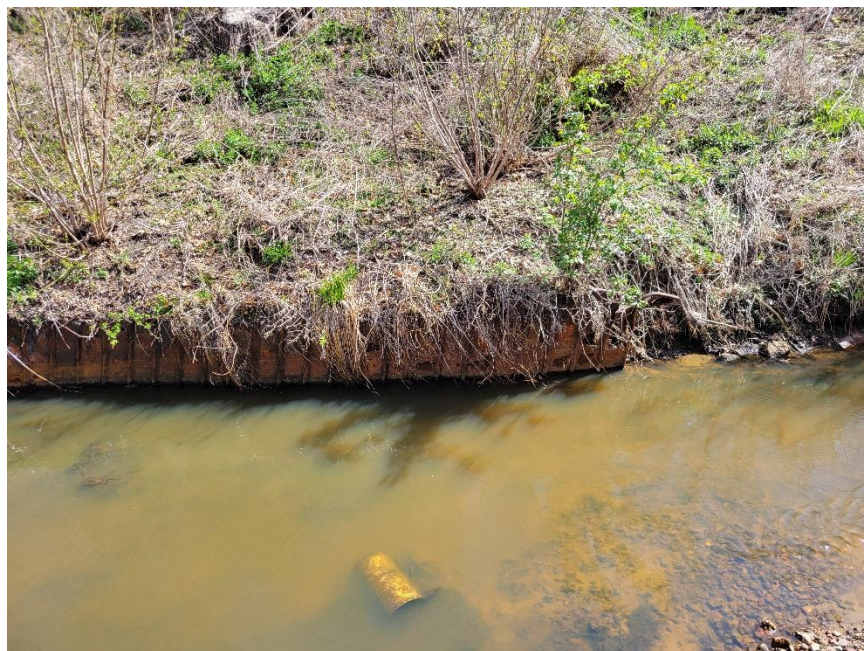
Photo 6- Bank Conditions Across from Pipe Outlet

As indicated in WSB's report, sediment deposited from the erosion failure needs to be cleaned out of the ACD 53-62 ditch. In addition, across the ACD 53-62 ditch from the City outfall, a sheet-pile wall exists that terminates upstream of the City outfall. **See Photo 6.** Under high flows, the City stormsewer could potentially cause scour of the opposing bank where the sheet pile ends. The sheet piling should be extended another 30-40 feet downstream to decrease this erosion risk. The RCWD may consider coordinating this work in conjunction with the City's repair of its stormsewer and erosion restoration.
