Technical Memorandum

Subject: Ramsey County Ditch 1 – Historical Review

Date: April 10, 2024

Project #: 5555-0345

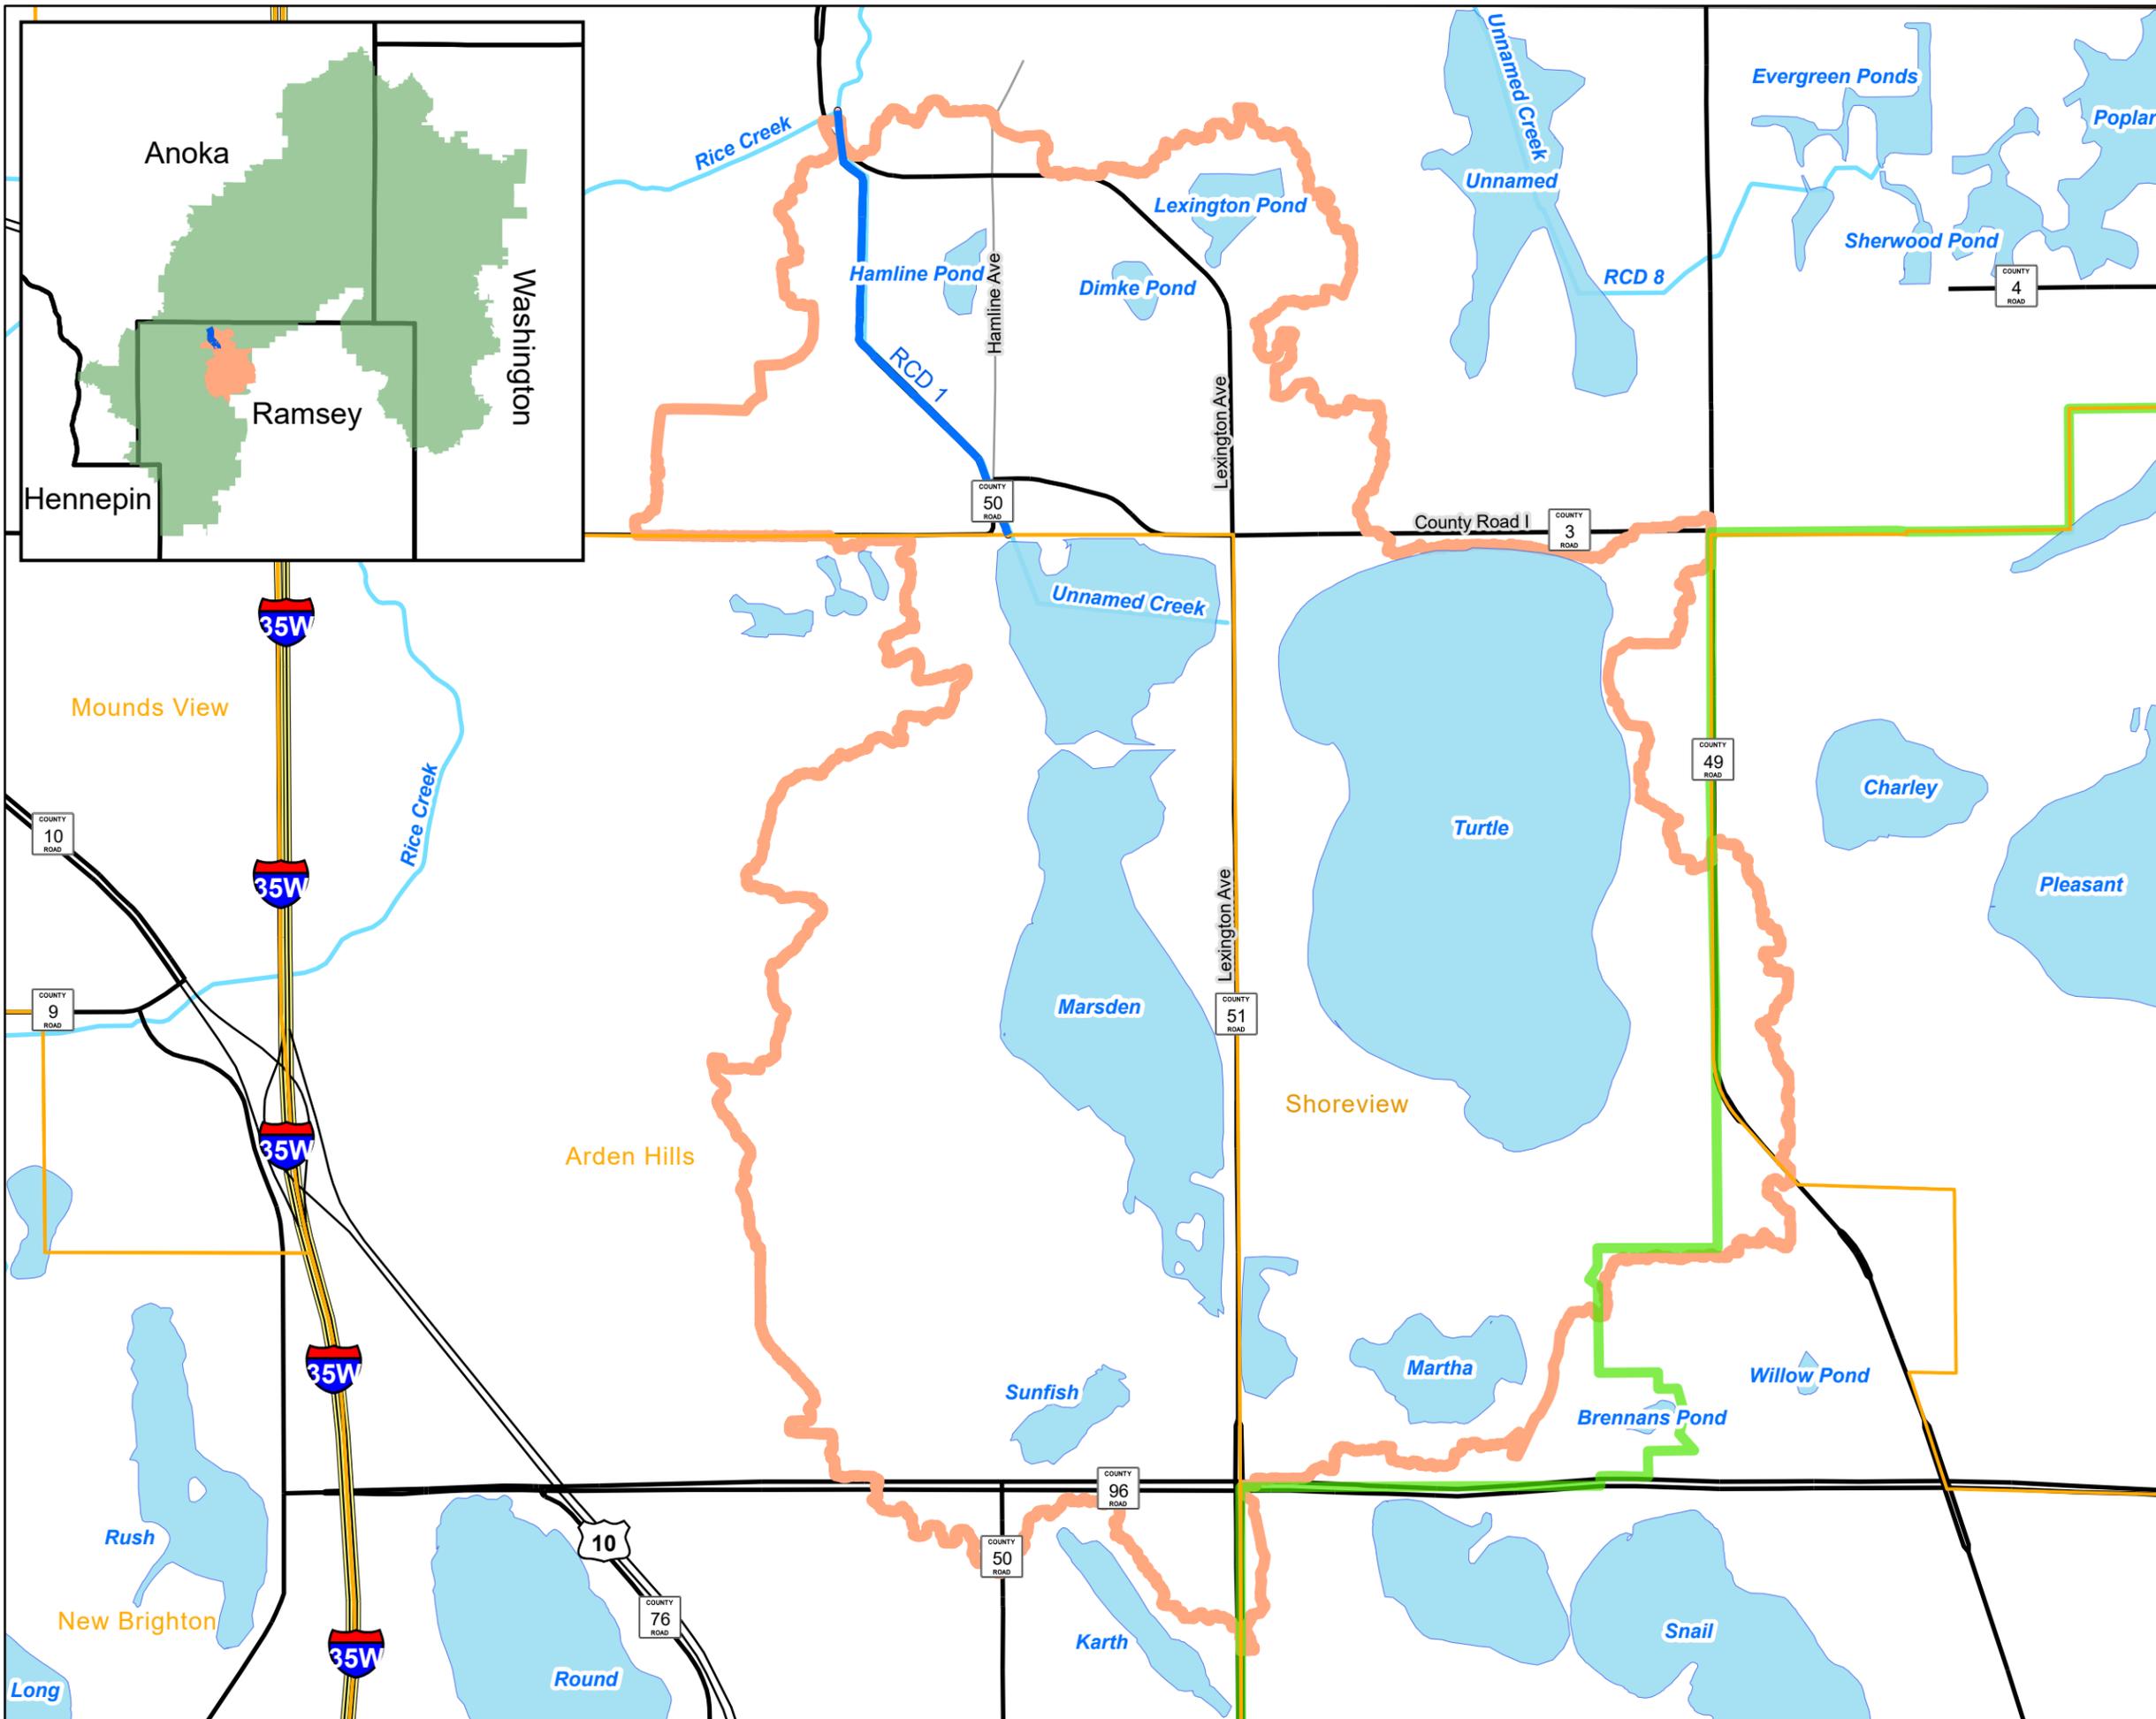
Figure 1: Hydrologic Boundary RCD 1

The RCD 1 public drainage system consists solely of a Main Trunk open channel approximately 1.1 miles in length and is located within Section 3 T30N, R23W within the city of Shoreview, Ramsey County. RCD 1 generally flows north and west from the Patrol Road at the Twin City Army Ammunition Plant; and terminates at the confluence with Rice Creek east of Lexington Avenue as displayed in **Figure 1**. The land that contributes runoff (i.e. drainage area) to RCD 1 is approximately 3,000 acres (or 4.7 square miles) in Sections 1-4, 9-16, 22, and 23 of T30N, R23W and flows through Marsden Lake, Public Waters Inventory Number 62-59P as displayed on **Figure 2**. The drainage area is predominantly developed for residential, commercial, and military land uses with no agricultural lands served by this public drainage system. The surrounding area is fully urbanized with some low lying areas and several lakes, including Turtle Lake, which occasionally overflows into a private ditch, flows through Marsden Lake and then connects to RCD 1.

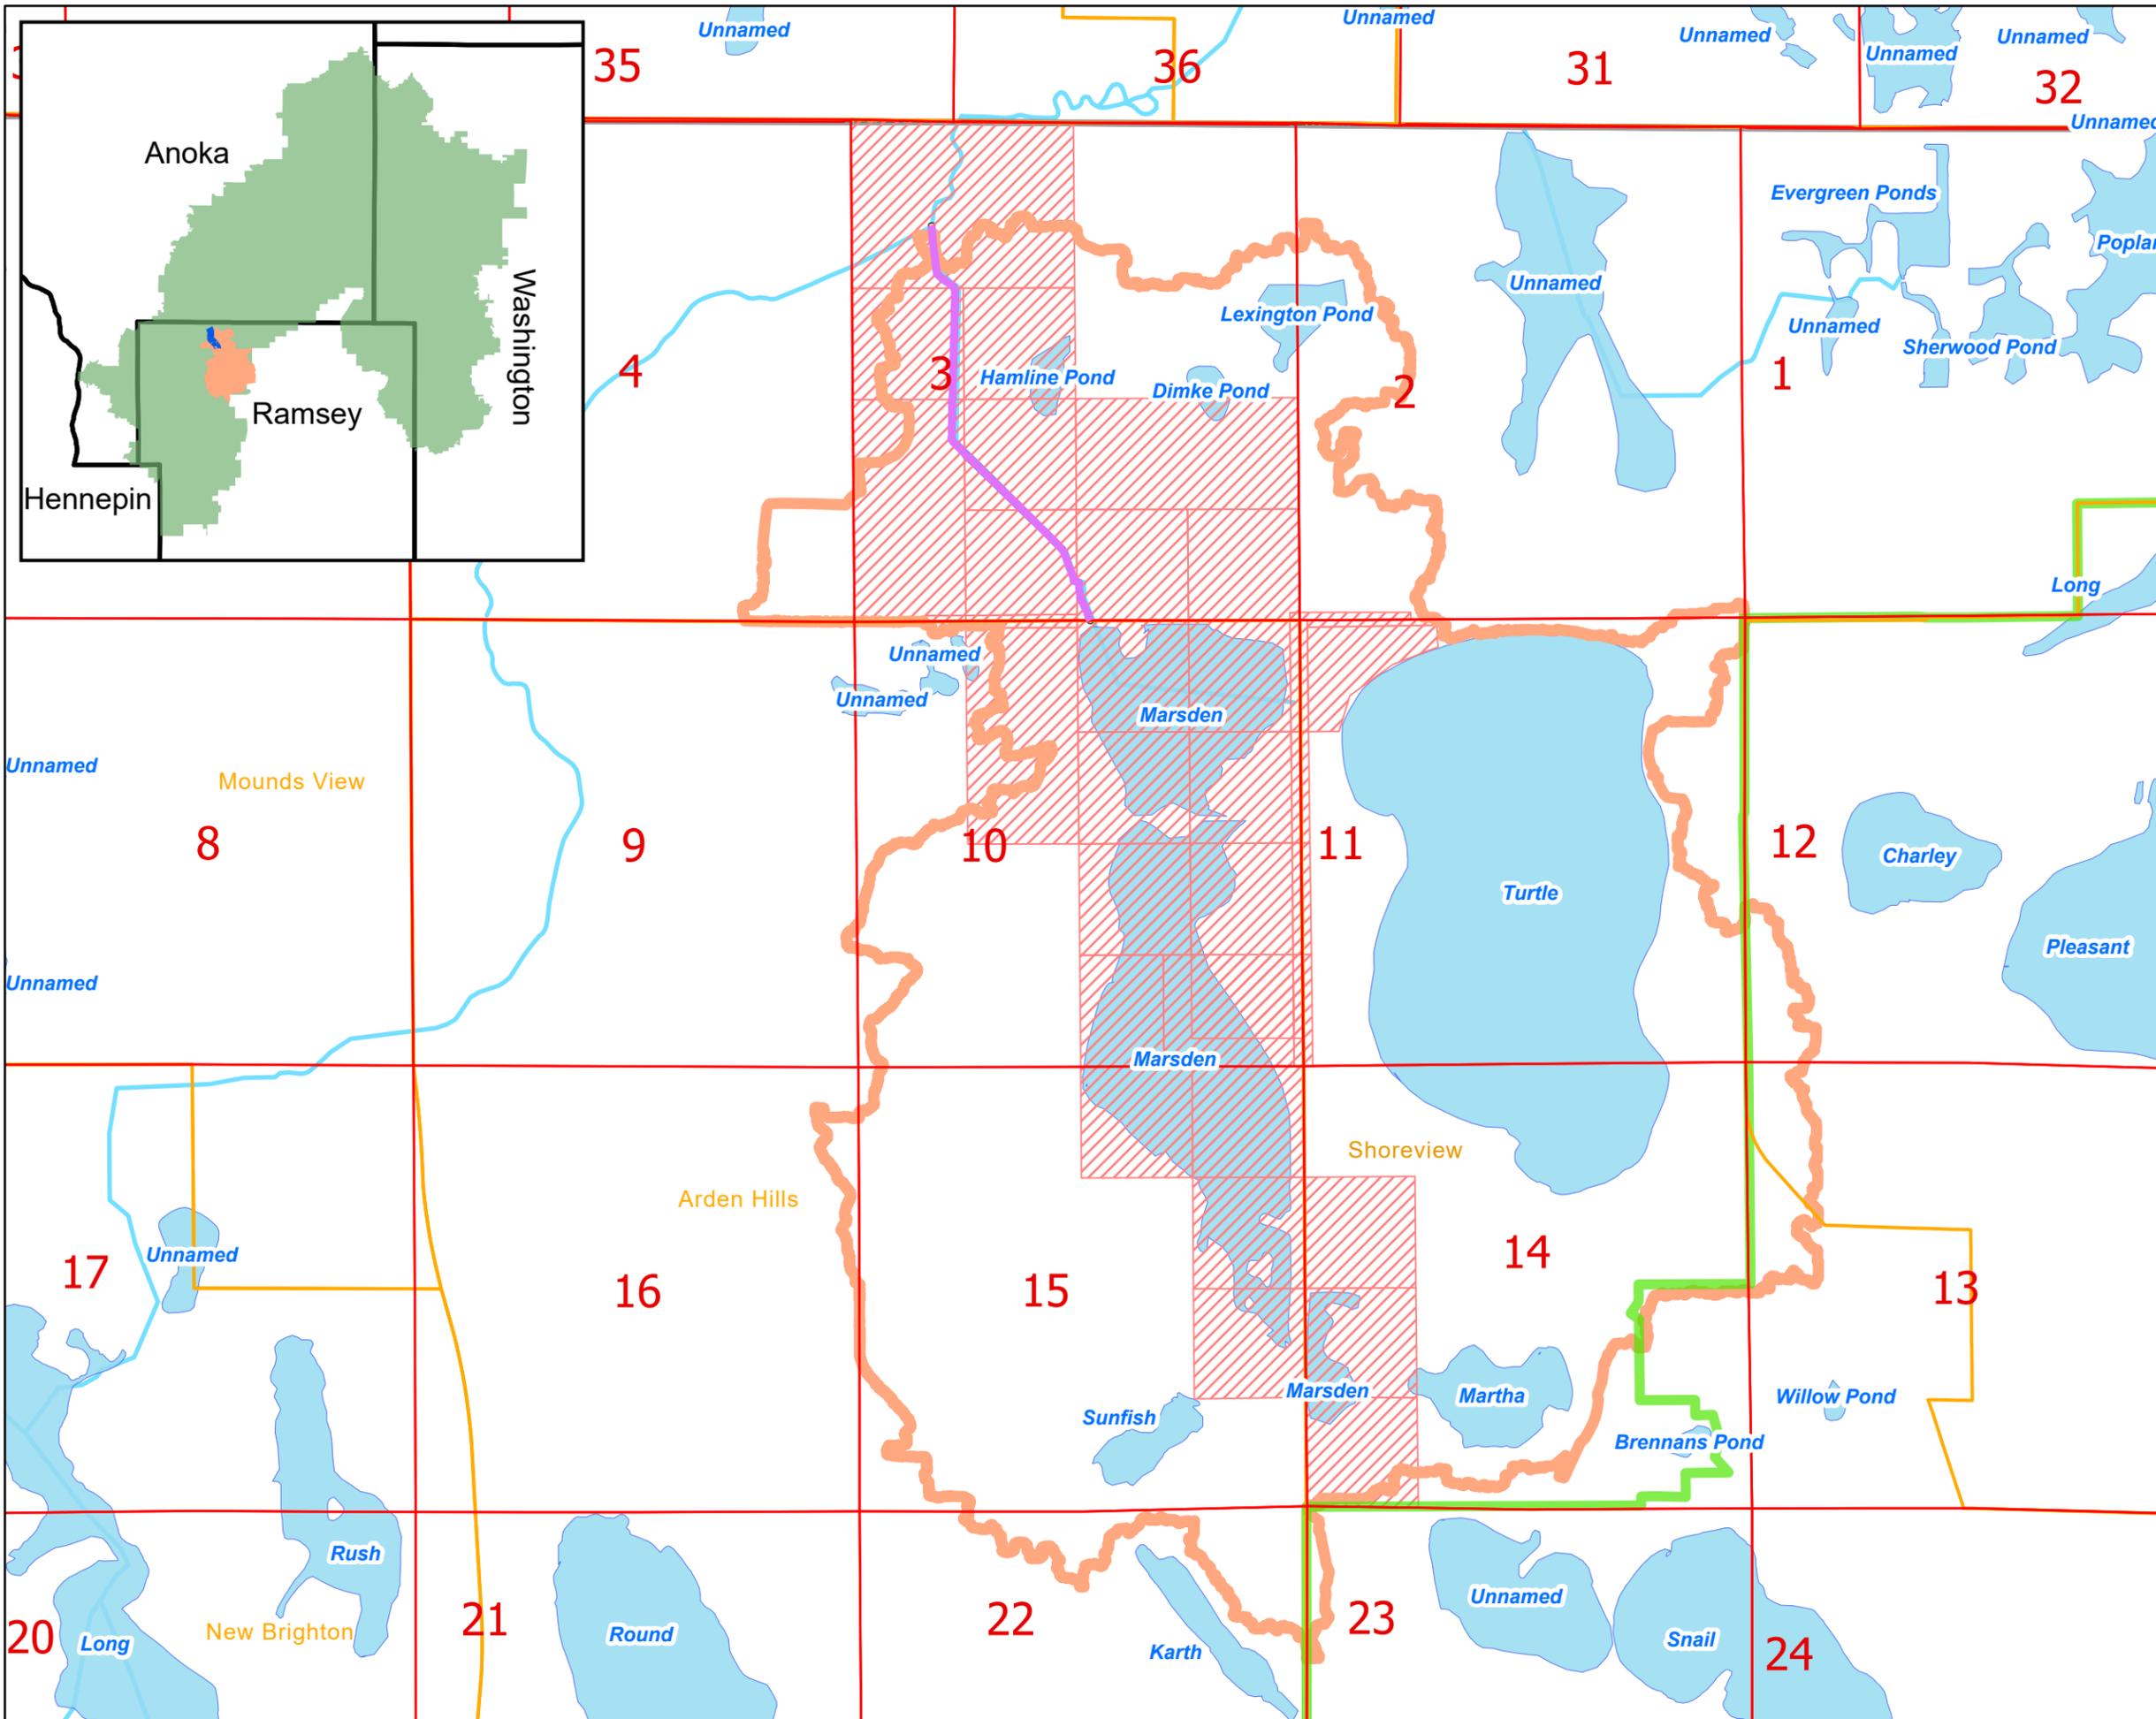
Figure 3: RCD 1 Benefiting Lands

*As defined in the 1914 Assessment for Repair

Repairs to the ditch in 1914 are documented through an auditor's tabular assessment statement, including costs that were assessed to benefitting acres presented visually in **Figure 3**. Charges were split up into equal installments for a 10-year pay back period.

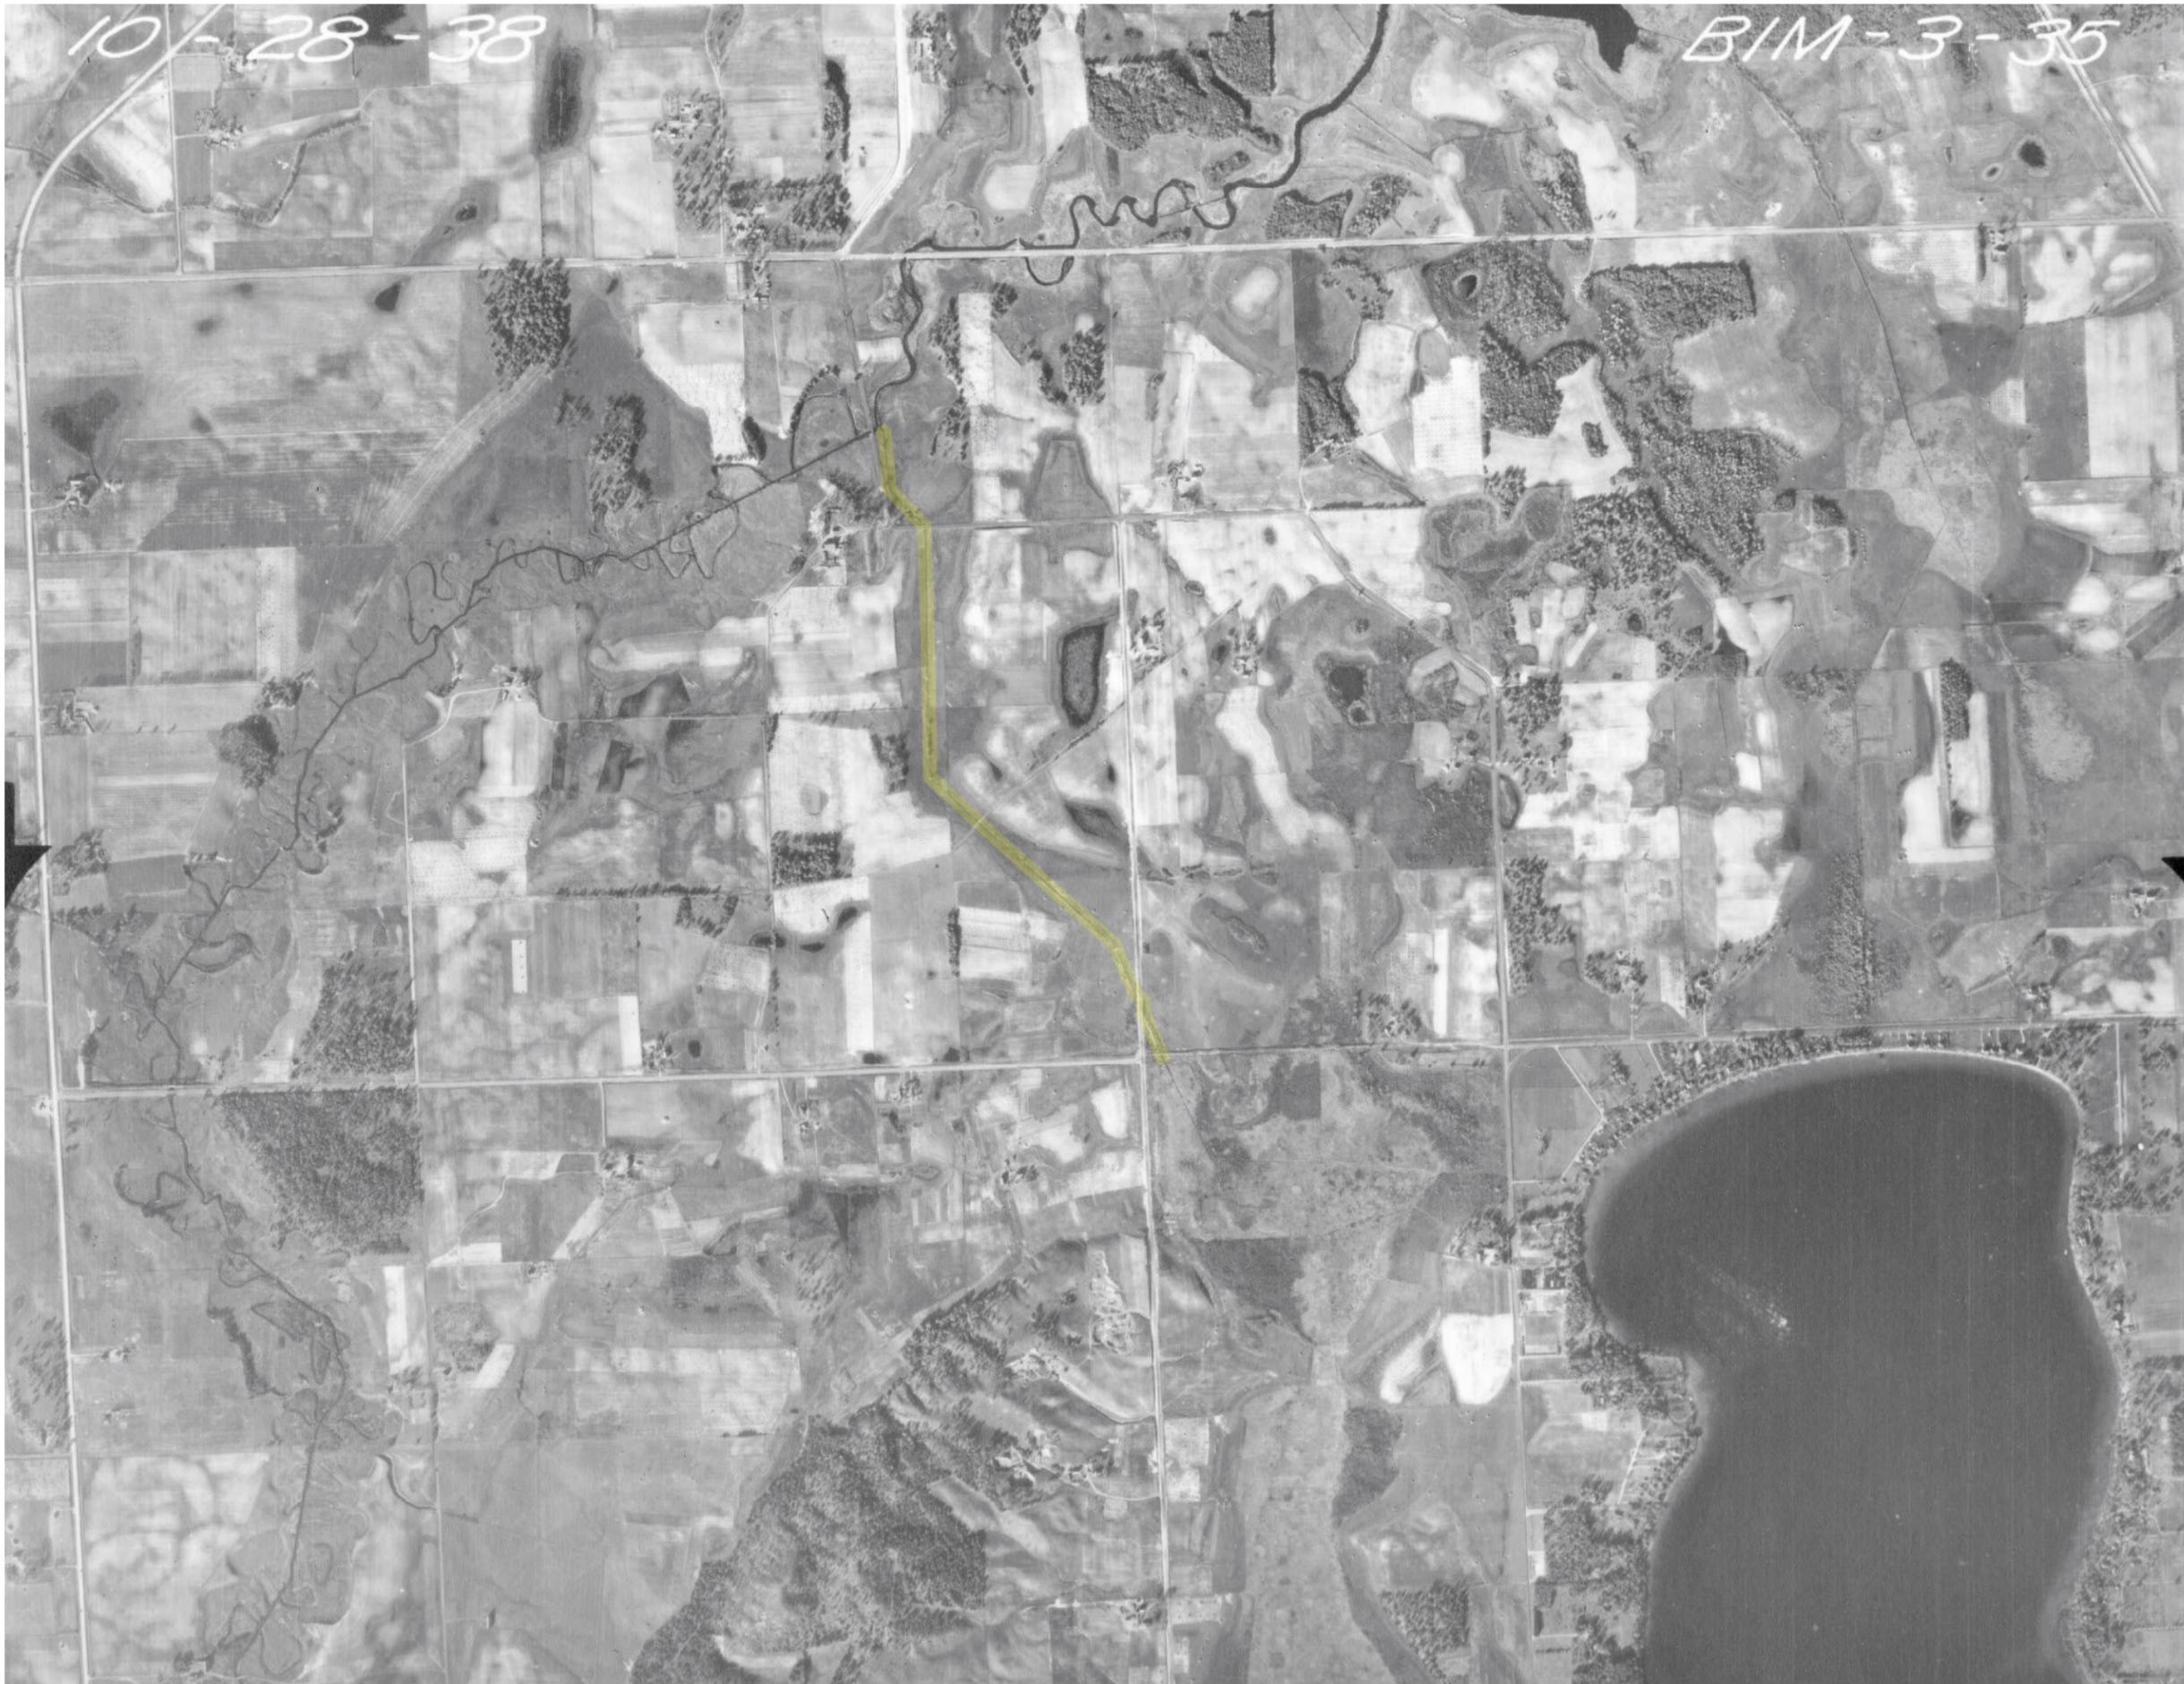
Figure 4: Historic Aerial 1938

Yellow Highlights
Added to Show RCD 1
Alignment

Historic aerial imagery is captured in 1938, 1940, 1953, 1957, 1960, and 1964 and is stored digitally at the University of Minnesota's web portal MHAPO <https://apps.lib.umn.edu/mhapo/>. These historic images help defined when and where the different roadways traversed adjacent to and across the ditch. They aid in the understanding of the landuse in the watershed, and the extents of development at different times in the history of RCD 1. **Figure 4** displays the landuse adjacent to the ditch in 1938.

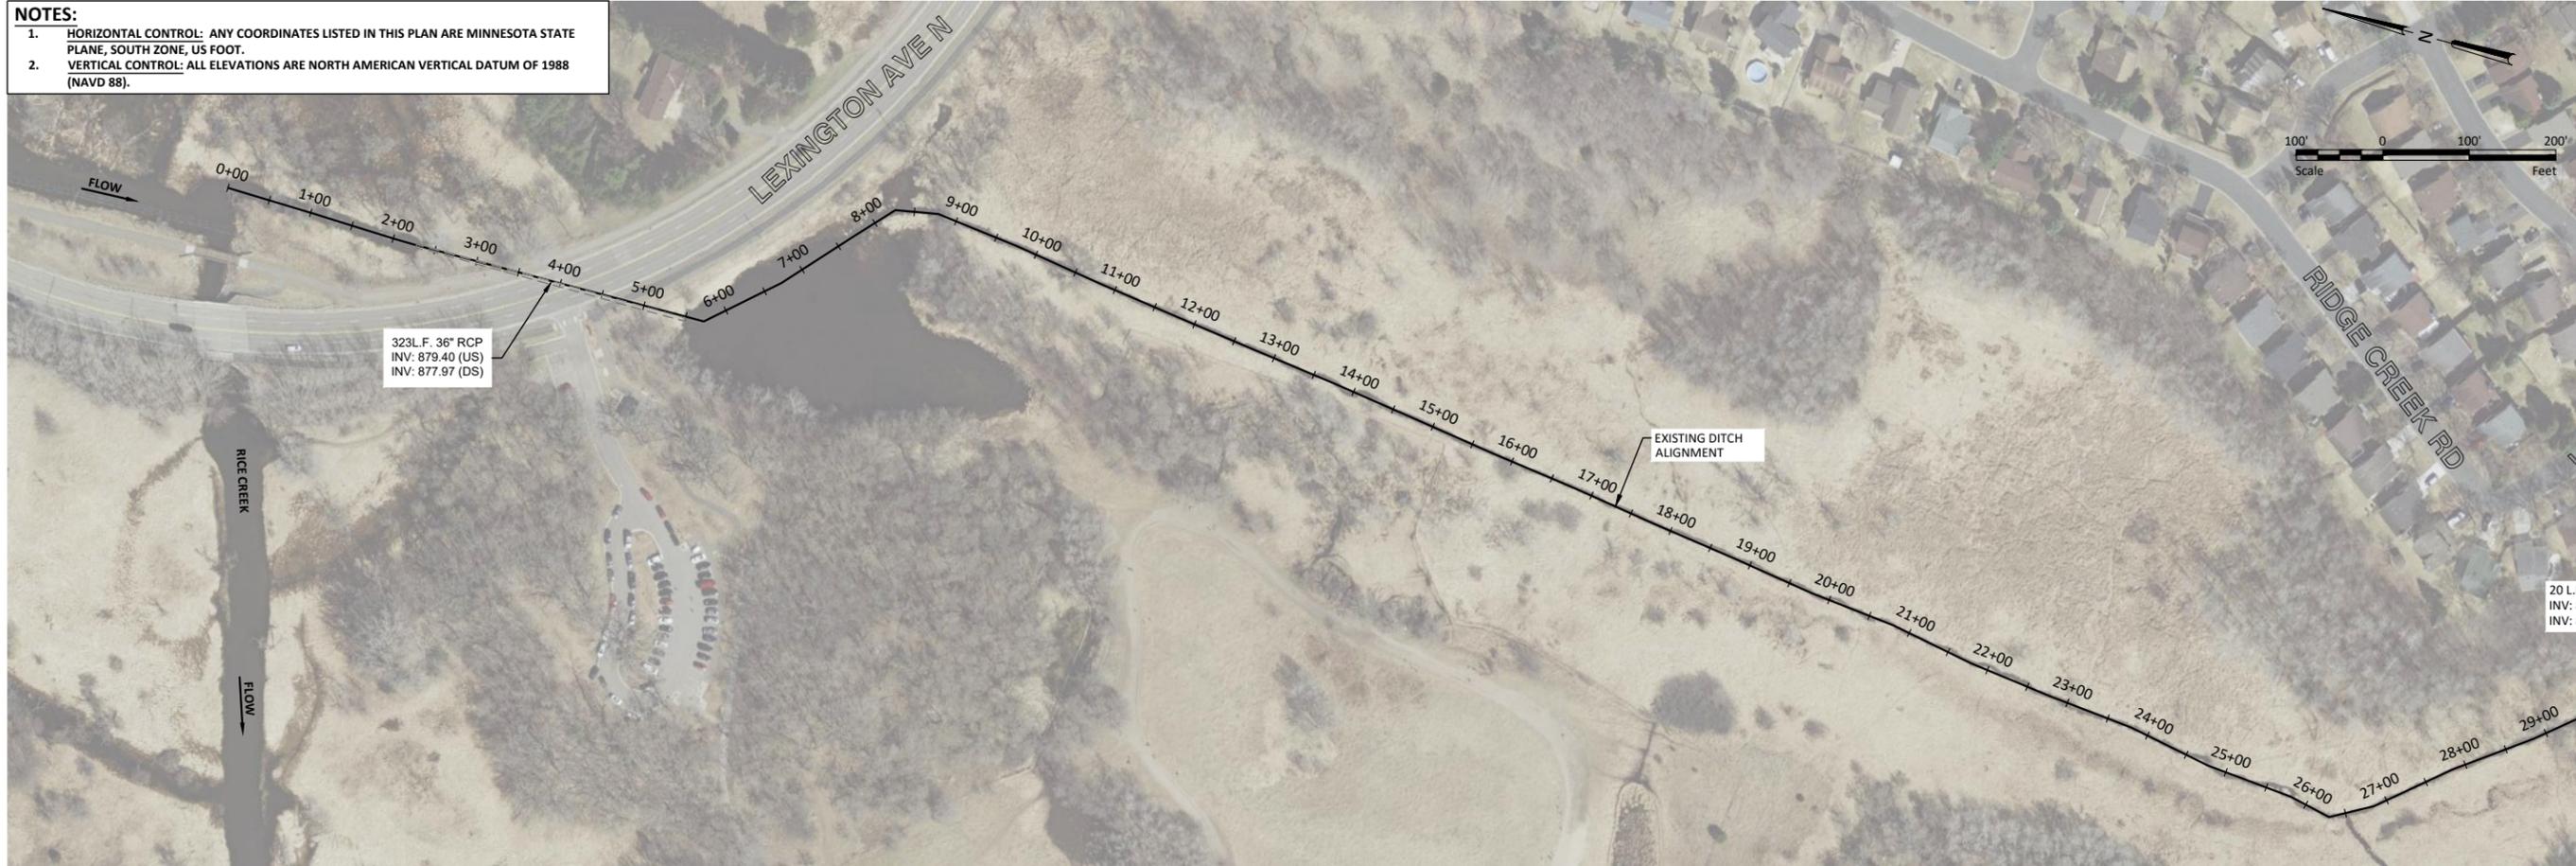
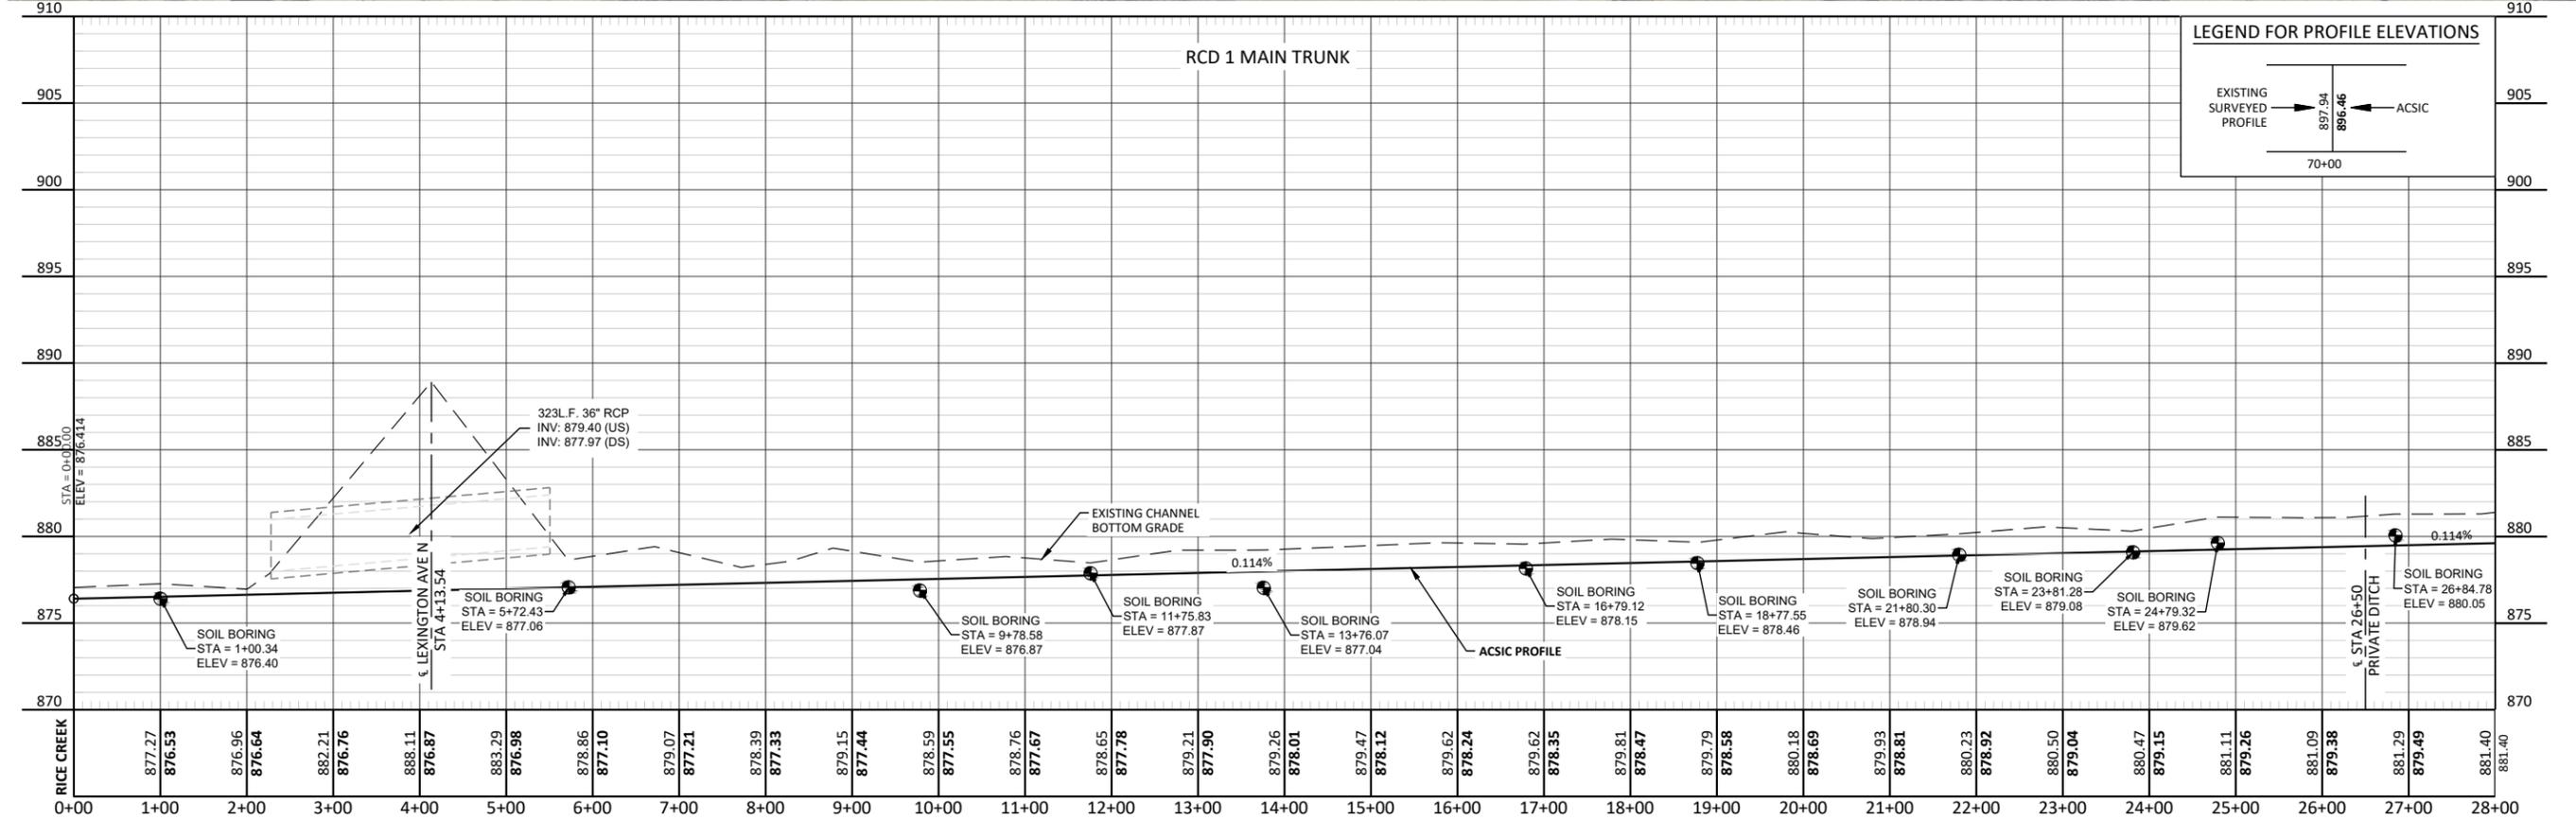
By	
Date	
Revision	
No.	
RAMSEY COUNTY DITCH 1 HISTORIC REVIEW RICE CREEK WATERSHED DISTRICT PLAN AND PROFILE (1 OF 2)	
Drawn By	APD
Checked By	ANN
Date	TBD
Scale	As Shown
Project No.	5555-0345
SHEET	1

EXISTING SURVEYED PROFILE: 897.94

ACSIC PROFILE: 896.46

Pertinent documents for determining the as-constructed ditch grade and cross section include inspection reports and profiles previously referenced in this report, and briefly summarized here. A surveyed profile from 1944 displays an existing ditch grade of 0.1%. The St. Paul Water pipeline profiles from 1960 add some information regarding crossings on the upstream end of the ditch. An inspection report from 1985 claims the original design was completed in 1898 with a 2-foot ditch bottom width, 0.5:1 ditch side slopes, average depth of 2.5 feet, and an average design slope of 0.15%. This same report also documents the condition of the ditch at time of inspection having a bottom width of 4 feet, side slopes of 1.5:1, average depth of 3 feet, and an average slope of 0.1%. A historical plan and profile drawing of RCD 1 assumed to be from the mid-1980's shows the as-constructed ditch slope of 0.114%. An inspection report from 1995 shows an existing profile of 0.1%. All of this information is utilized to corroborate the ACSIC ditch grade and cross section of RCD 1.

Within this historic review, field survey of the ditch and drainage structures are utilized to assist in the establishment of the ACSIC grade and cross section. The survey confirms the current conditions of the ditch cross section and profile, and confirms the as-constructed profile through the use of soil borings, which determine the “hard” clay elevation of the true ditch bottom. In the absence of design profiles, it is assumed that the elevation of bottom of organic sediments indicates the historical channel bottom. A “best-fit” line through the soil boring data is utilized to determine the as-constructed profile and has a slope of 0.114% and is the ACSIC determination of ditch grade for RCD 1 as displayed in **Appendix B**. Surveyed cross sections along the ditch are utilized to establish the ACSIC ditch cross section for RCD 1 with a 5-foot average bottom width, and 1.5:1 average ditch side slopes. This compares well with the cross section geometry listed in the 1985 inspection report.
