# Technical Memorandum

**Subject:** ACD 53-62 Branches 5+6 Repair Report

**Project #:** R005555-0347

# RICE CREEK WATERSHED DISTRICT ACD 53-62 BRANCH 5 & 6 REPAIR RICE CREEK WATERSHED DISTRICT JULY, 2024

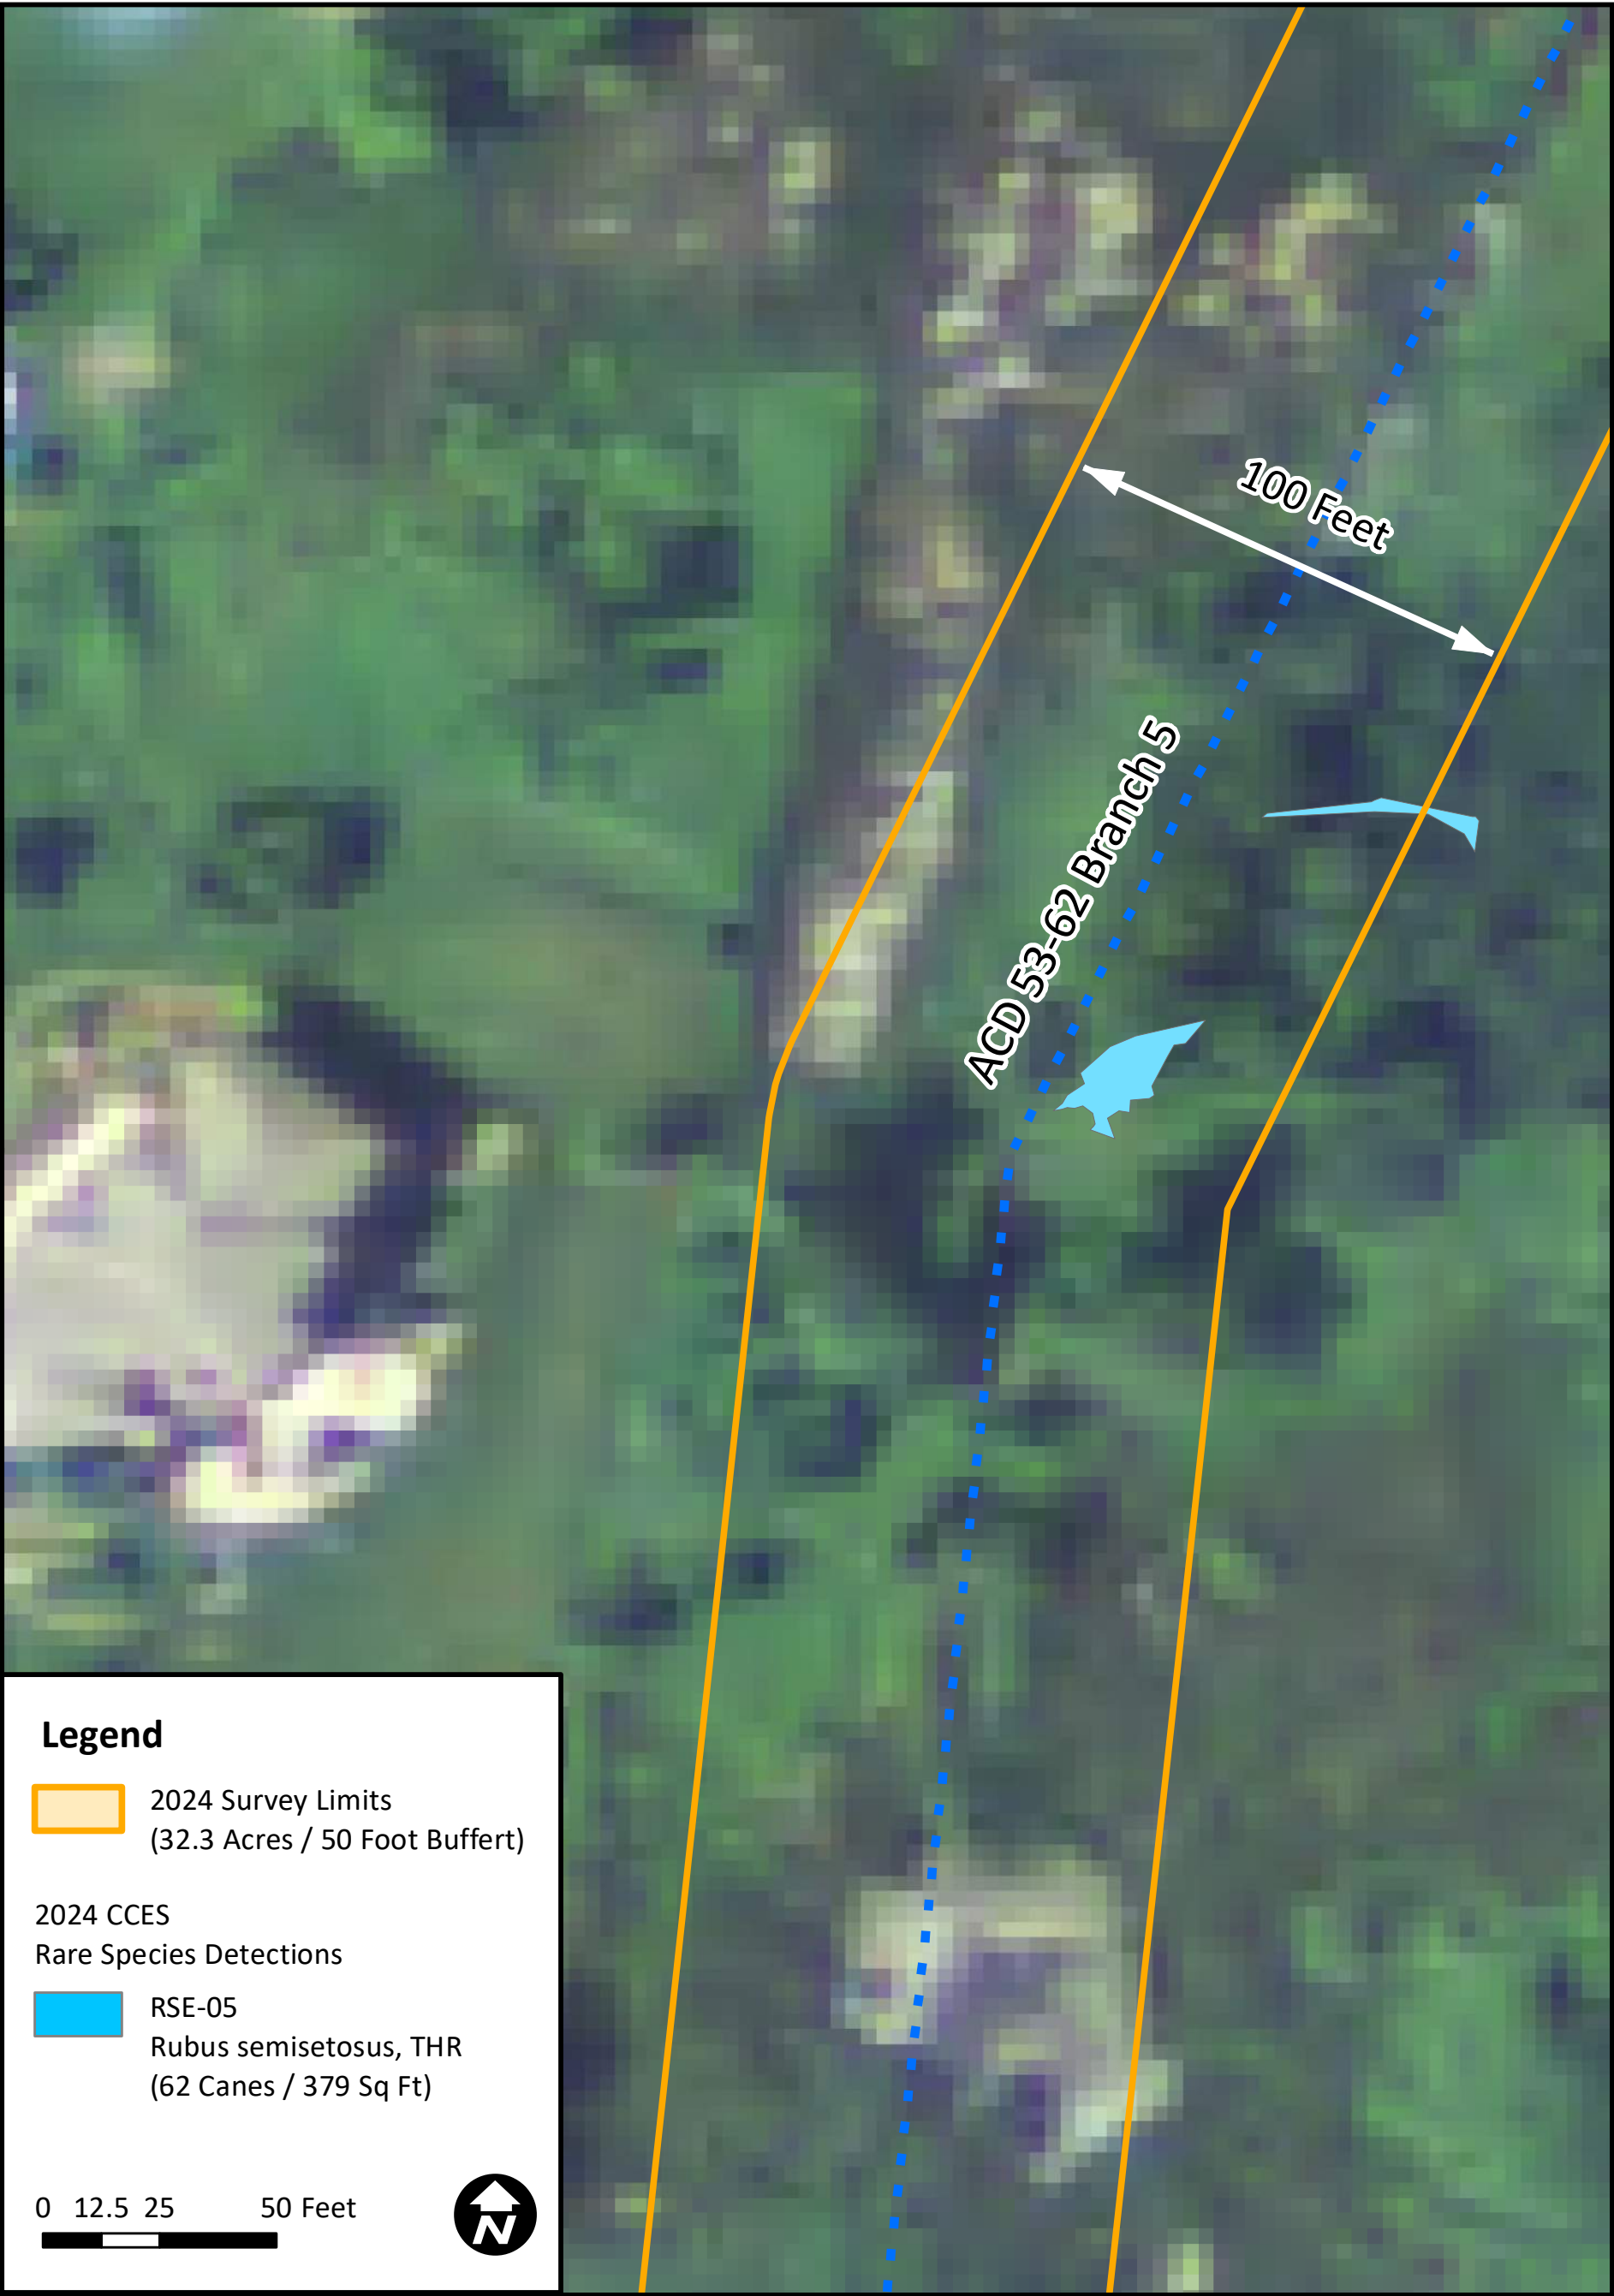
Anoka County Ditch 53-62, Branch 6  
Rare Plant Surveys  
2024 CCES Rare Plant Detections (Detail)  
Rice Creek Watershed District, Blaine, Anoka County, MN

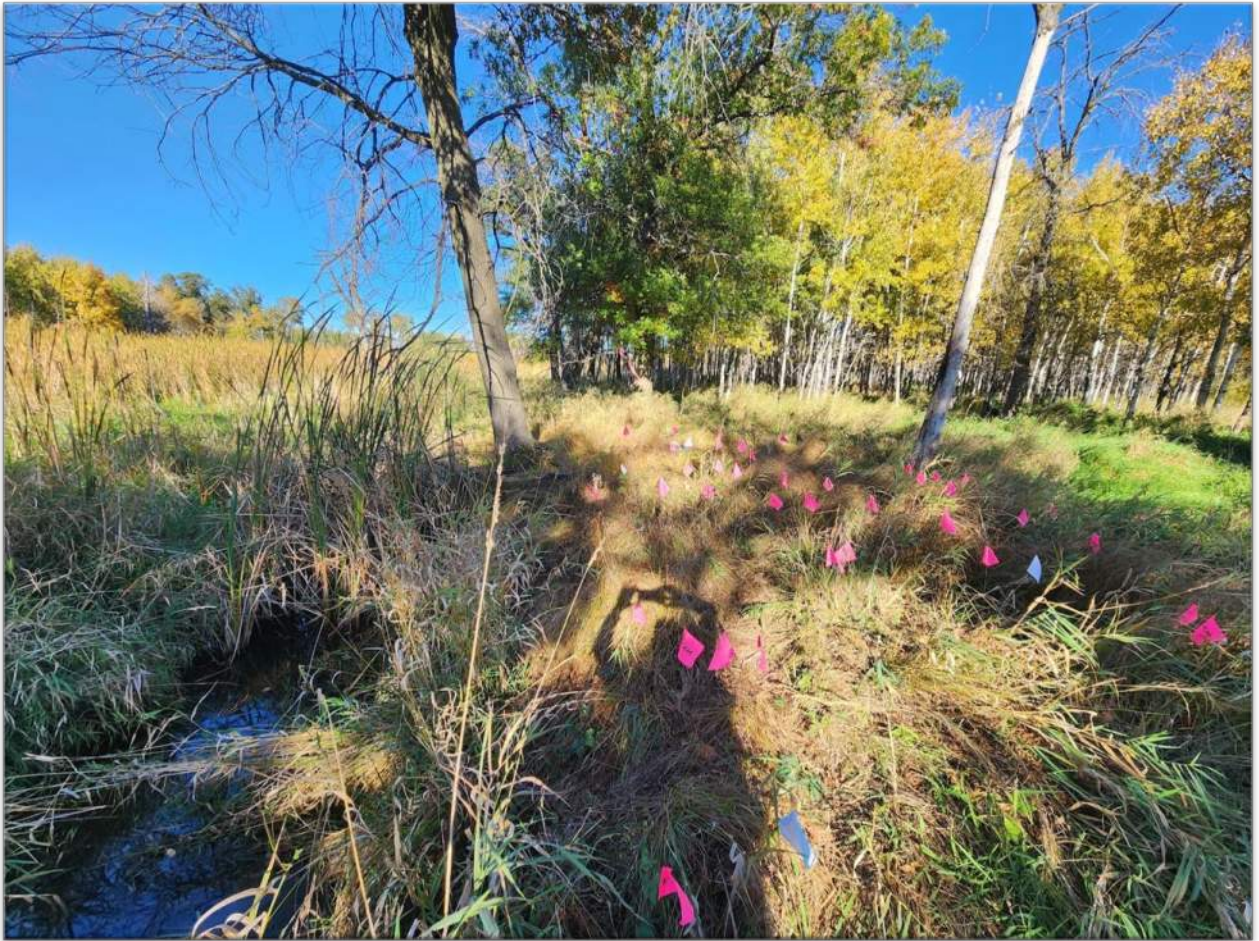
*Rubus semisetosus* subpopulation RSE-05 along the eastern edge of ACD 53-62 Branch 5

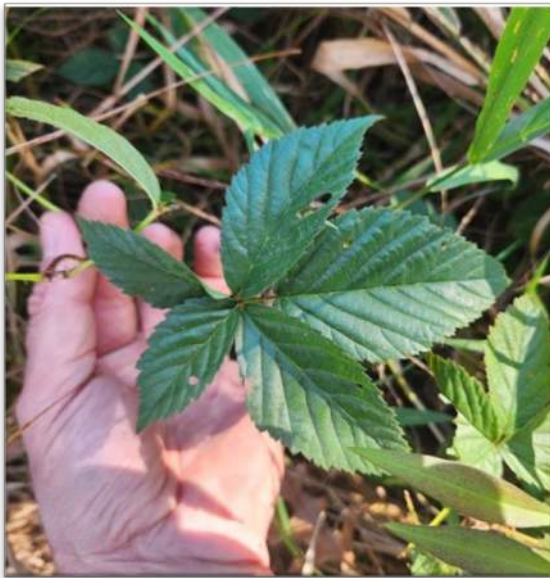
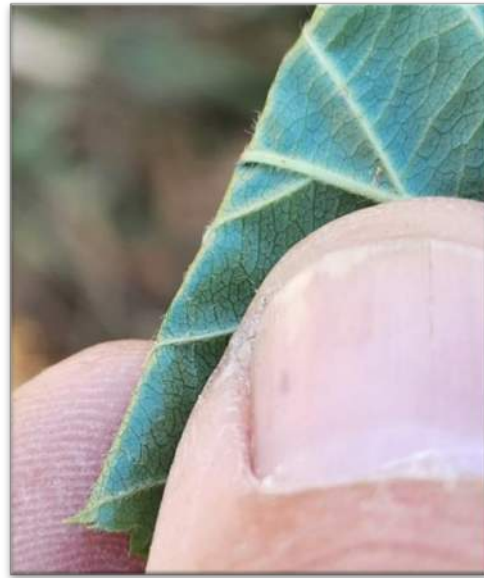
*Rubus semisetosus* subpopulation RSE-05, primocane leaf and leaf hairs detail

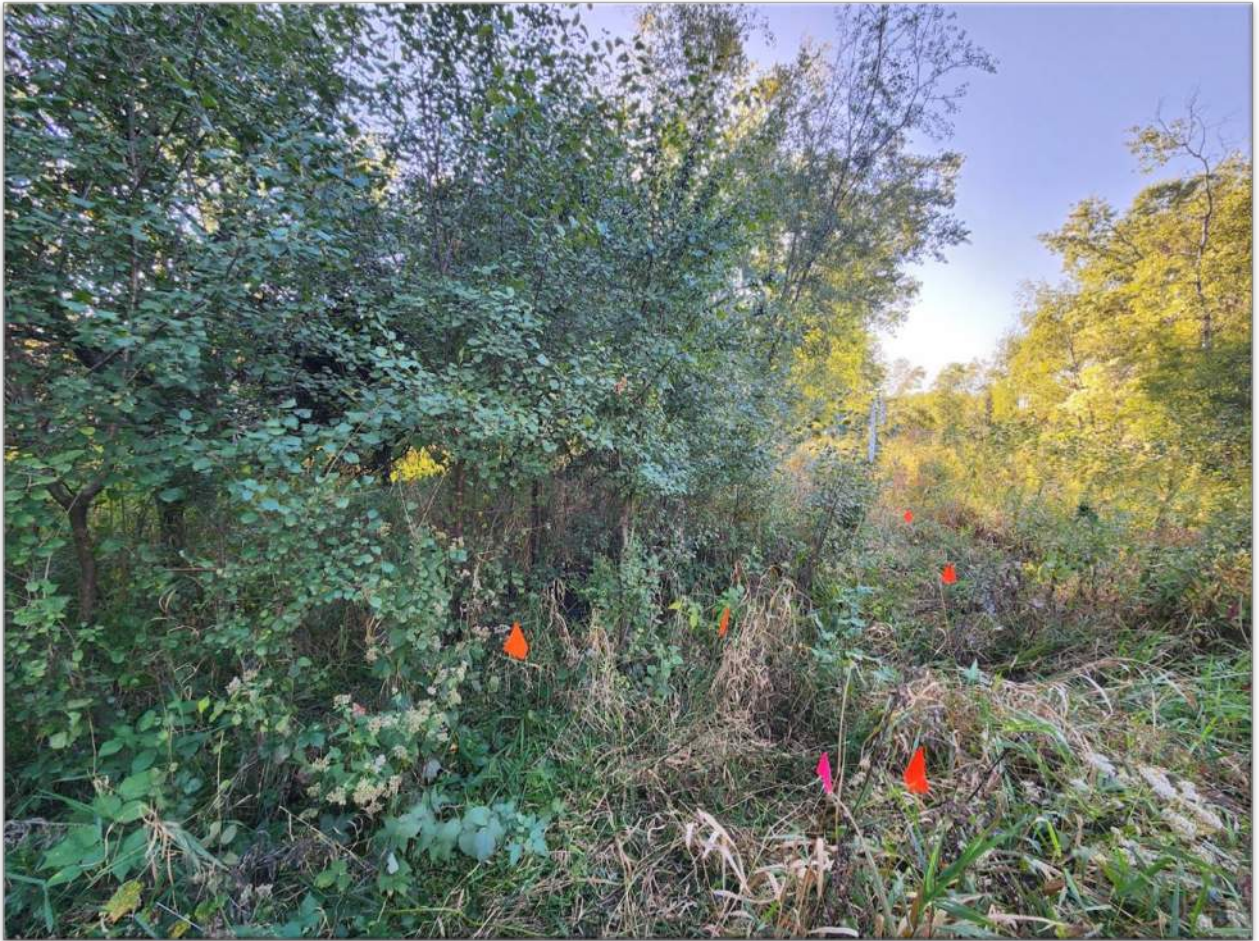
*Rubus stipulatus* and *R. semisetosus* habitat at southern end of ACD 53-62 Branch 6

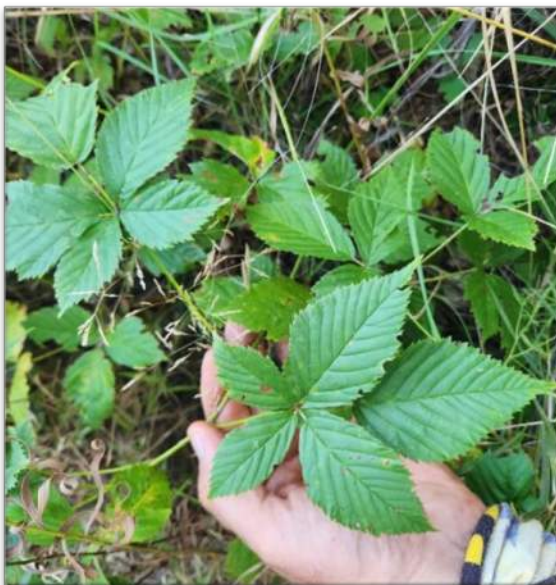
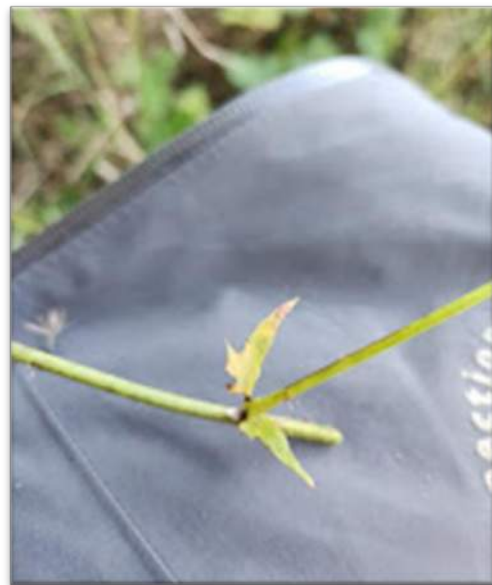
*Rubus stipulatus* subpopulation RST-06 leaf and diagnostic stipules

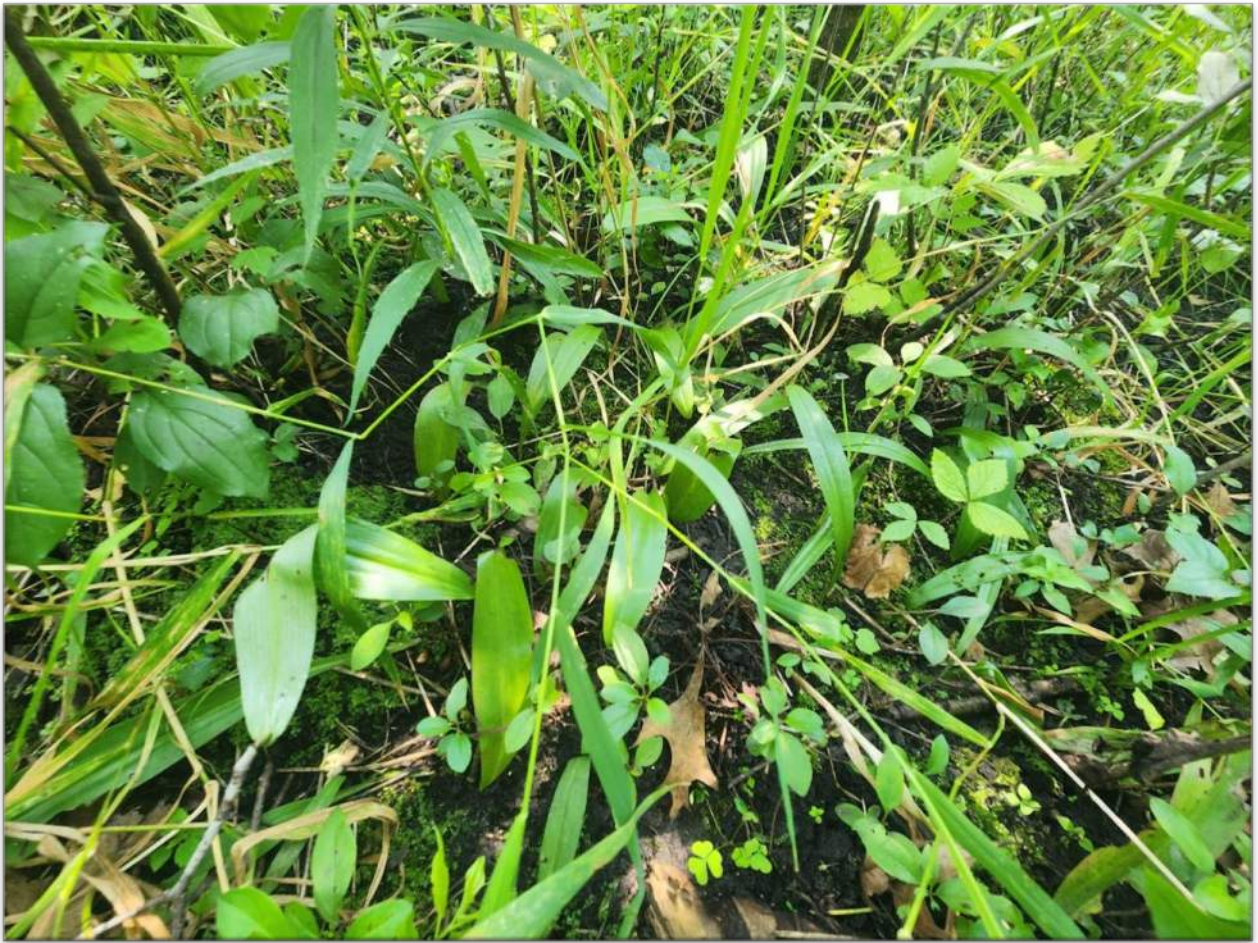
*Platanthera flava* subpopulation PF-06, cluster of basal leaf plants at ACD 53-62 Branch 6

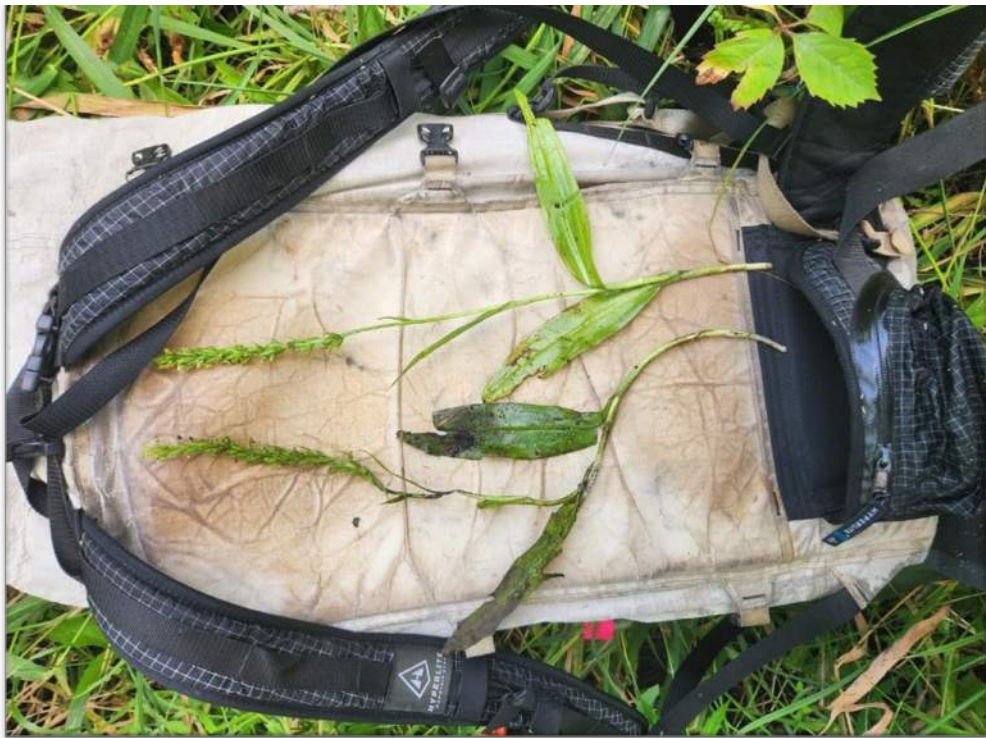
*Platanthera flava* subpopulation PF-06 voucher specimens of flowering orchids

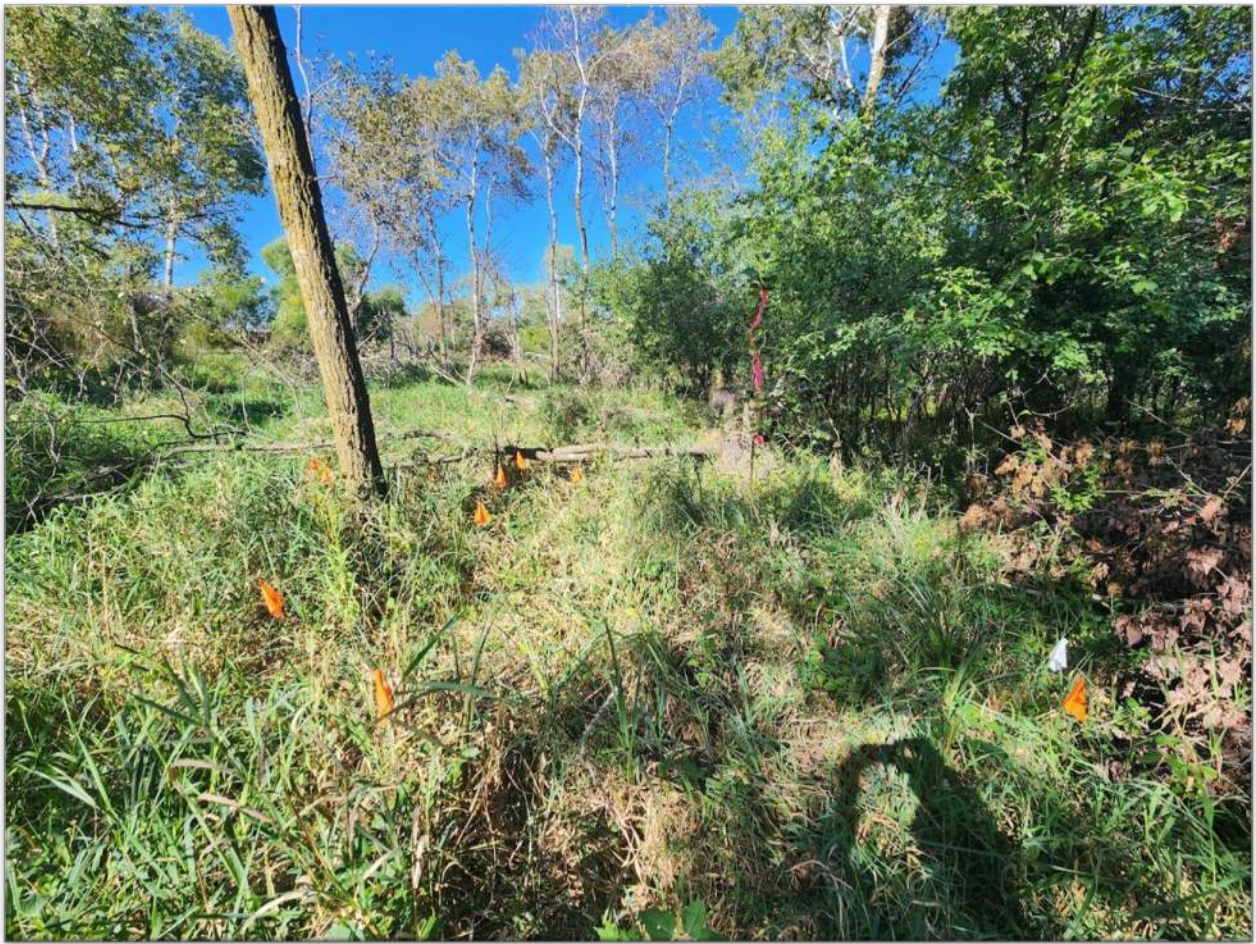
*Rubus semisetosus* subpopulation RSE-05 along the eastern edge of ACD 53-62 Branch 6

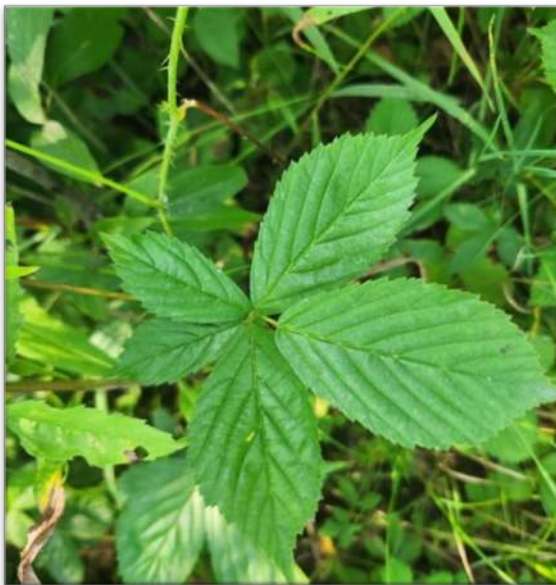
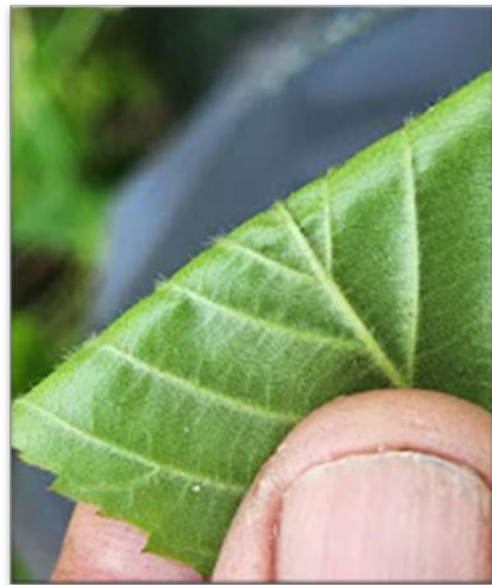
*Rubus semisetosus* subpopulation RSE-05, primocane leaf, aciculate prickles, and leaf hairs detail
