Section 319 Nonpoint Source Pollution Control Program Watershed Project Final Report

Hardwood Creek TMDL Implementation Project

The Rice Creek Watershed District

September 2014

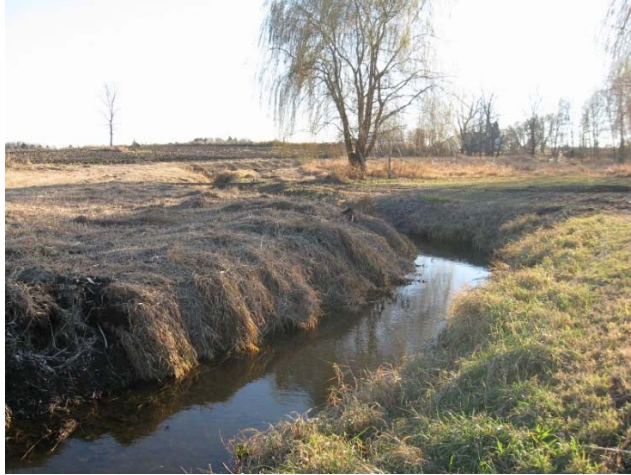
Figure 1. Streambank stabilization site, prior to restoration

The primary streambank stabilization activities occurred on a reach in Hugo, MN. This reach had become incised, and was vertically separated from the floodplain. Flood flows were contained within the channel. Stream banks were steep and eroding; the creek was actively widening - i.e. Stage 3 in the Channel Evolution Model (Schumm et al 1984) (Figure 1). To reduce erosion, and bring the channel in a stable state, a floodplain bench was excavated (Figure 2). The intent was to “push” the stream evolution forward to Stage 5 in the channel evolution. A floodplain bench was excavated at approximately at 1-year return flood elevation, and stabilized using native grasses, shrubs and trees (Figure 3). Two full years after construction, the streambank stabilization site remains stable, with no indication of in-stream erosion. **RESULT: 950 feet of channel were stabilized.**

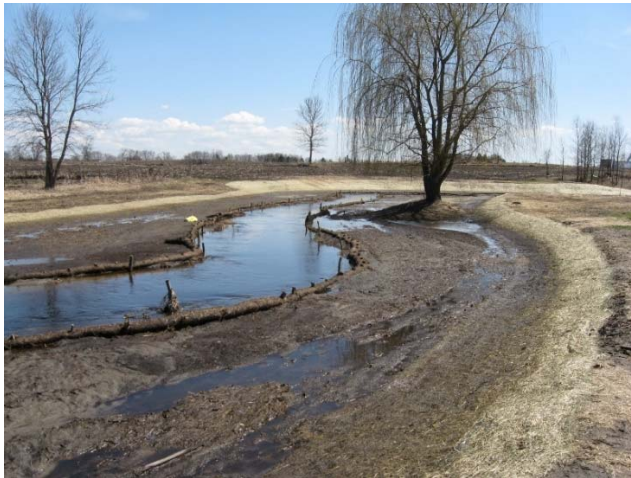
Figure 2. Streambank stabilization site immediately following construction

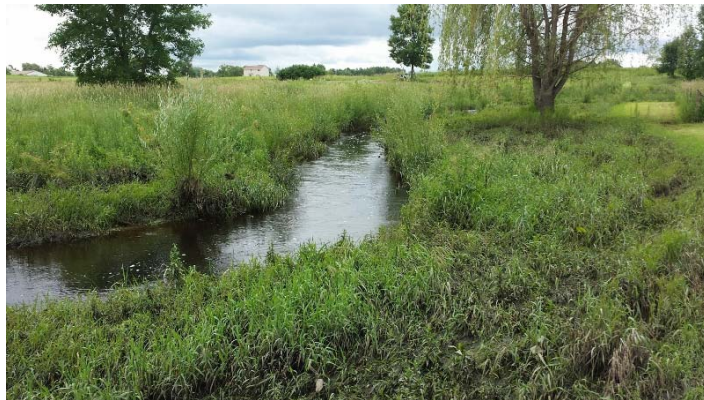
Figure 3. Streambank stabilization site 1.5 years after construction

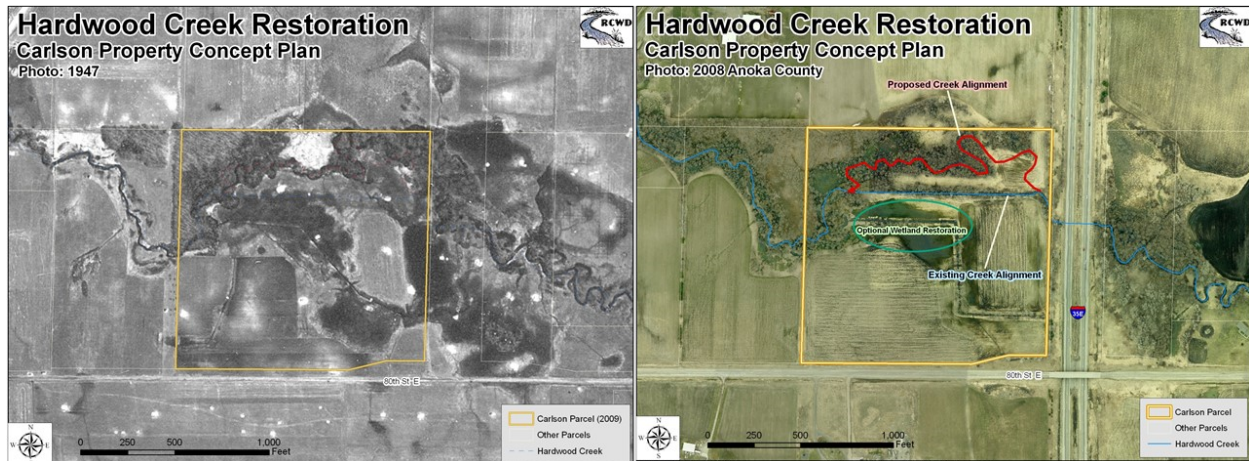
Figure 4. The meander restoration project site, prior to and after historic channelization

The channelization abandoned approximately 2000 feet of natural channel. The resulting ditch had an increase in sediment transport capacity, manifested in eroding and actively widening stream banks. Additionally, the stream no longer had access to the floodplain; ditch spoils were deposited on the banks, creating a dike effect.

To decrease sediment transport capacity, and reconnect the stream to the original floodplain, the Hardwood Creek TMDL Implementation Project reconnected this channelized reach to its original meandering pattern. This concept is shown in Figure 4, and a post-project photograph is shown in Figure 5.

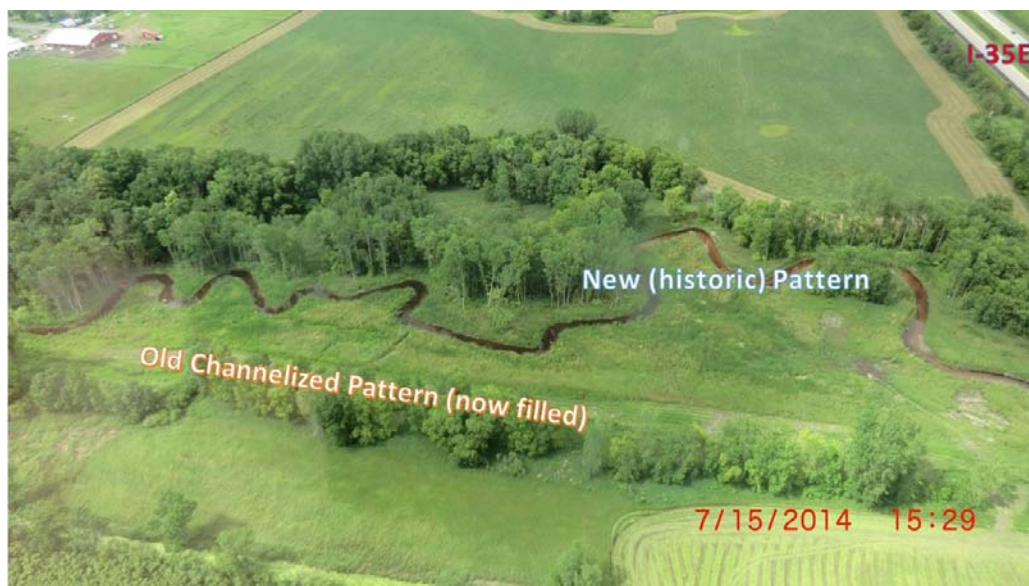
Figure 5. Aerial view of the meander restoration site, showing the newly meandered channel, the old channelized section (filled during construction), and Interstate 35E.

2150 feet of new channel. Once it was determined that the concepts were feasible, final plans were created. Construction occurred in two phases. During phase 1, the new meander pattern was excavated. Bank protection devices, such as root wads and live stakes, were installed. Native grasses, shrubs, and trees were planted. However, “plugs” were left at the up- and downstream end of the new pattern, keeping it offline while vegetation could establish. Phase 2 of construction occurred one year later. Plugs were removed, and water was allowed to flow through the new pattern. The old, channelized section was filled to the elevation of the surrounding landscape (floodplain wetland).

The newly meandered pattern has been online for one full season. The reach has remained stable, without any indication of bank or bed erosion, despite 2014 having some of the highest flows in nearly 10 years. **RESULT: 2150 feet of meandered and stabilized channel was added, which reestablished connection to adjacent floodplain wetlands.**

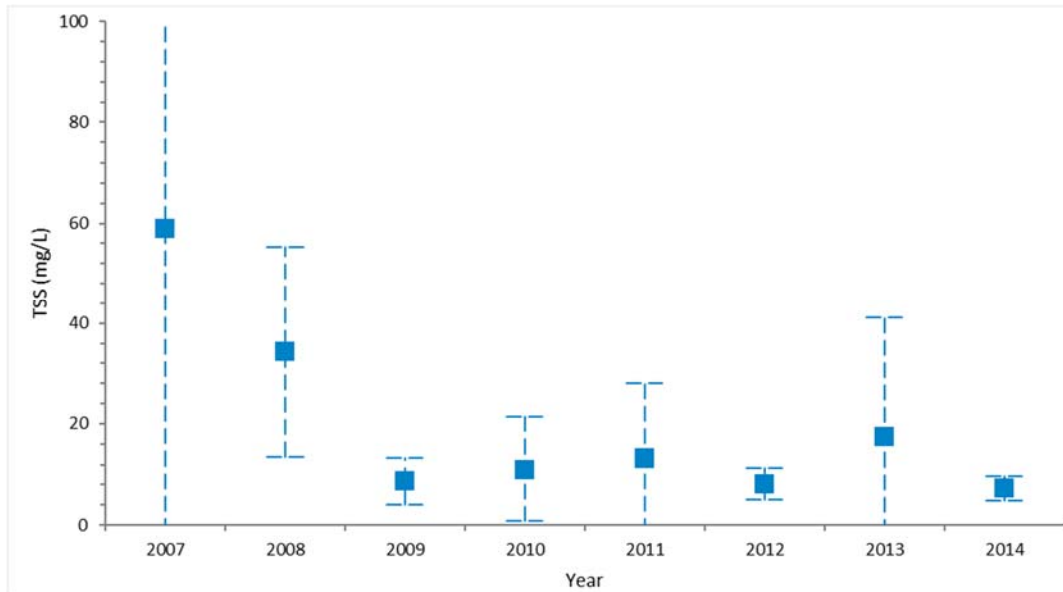
Figure 7. Mean and 1 SD of TSS concentrations at the H2 (S003-032) monitoring site on Hardwood Creek, by year.

TSS concentrations are currently meeting the goals set in the workplan. Average annual TSS concentrations have been below 19 mg/L since 2009. This may be the result of cumulative restoration projects on Hardwood Creek; several restoration projects have occurred previously, including one in 2007. The most recent average, 7.3 mg/L, is the lowest on record. TSS samples will be collected and analyzed for the foreseeable future as part of the regular RCWD monitoring program. All future data will be submitted to EQUIS.

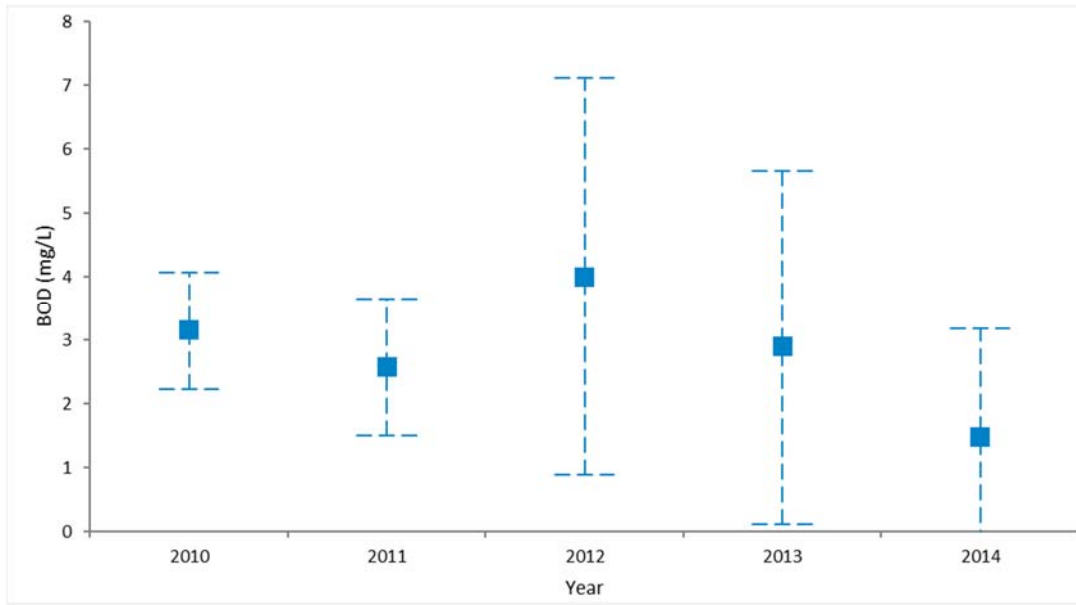
Figure 8. Mean and 1 SD of BOD concentrations at the H2 (S003-032) on Hardwood Creek, by year

BOD concentrations are currently meeting workplan goals. The most recent average, 1.5 mg/L, is the lowest on record. BOD samples will be collected and analyzed for the foreseeable future as part of the regular RCWD monitoring program. All future data will be submitted to EQUIS.

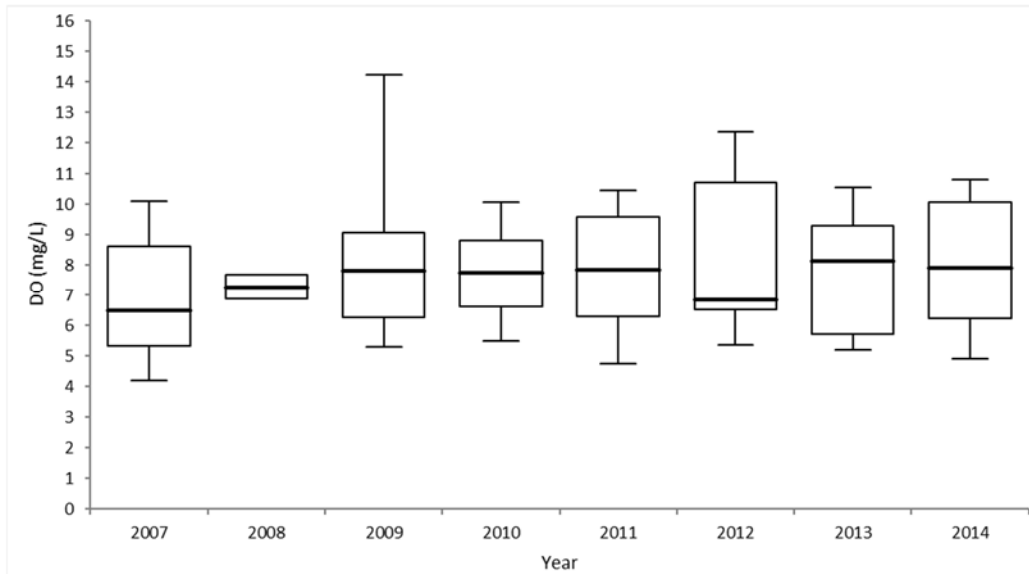
Figure 9. Mean, quartile, and range of DO measurements at H2 (S003-032) on Hardwood Creek, by year

Mean DO concentrations have remained stable since 2007. DO will be measured in Hardwood Creek for the foreseeable future as part of the regular RCWD monitoring program. All future data will be submitted to EQUIS.
