Appendix J

Centerville Lake Diagnostic Studies

Subject: Internal Load Investigation for Centerville Lake

RELATIVE IMPACT OF BACKFLOW PHOSPHORUS
LOADING ON CENTERVILLE LAKE

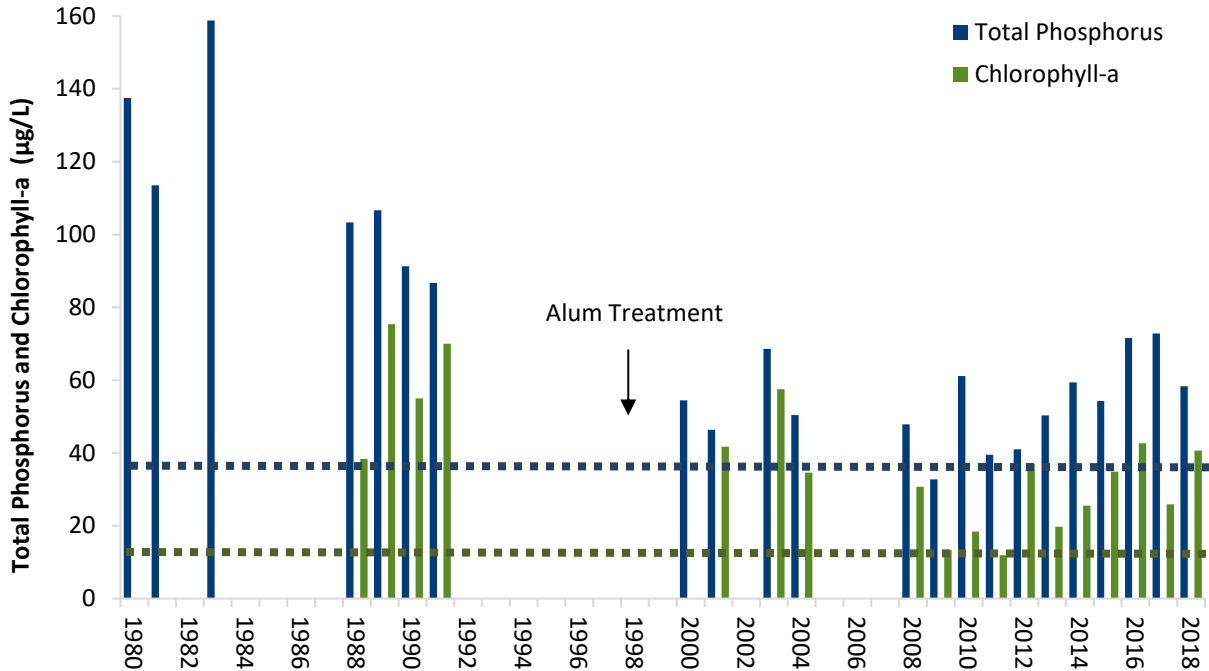
Figure 2. Average surface total phosphorus (TP) and chlorophyll-a (chla) concentrations of Centerville Lake from June through September, 1980 to 2018. The blue and green dotted lines represent the state standards for TP and chla, respectively. A 1998 alum treatment greatly reduce TP and chla levels.

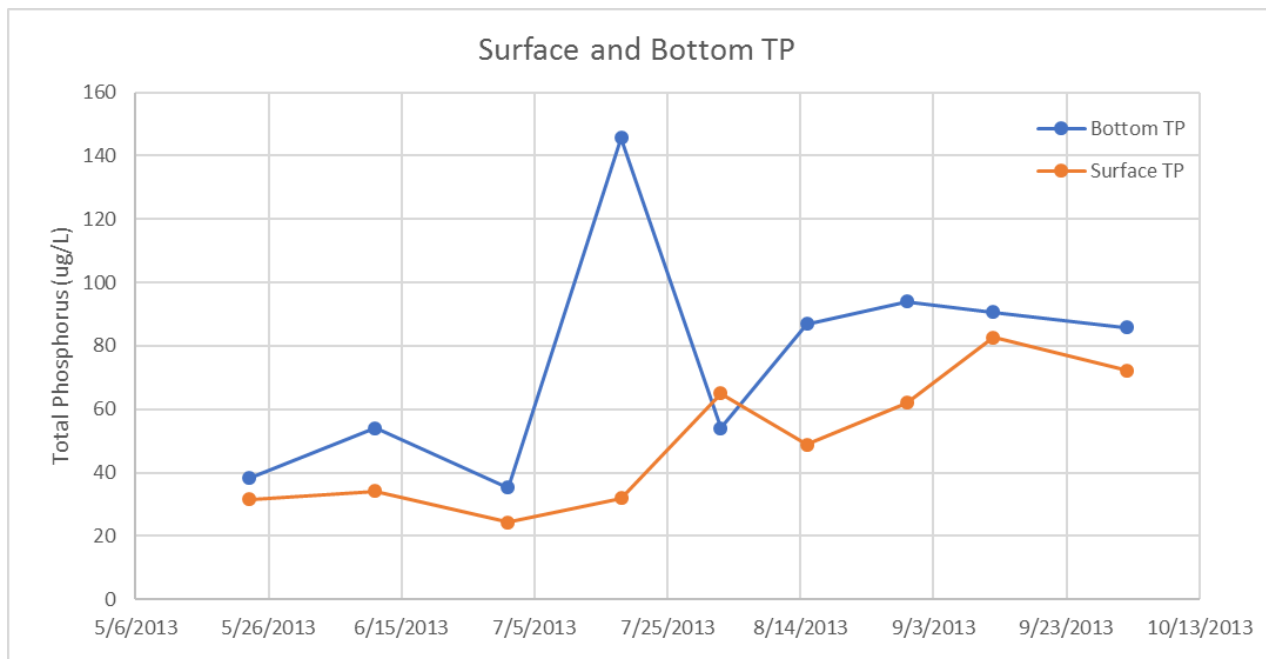
Figure 5. Surface and bottom total phosphorus in 2014 where a significant drop occurred in hypolimnetic phosphorus midsummer.

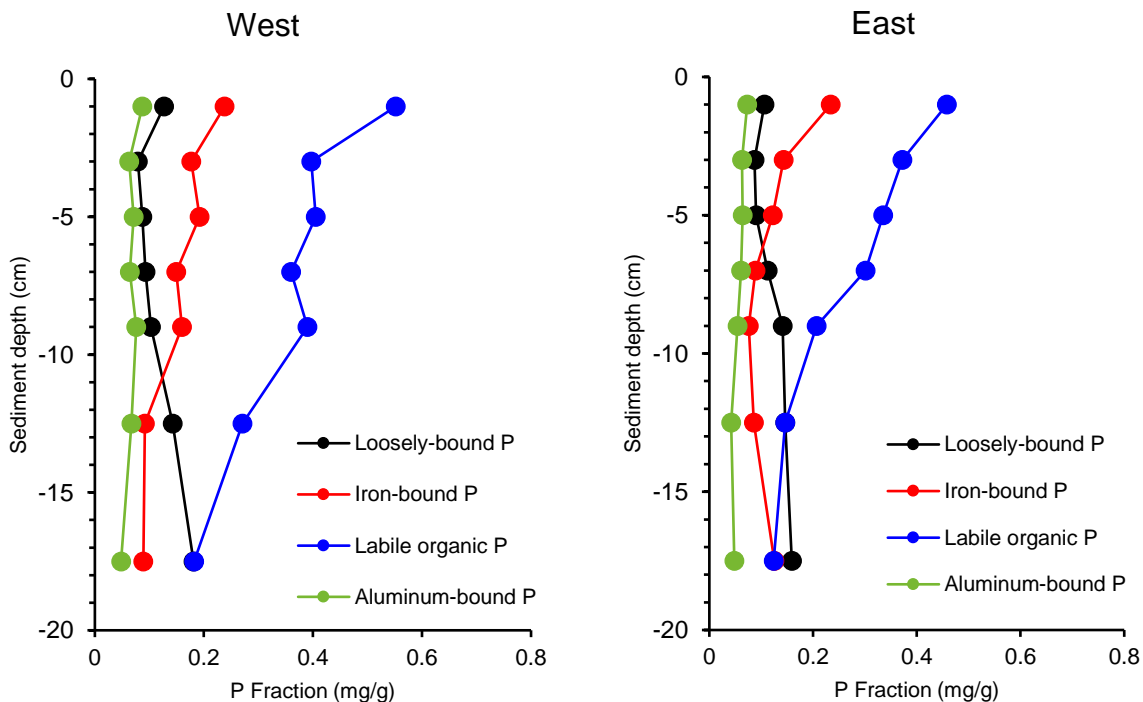
Figure 7. Phosphorus fractions in sediments at west and east coring locations.

Sediment in both coring locations showed similar patterns (**Figure 7**). In both coring locations, iron-bound, loosely-bound and labile organic phosphorus concentrations were high and all in the 75th to 100th percentile of concentrations found in lake cores in the Twin Cities Metropolitan Area. In addition, concentrations of labile organic phosphorus were consistently higher than concentrations of iron-bound phosphorus. Finally, aluminum-bound phosphorus was quantified, and the signature of the 1998 alum treatment signature could not be detected, possibly because the 1998 alum dose was relatively low (about 18 g Al/m²).

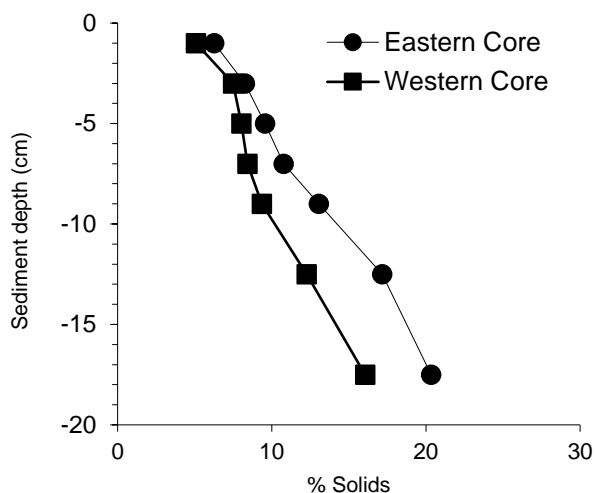
Figure 8. Percent solids, a measure of density, in both sediment cores.

Physical characteristics of Centerville Lake sediment were also assessed for alum dosing considerations. In lakes, we typically use the top 5-10 cm to determine the amount of alum needed to inactivate mobile phosphorus. We assume that the alum floc will incorporate into the upper 5-10 cm and convert redox-P to aluminum-bound P. Density of sediments, however, may reduce the ability of alum to sink into these sediments. Sediment in both cores had average density for lake sediment, at about 5-20% solids, with sediment becoming denser with depth (**Figure 8**). Therefore, sediment density should not present issues for an alum treatment on Centerville Lake.

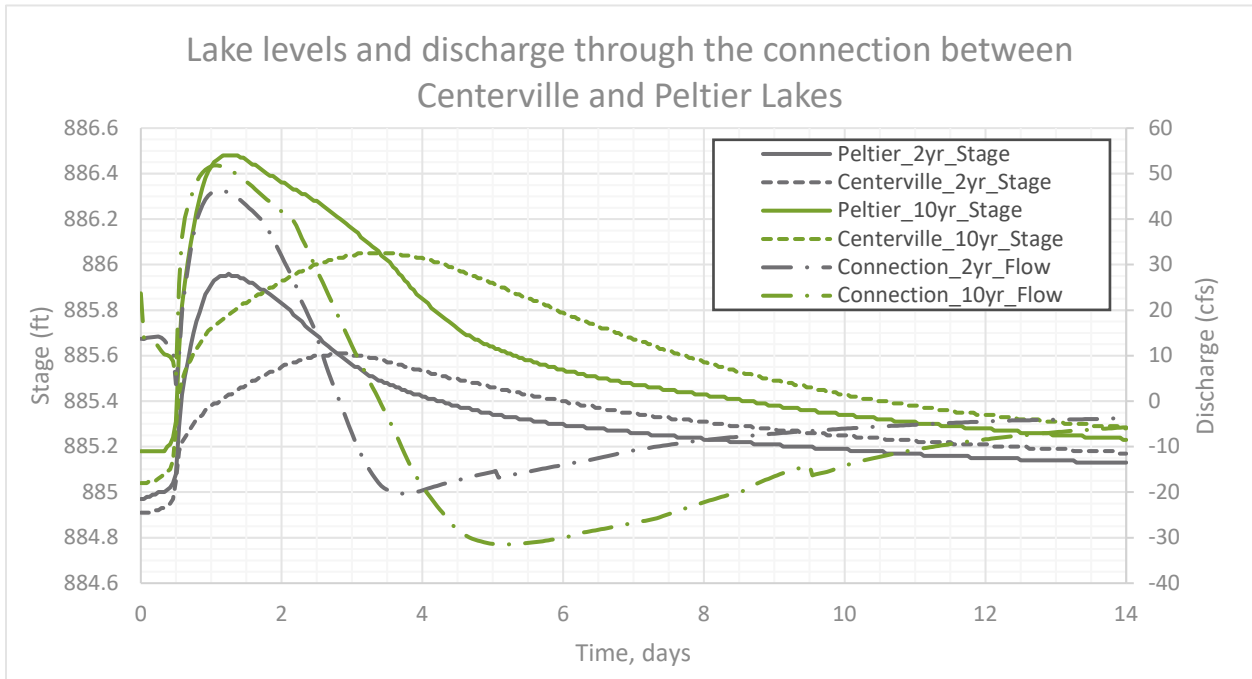
Figure 2. Stage and flows through the connection between Peltier and Centerville Lakes.

The discharge through the connection between Peltier and Centerville Lakes was modeled for the 2-year and 10-year storm simulations by the District's HEC-RAS model (**Figure 2**). A rating curve is also presented as the discharge from Centerville Lake to Peltier Lake (or vice-versa) based on the head differential between the two lakes (**Figure 3**).

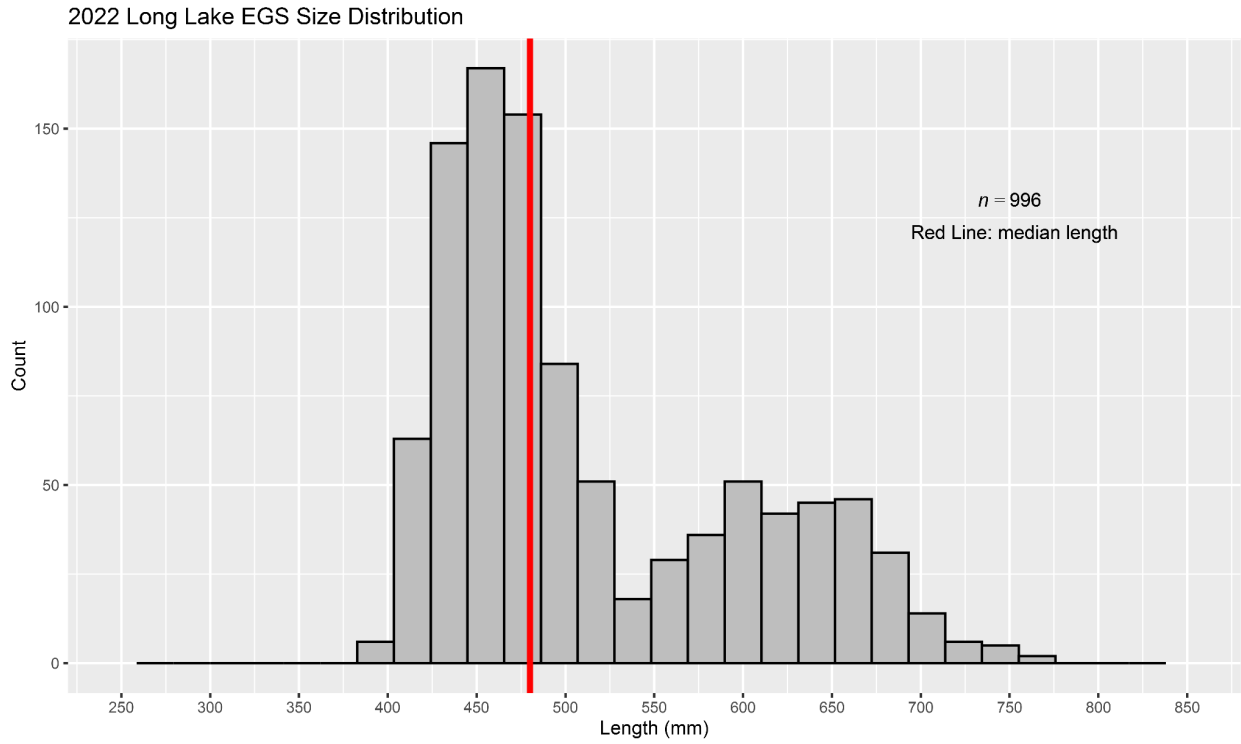
Figure 2: The distribution of size of collected carp (N=996) from the Rice Creek EGS trap.

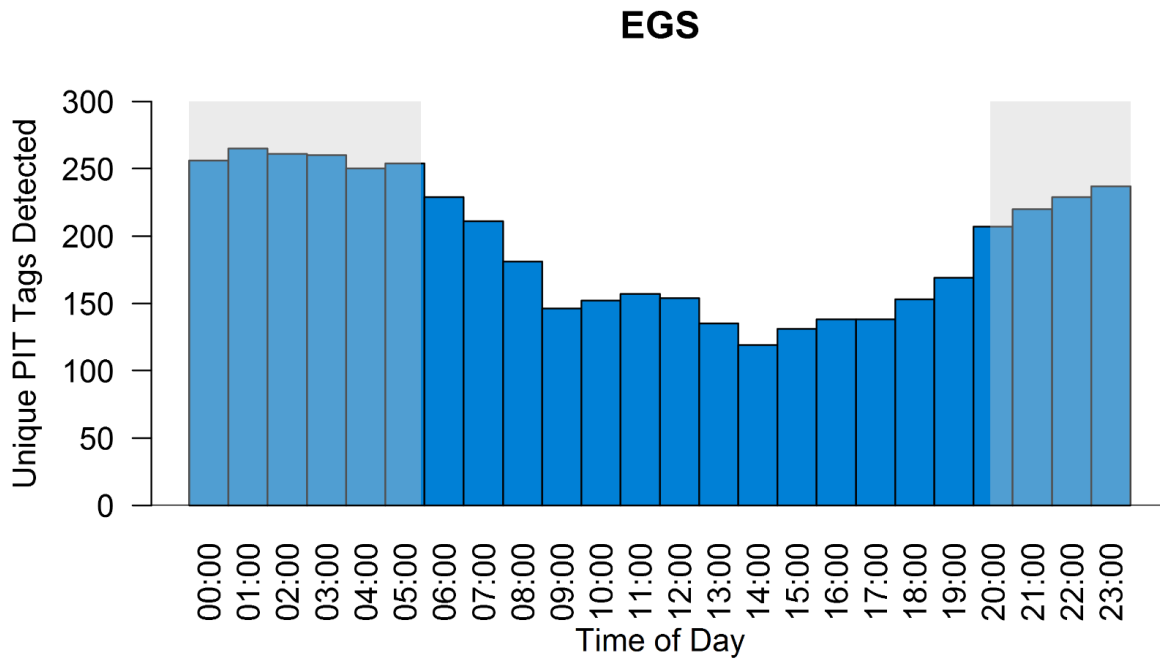
Figure 4: Hourly PIT detections at the PIT antennas below the EGS (top) and inside the trap (bottom).

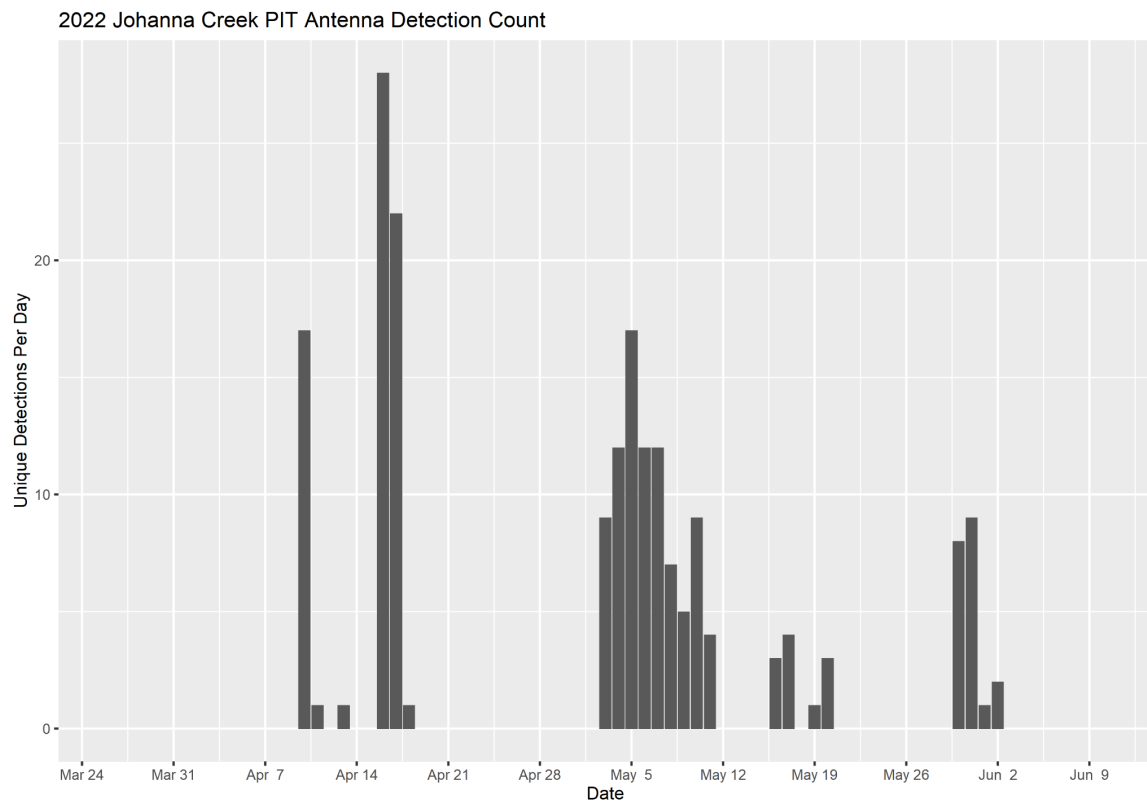
Figure 7: The number of detections per day at the Johanna Creek PIT antenna during the spring of 2022.

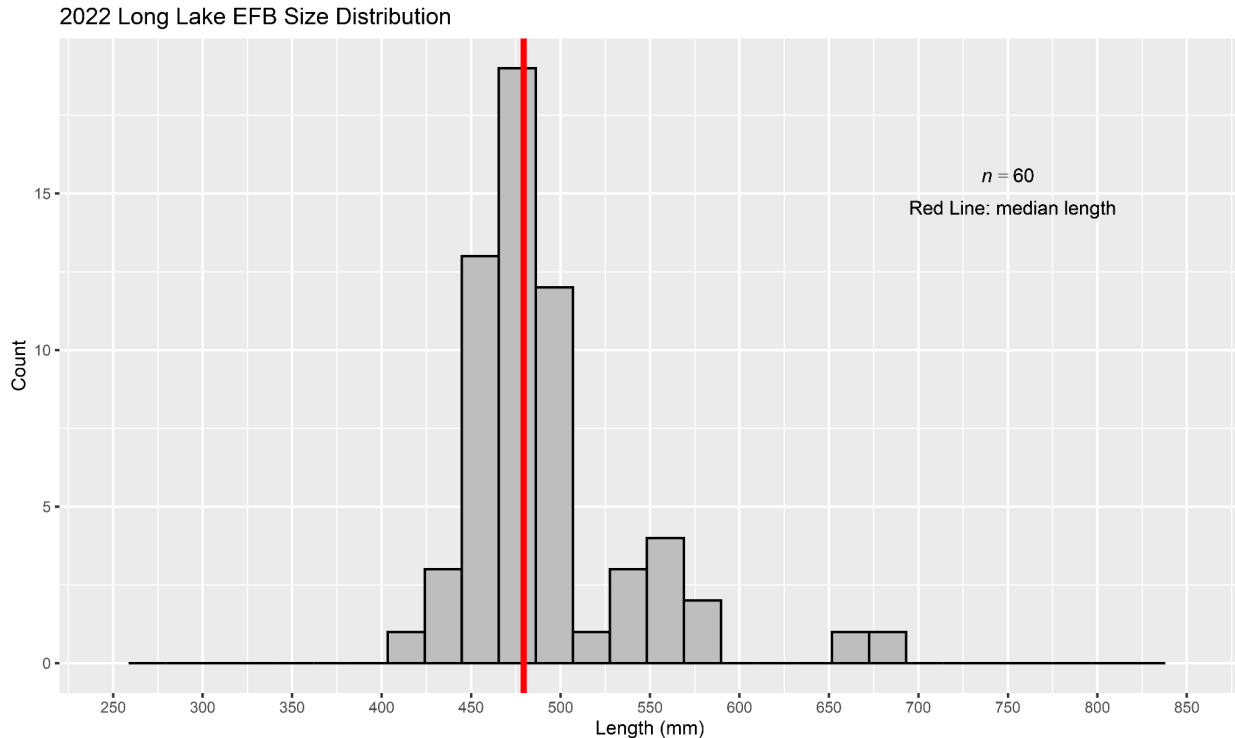
Figure 9: Length distribution of carp captured ($n=60$) while electrofishing Long Lake.

Three boat electrofishing surveys were conducted on Long Lake between July and August. These surveys aimed to collect common carp to mark with PIT tags. These efforts yielded in the tagging of 60 carp that were measured for length, had their left pelvic fin clipped, were implanted with a PIT tag, and released back into the water. The distribution of lengths is shown in Figure 9.

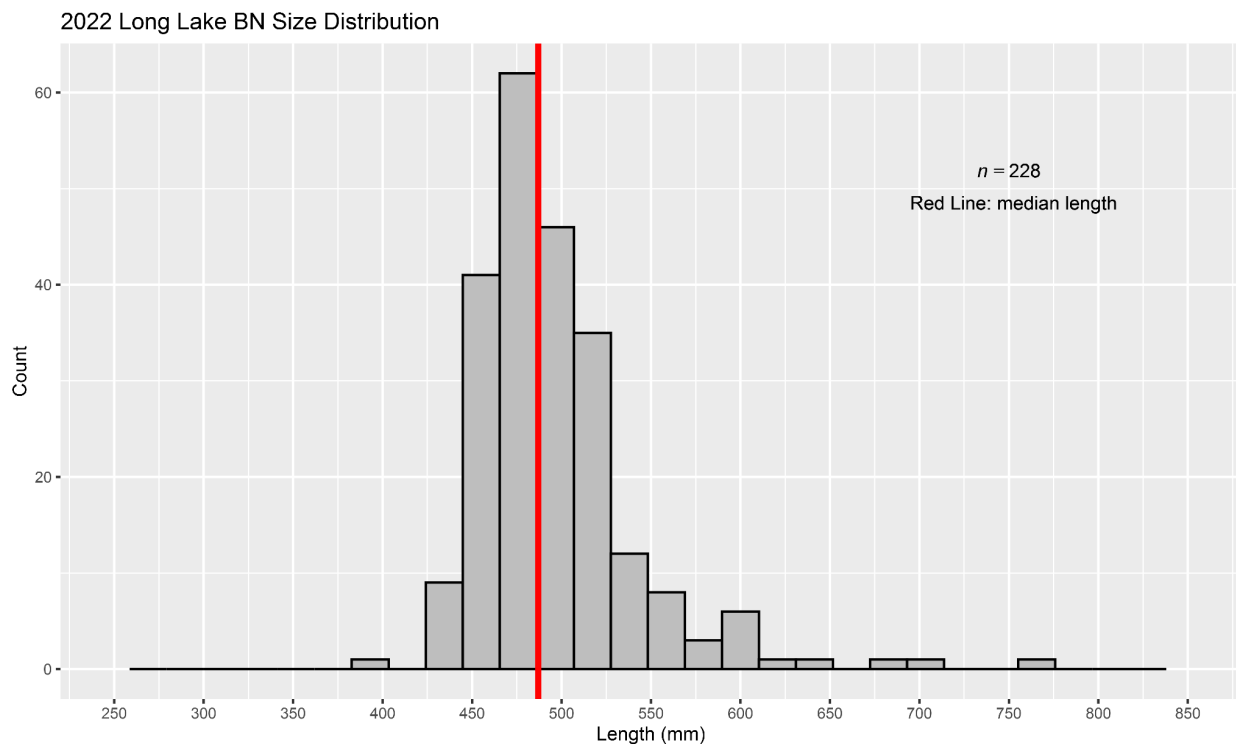
Figure 11: The distribution of size of collected carp ($n=228$) from box nets in Long Lake.

A total of 1,379 carp were removed across 5 removal days (Table 4). The mean catch per net pull was 69 carp. The length distribution of the 228 carp measured from these removals shows that the carp were relatively small and dominated by 450mm - 550mm Individuals. A distribution of these lengths is shown in Figure 11. A total of 32 PIT tagged carp were captured among the harvested carp, including 14 of the 60 (23%) of the carp tagged in 2022, and 18 tagged carp from previous years electrofishing efforts (Table 4).

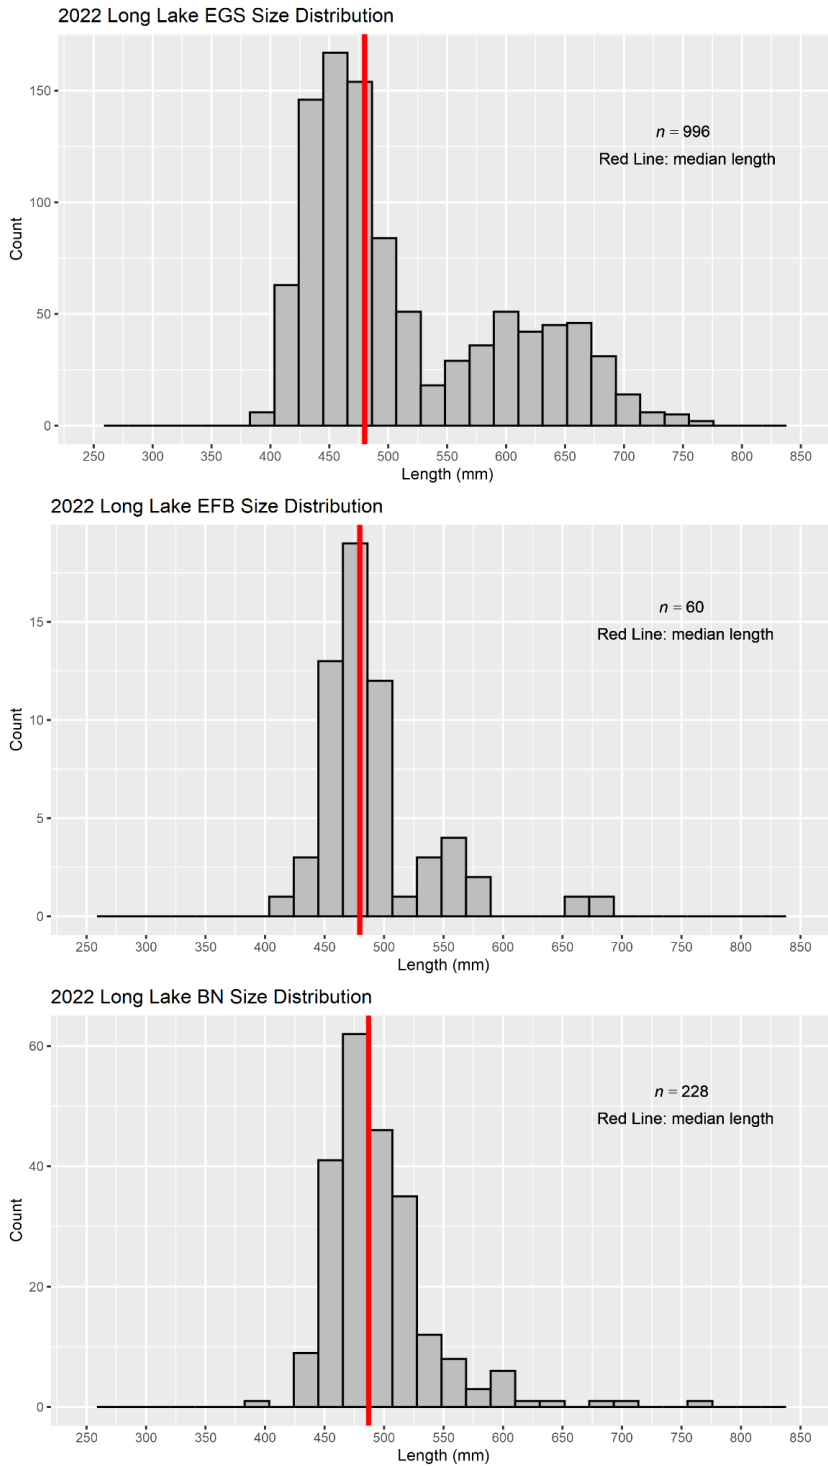
Figure 16: Length distributions of carp captured at the EGS (top), boat electrofishing (middle), and box netting (bottom) in 2022.
