# ANOKA RAMSEY JUDICIAL DITCH 1 REPAIR REPORT

Blaine/Mounds View, MN

July 14, 2026  
Blaine / Mounds View, MN

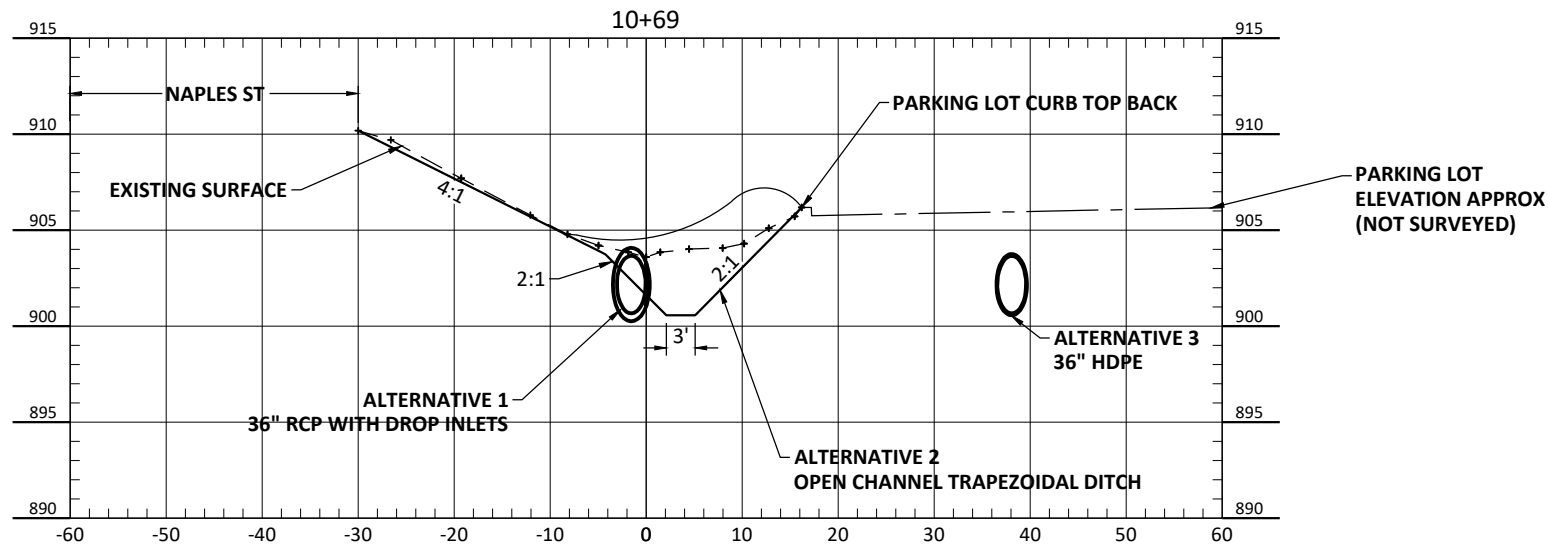
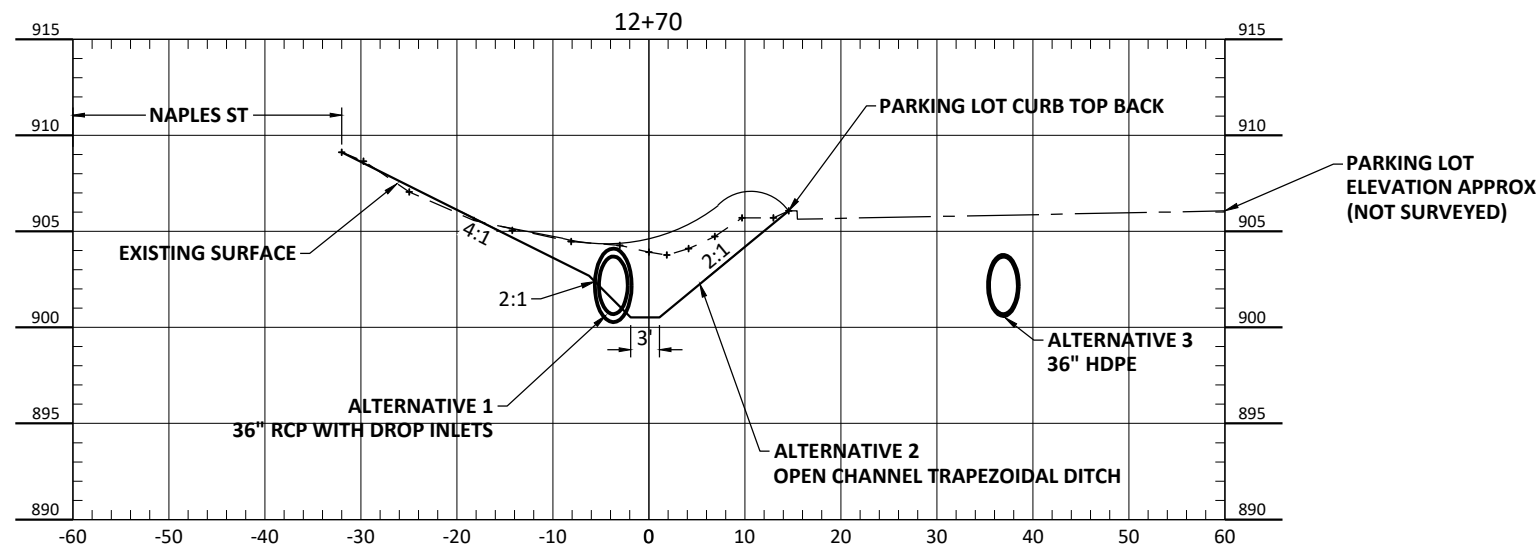
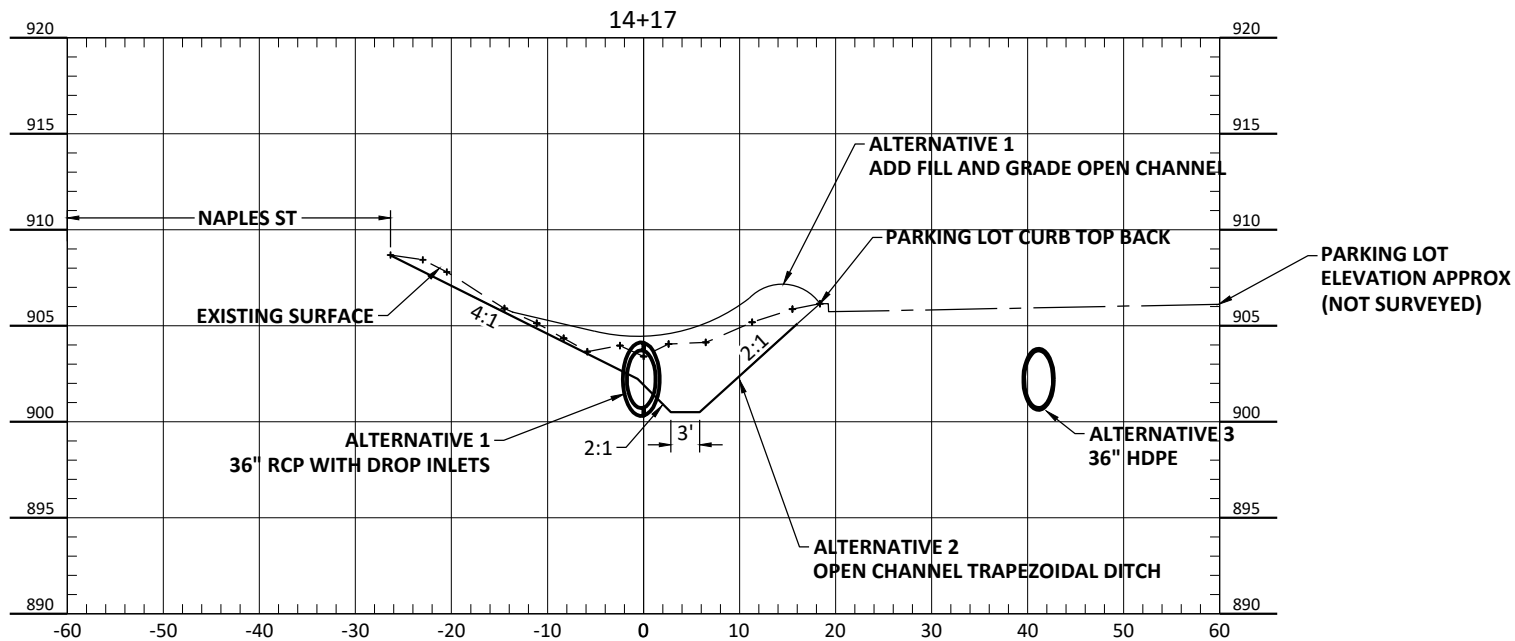
- 1) CROSS SECTION DISPLAYS ALTERNATIVES ADJACENT TO NAPLES STREET
- 2) ALTERNATIVE 1 AND 2 SIDE SLOPES ARE GRADED TO LEAVE EXISTING PARKING LOT AND NAPLES ST AS IS
- 3) COUNTY RIGHT OF WAY OFF NAPLES STREET IS 25 FT AND WILL BE MAINTAINED IN EACH ALTERNATIVE

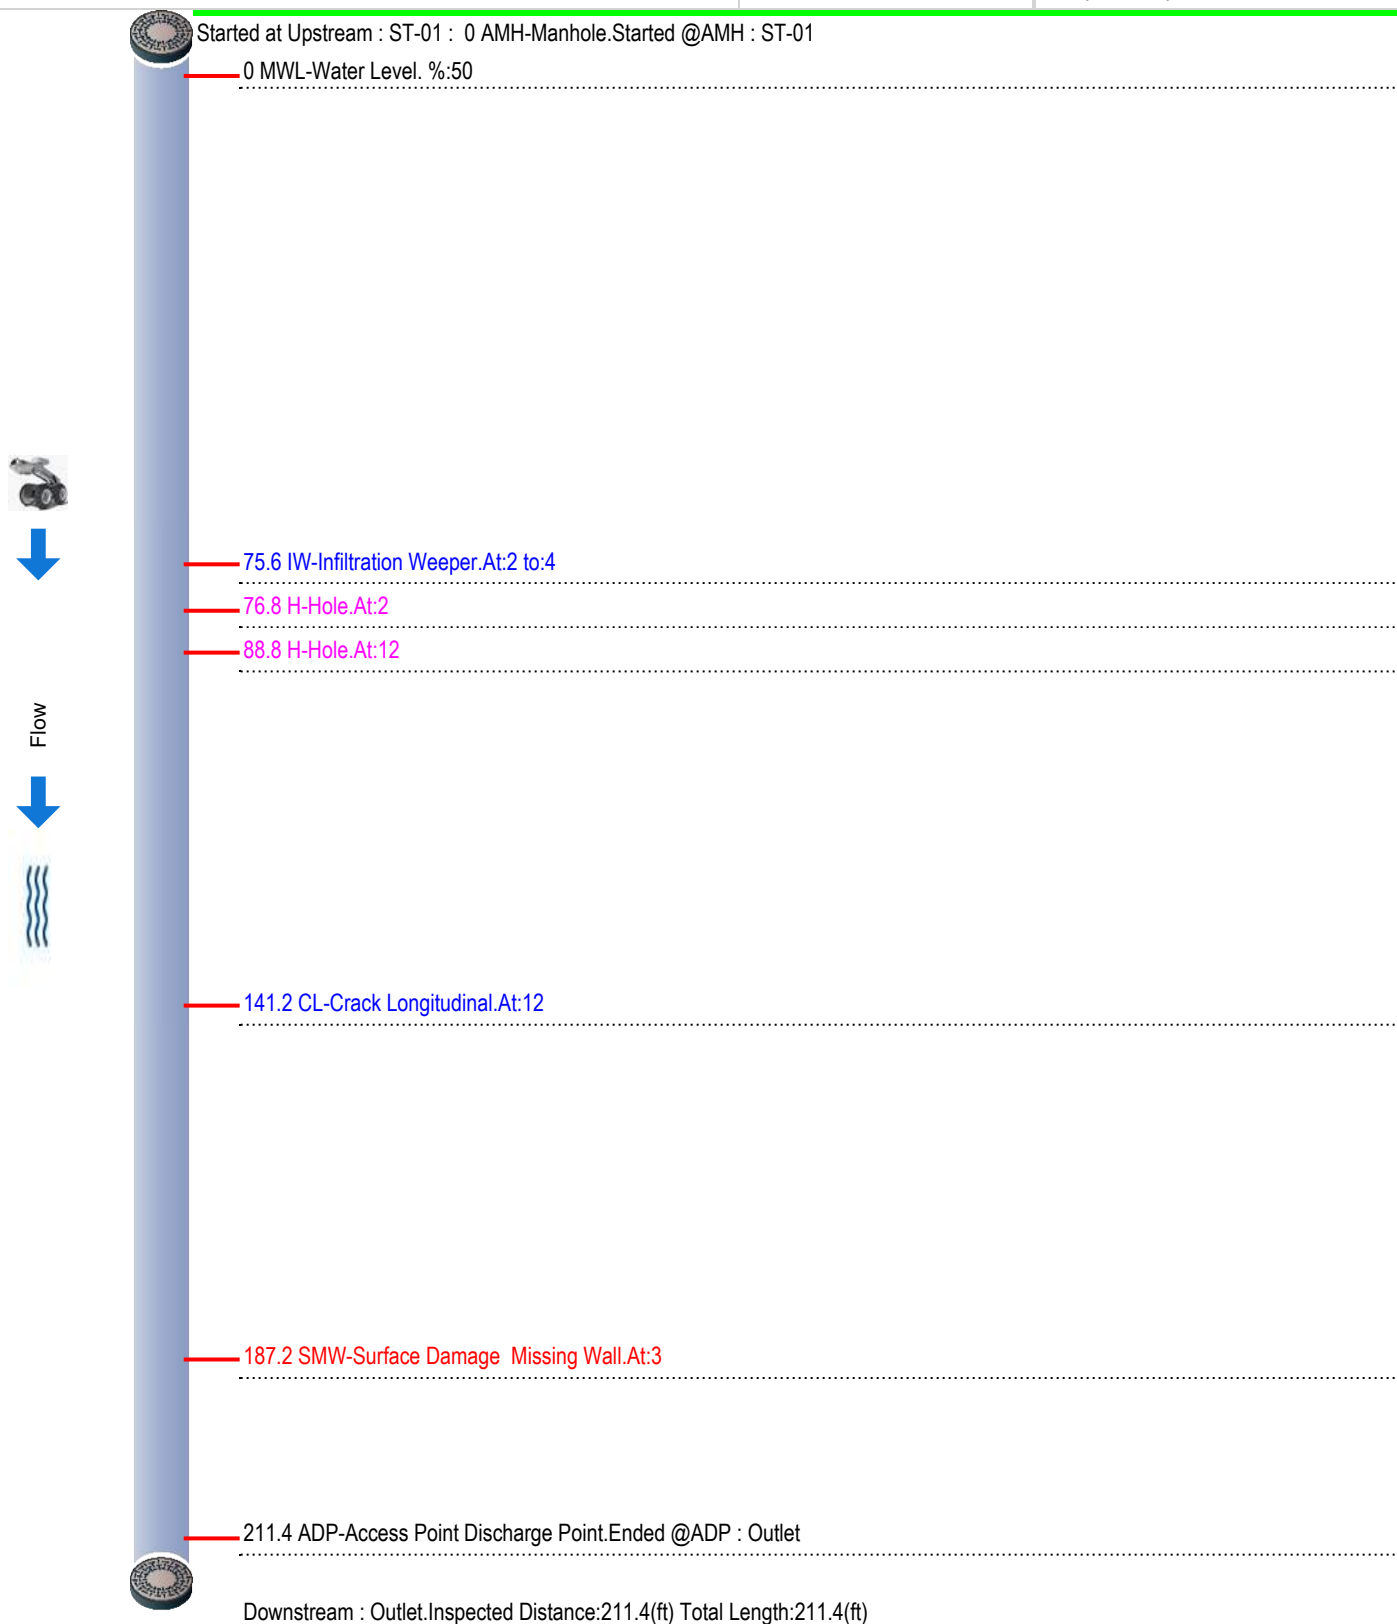
| ST-01 - Outlet | |

Img:3,Distance:187.2  
Surface Damage Missing Wall,@:3,Rmk:
