То:	Nick Tomczik, Administrator
	Rice Creek Watershed District
Cc:	Tom Schmidt
	John Kolb
From:	Chris Otterness, PE
Subject:	ACD 53-62 Branches 5+6 Repair Report
Date:	March 5, 2025
Project #:	R005555-0347

The purpose of this memorandum is to provide the Rice Creek Watershed District (District) with an analysis and description of proposed repair alternatives to portions of Anoka County Ditch (ACD) 53-62 Branches 5 and 6, including a preliminary opinion of probable cost for the recommended repairs.

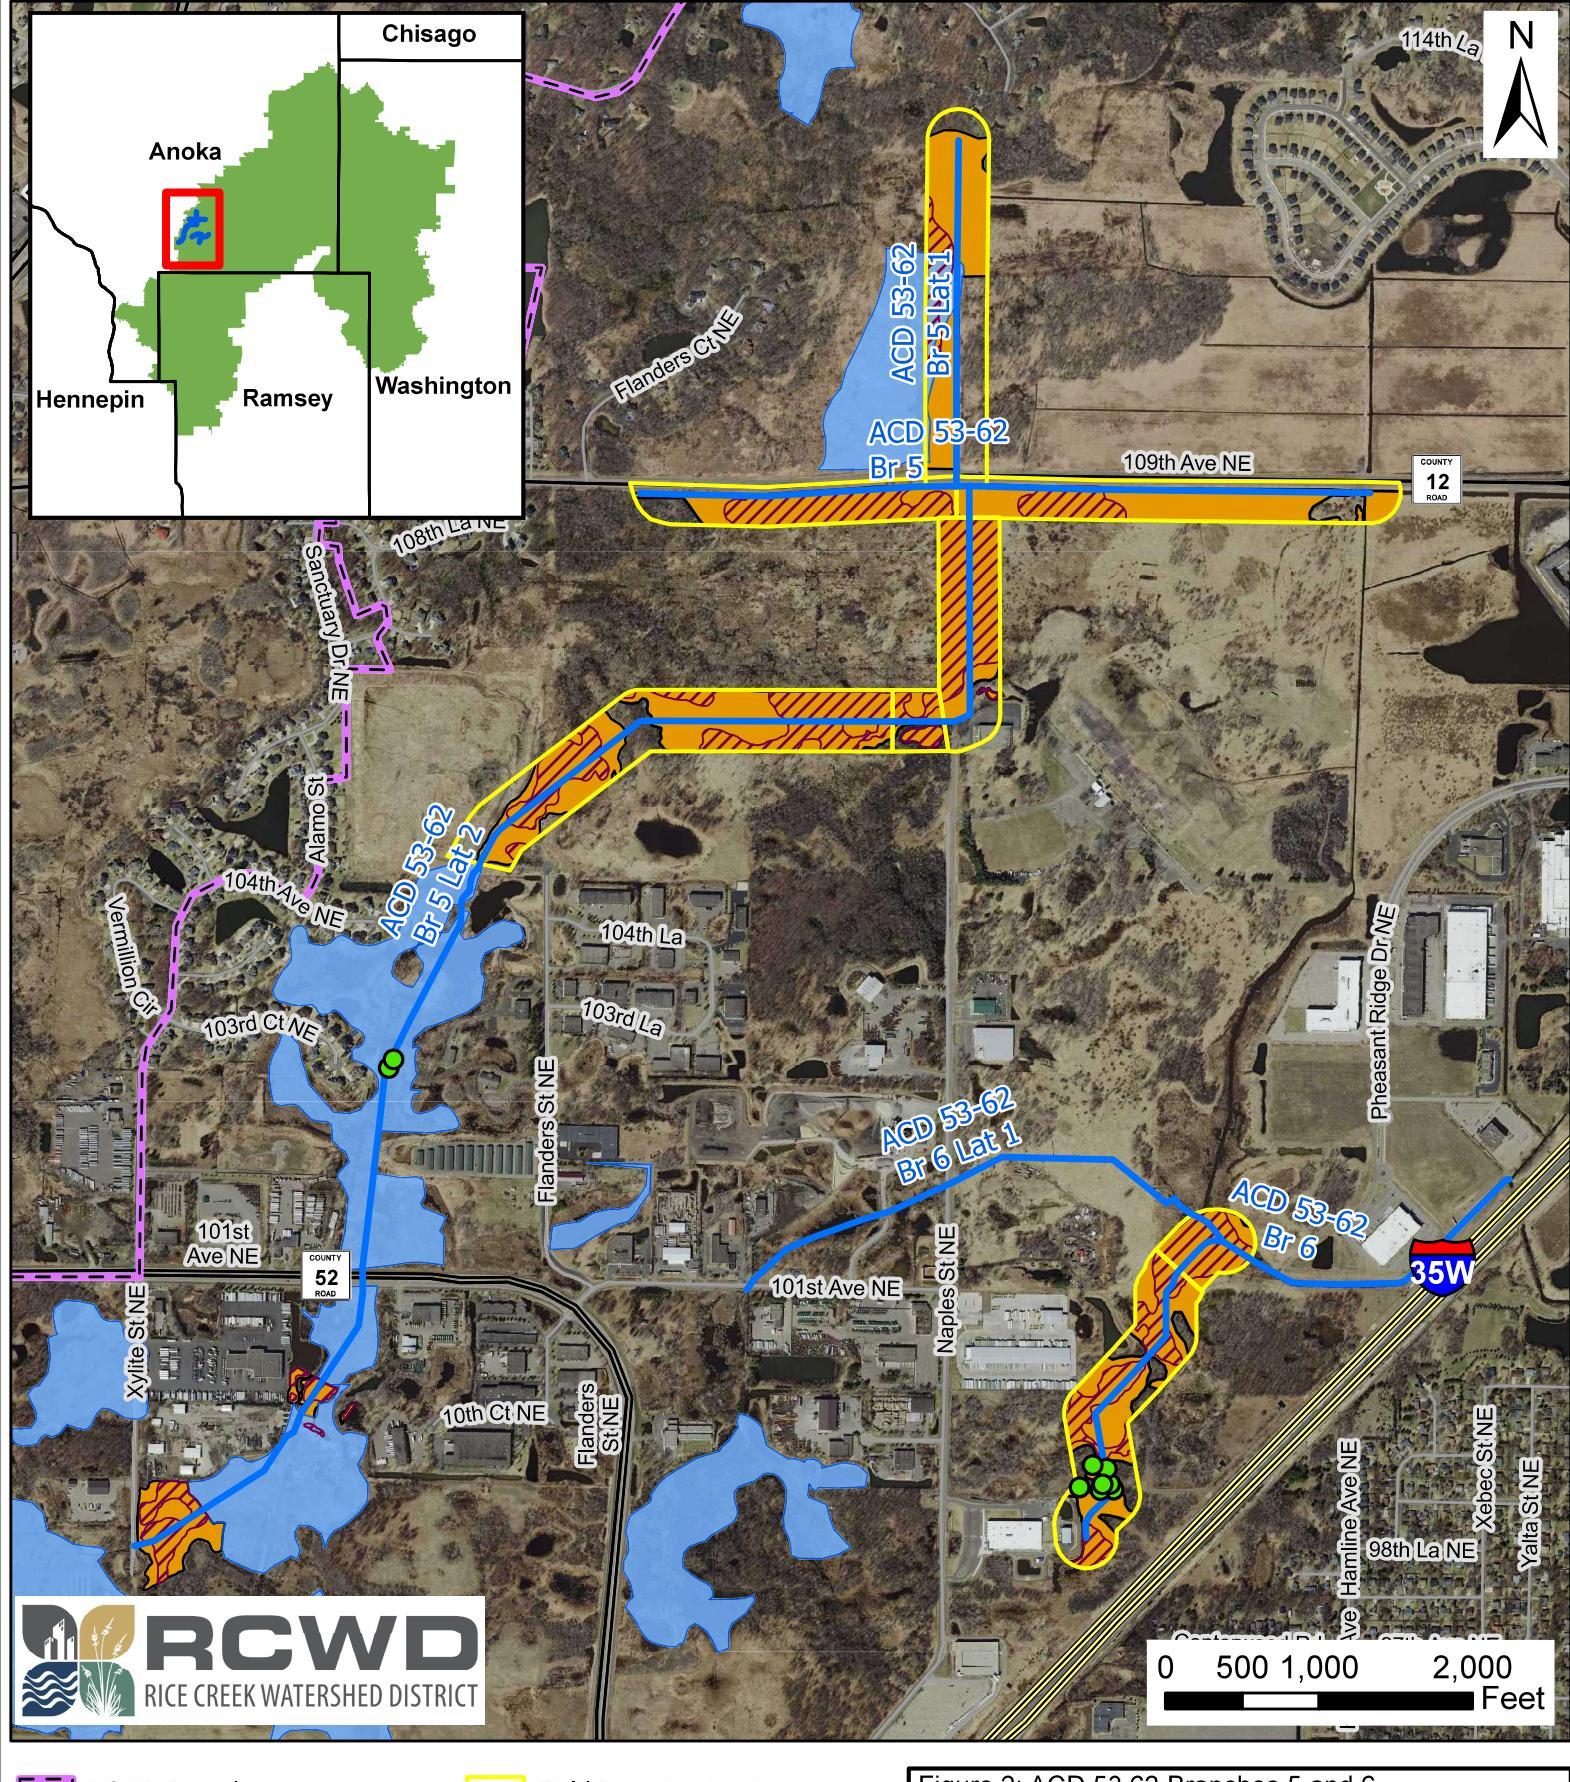
igure 2: ACD 53 62 Branches 5 and 6 Public Waters and Field Delineated Wetlands						
icale: S SHOWN	cale: Drawn by: Checked by: Project No.: Date: S SHOWN KRB COO 5555-0347 1/15/2025

- Alignment
- **Public Water Inventory**
- Rare Plant Survey Detections 0
- Field Investigation Area
- - Field Delineated Wetlands
- Field Delineated Semi and Permanently Flooded Wetlands

The Wetland Conservation Act (WCA) uses the three criteria identified in the United States Army Corps of Engineers (USACE) Wetlands Delineation Manual issued in 1987, and the Regional Supplement to the USACE Delineation Manual, (North central and Northeast Region), to determine wetland locations. The three criteria are: 1) the presence of hydrophytic vegetation; 2) the presence of hydric soils; and 3) hydrology. Of those criteria, hydrology is the primary factor that has potential to be affected by ditch repair and/or improvements. A field wetland delineation was completed in the fall of 2024 to identify and characterize wetlands adjacent to ACD 53-62 Branches 5 and 6 that could potentially be impacted by repairs. The LGU approved the wetland boundary decision on December 16th, 2024.

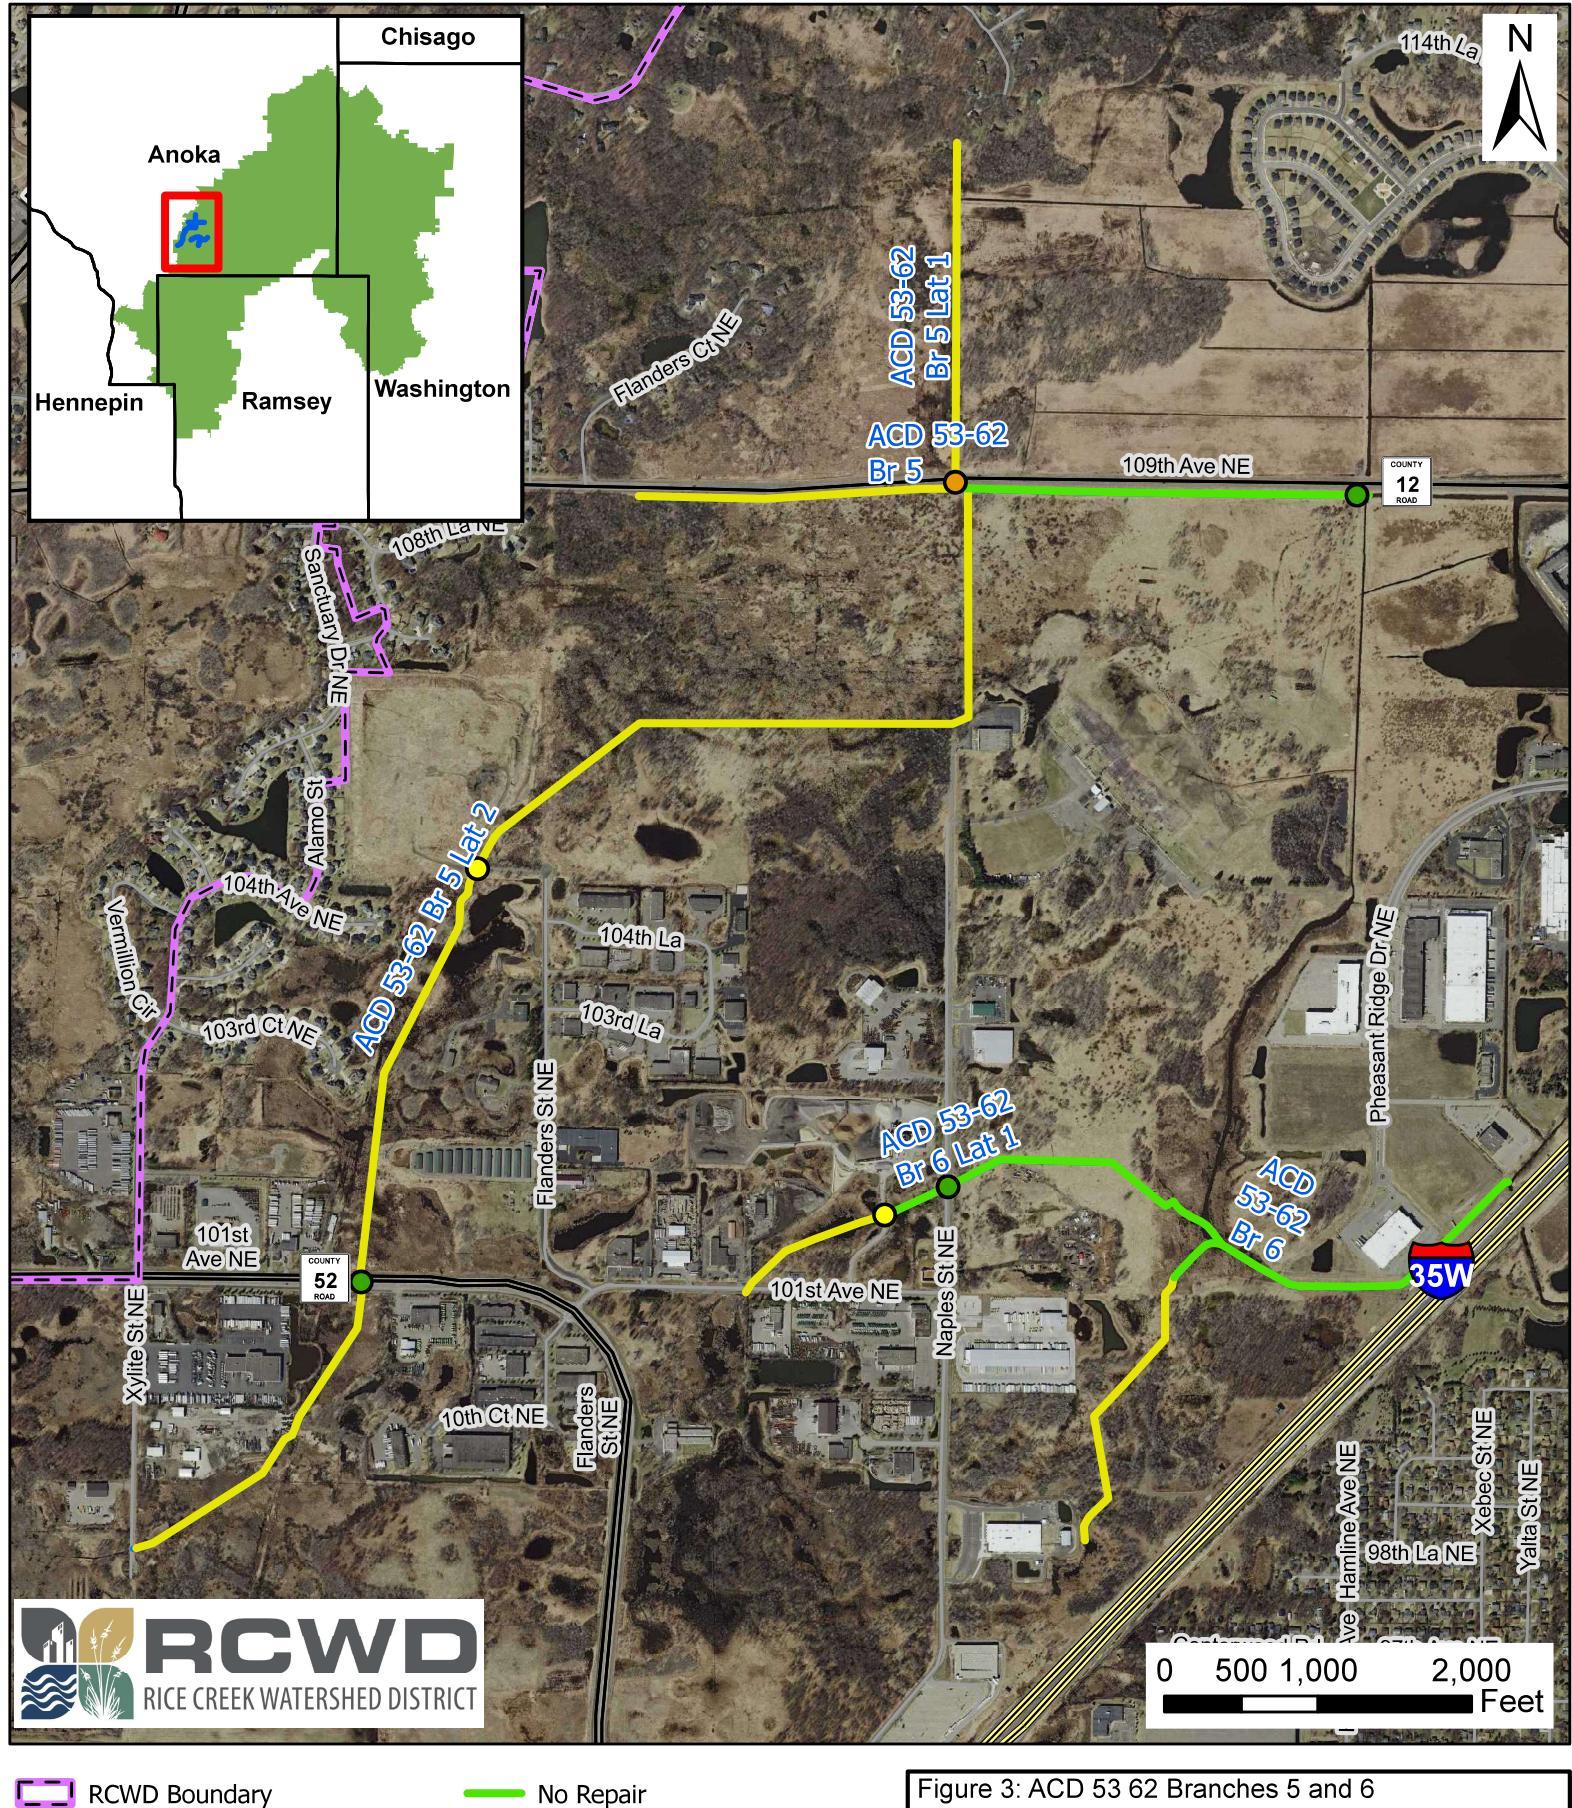
- ACD 53-62 Branch 5 and 6 Alignment
 - Repair to ACSIC

- No Repair
- Lower/Replace Culvert 0
- Install New Culvert 0
- No Repair to Culvert \bigcirc

The rationale for this alternative is to provide the maximum capacity and depth of drainage that would be considered to be "repair" under M.S. 103E. This alternative includes excavation of the entire length of open channel along Branches 5 and 6 and their laterals to the ACSIC grade and cross-section, where the current ditch grade is above the ACSIC grade or where vegetation in the channel bottom is restricting flow. This also includes lowering of culverts at public and private crossings of the ditch to the ACSIC grade, where the culverts are currently greater than one foot above the ACSIC grade, and adds a culvert under 109th Avenue to reconnect Branch 5 Lateral 1 (north of 109th Ave.) to Branch 5 (south of 109th Ave). **Figure 3** shows a graphic depiction of Alternative 2. This alternative lowers water levels in and along public waters and wetlands and therefore is subject to regulation under M.S. 103G and under the WCA. This alternative is likely to impact wetlands and rare plant species resulting in substantial mitigation cost and permitting conditions. These costs must be weighed against the added system capacity provided by this alternative.

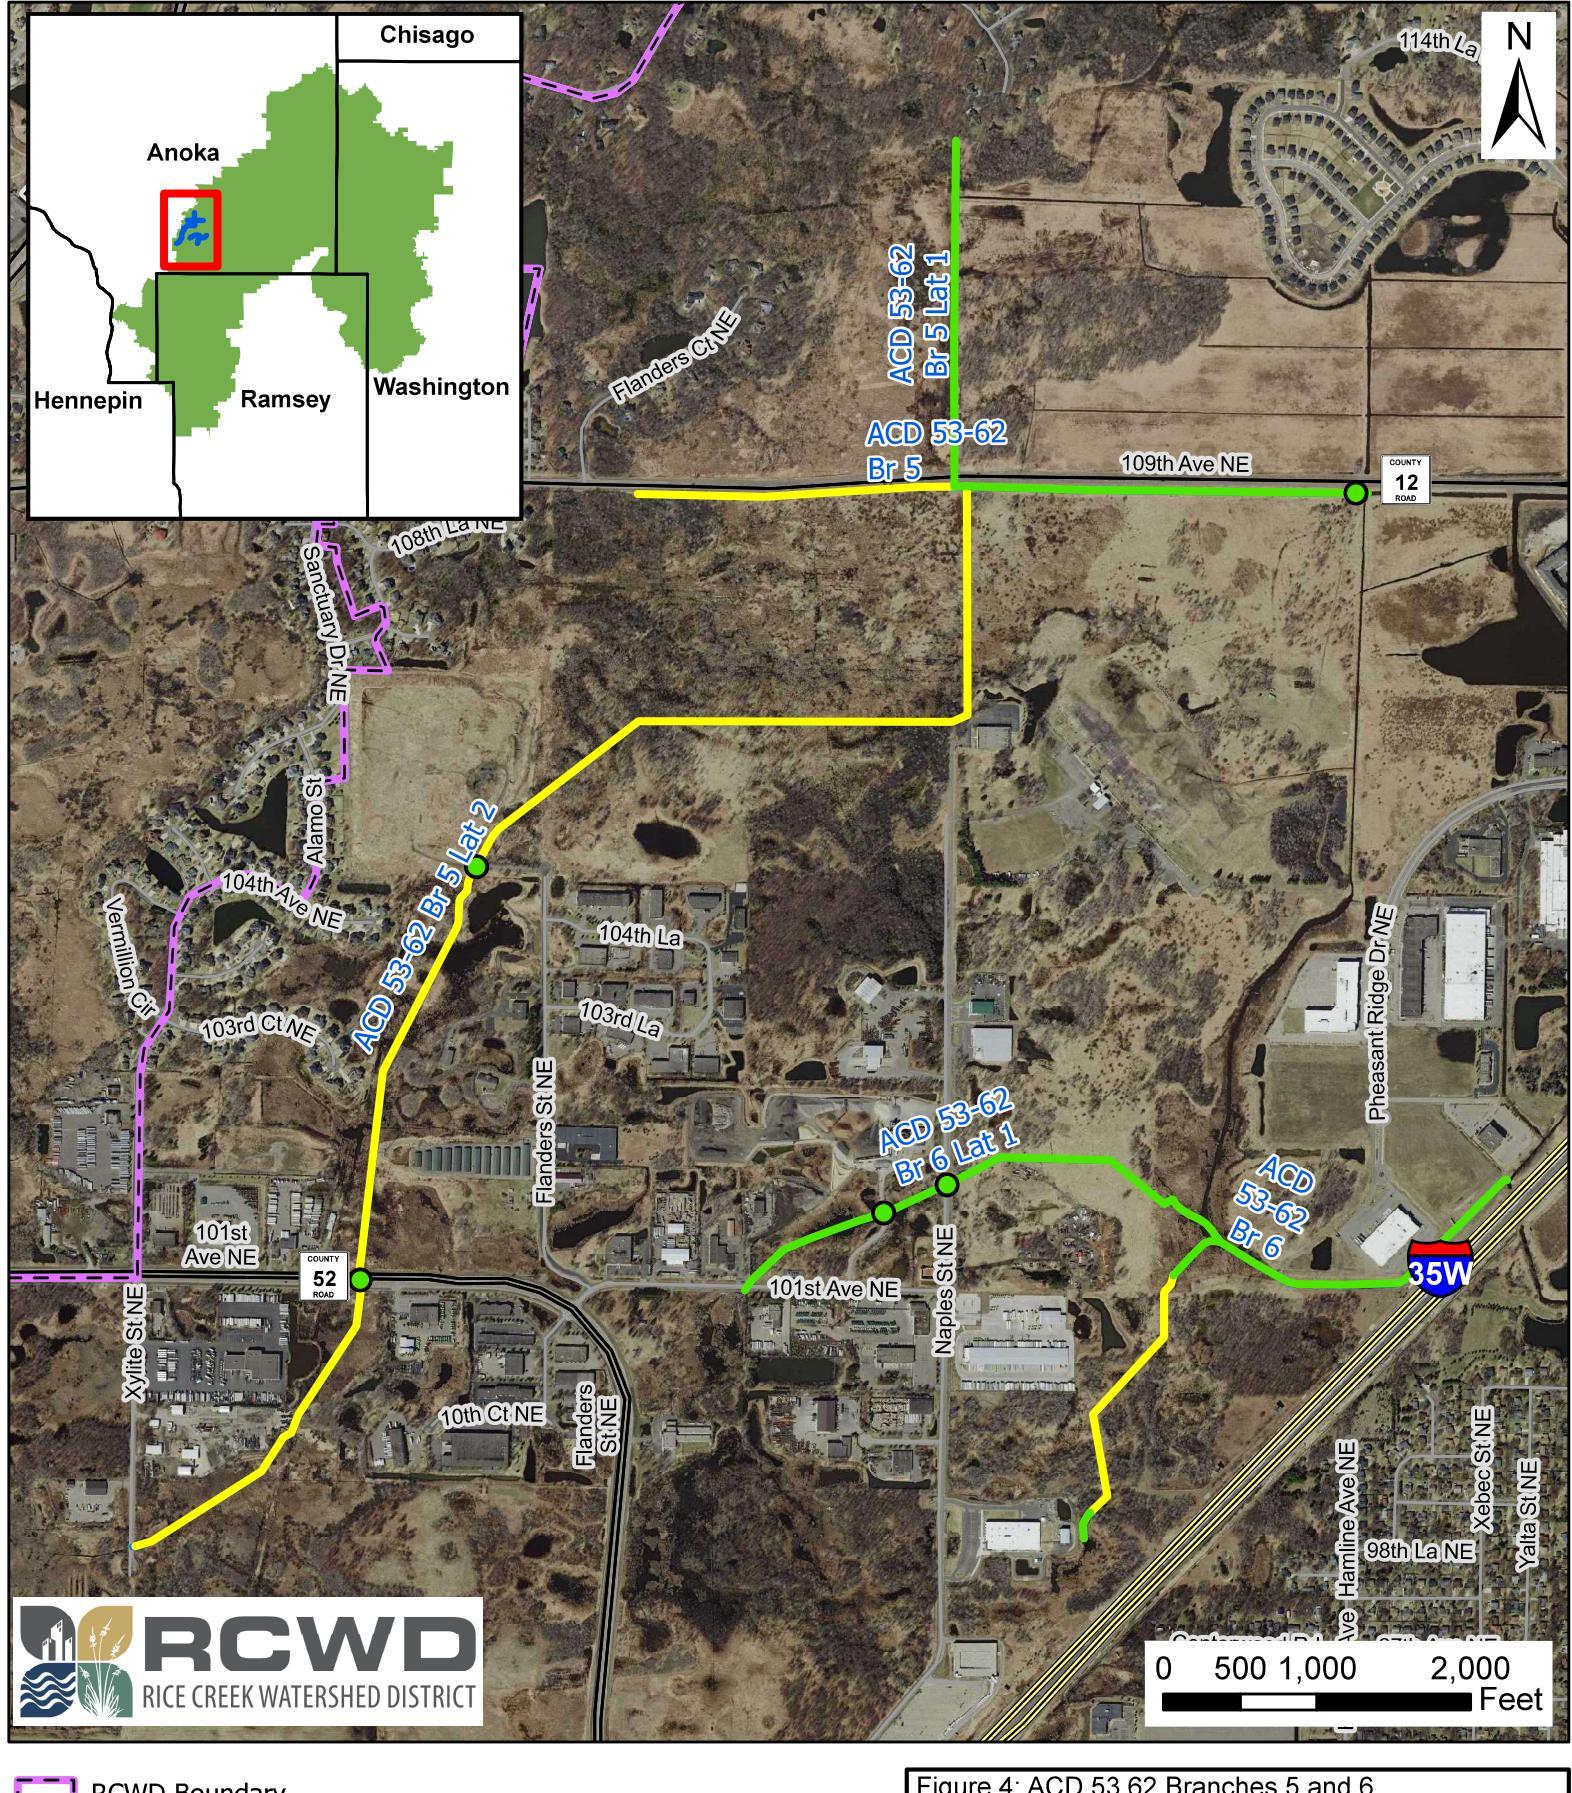
RCWD Boundary
 ACD 53-62 Branch 5 and 6 Alignment
 Repair to ACSIC
 No Repair Figure 4: ACD 53 62 Branches 5 and 6 Alternative 3 Repairs Scale: AS SHOWN CHecked by: COO S555-0347 Date: 1/9/2025 HOUSTON engineering, inc.

• No Repair to Culvert

A graphic depiction of Alternative 3 is provided in Figure 4 respectively.

For Alternative 3, Branch 5 Lateral 2 culverts will remain at their current inverts to hold the public water wetland runout elevations and no lowering of the 3 other culverts will take place. Full repair to

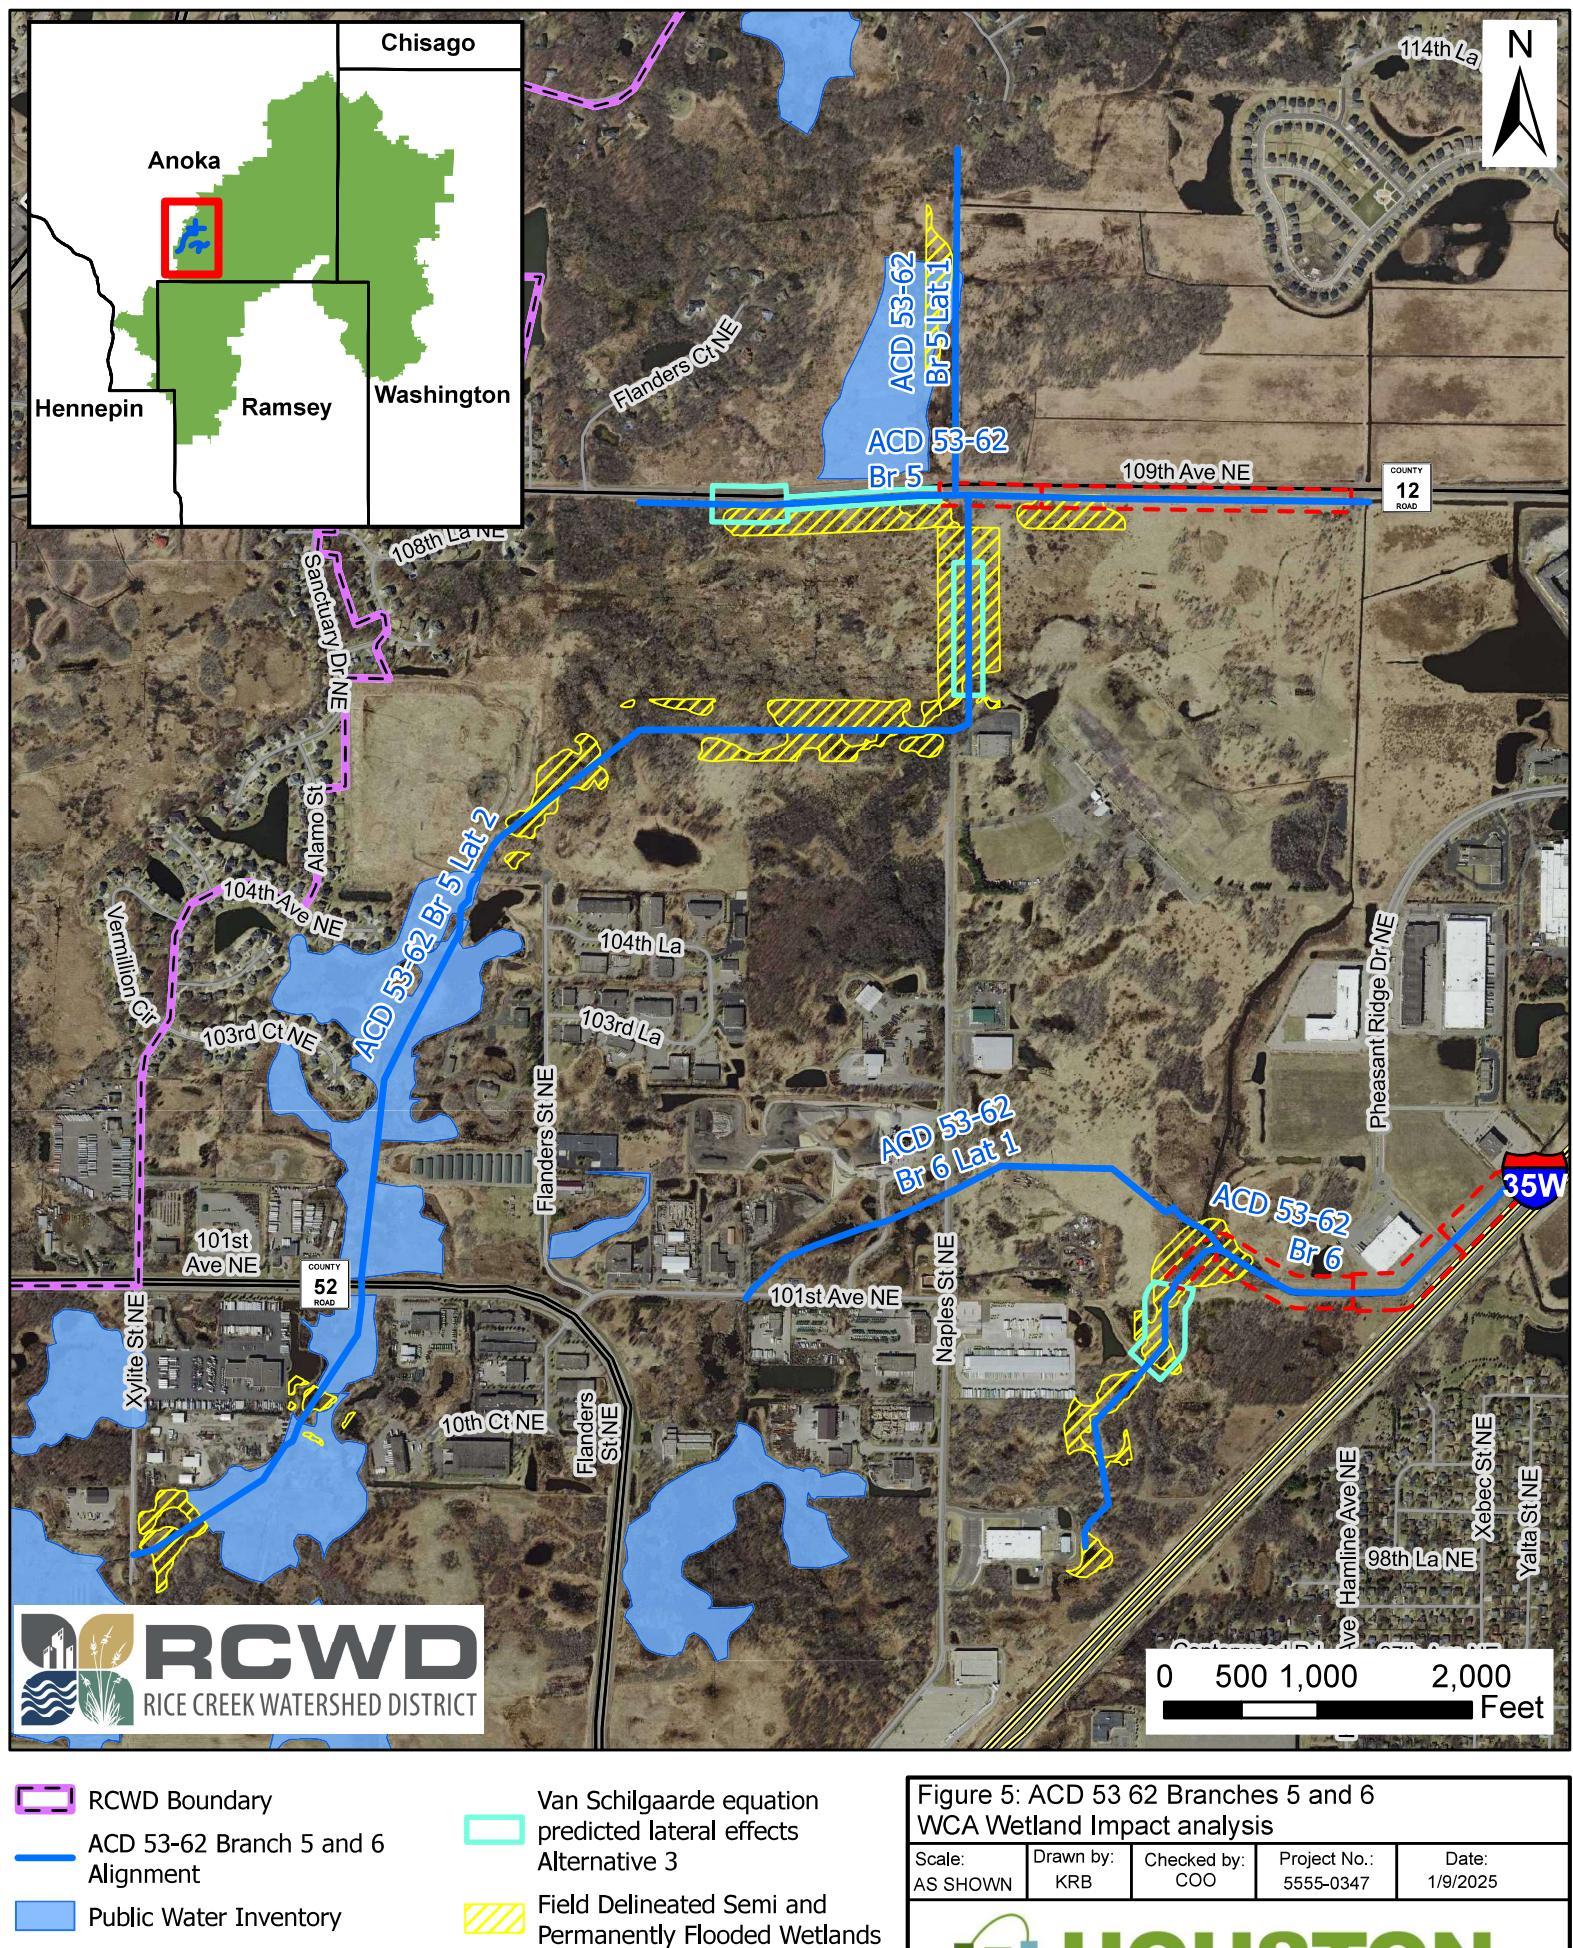
- 1 Van Schilgaarde equation L _ predicted existing lateral effects

Repair alternatives restore conveyance and reduce the water levels in the ditch relative to current conditions. The effective lowering of the water levels is dependent on the location and physical properties of each location; alterations proposed for the ditch; and the hydrology moving through the site. To capture this variability across the ACD 53-62 watershed, the lateral effect analysis was performed by segments of the drainage system. The system was divided into segments consistent with the spatial scale used for the InfoSVMM hydraulics. The segments were intersected with the soil layer for Anoka County. Average daily water level depths over the growing season were generated using an iterative process to calculate the equivalent depth in the van Schilfgaarde equation based on the depth of the free water surface for the drainage segments, sub-divided based on the soil type and drainage system type. Inputs for the drainable porosity in the equation account for the water storage by surface roughness. GIS software was then utilized to map the lateral effect distance from the ditch segment centerline on both sides of the ditch segment. The calculated lateral effects from Van Schilfgaarde for each ditch segment are displayed in **Figure 5**.

Note that the Van Schilfgaarde equation predicts that the existing ditch drains portions of the adjacent wetlands, including areas that currently are permanently or semi-permanently inundated. This indicates that the ditch in these locations is not affecting the hydrology of adjacent wetlands, due to nature of the underlying soils and/or the amount of hydrology coming lateral into the wetland. In these cases, further deepening of the ditch via a repair does not have the potential to impact the wetland. These locations include STA 27+00 to 43+00 of Branch 5 and STA 27+00 to 35+00 of Branch 6.

In other locations (specifically, STA 5+00 to 13+00 of Branch 5 Lateral 2), Van Schilfgaarde predicts no lateral effects to semi-permanently or permanently flooded wetlands along the ditch under existing conditions but significant lateral drainage effect under proposed conditions. In these locations, the likely effect of repairs can be predicted by considering the effect of previously maintained ditches in nearby wetlands.

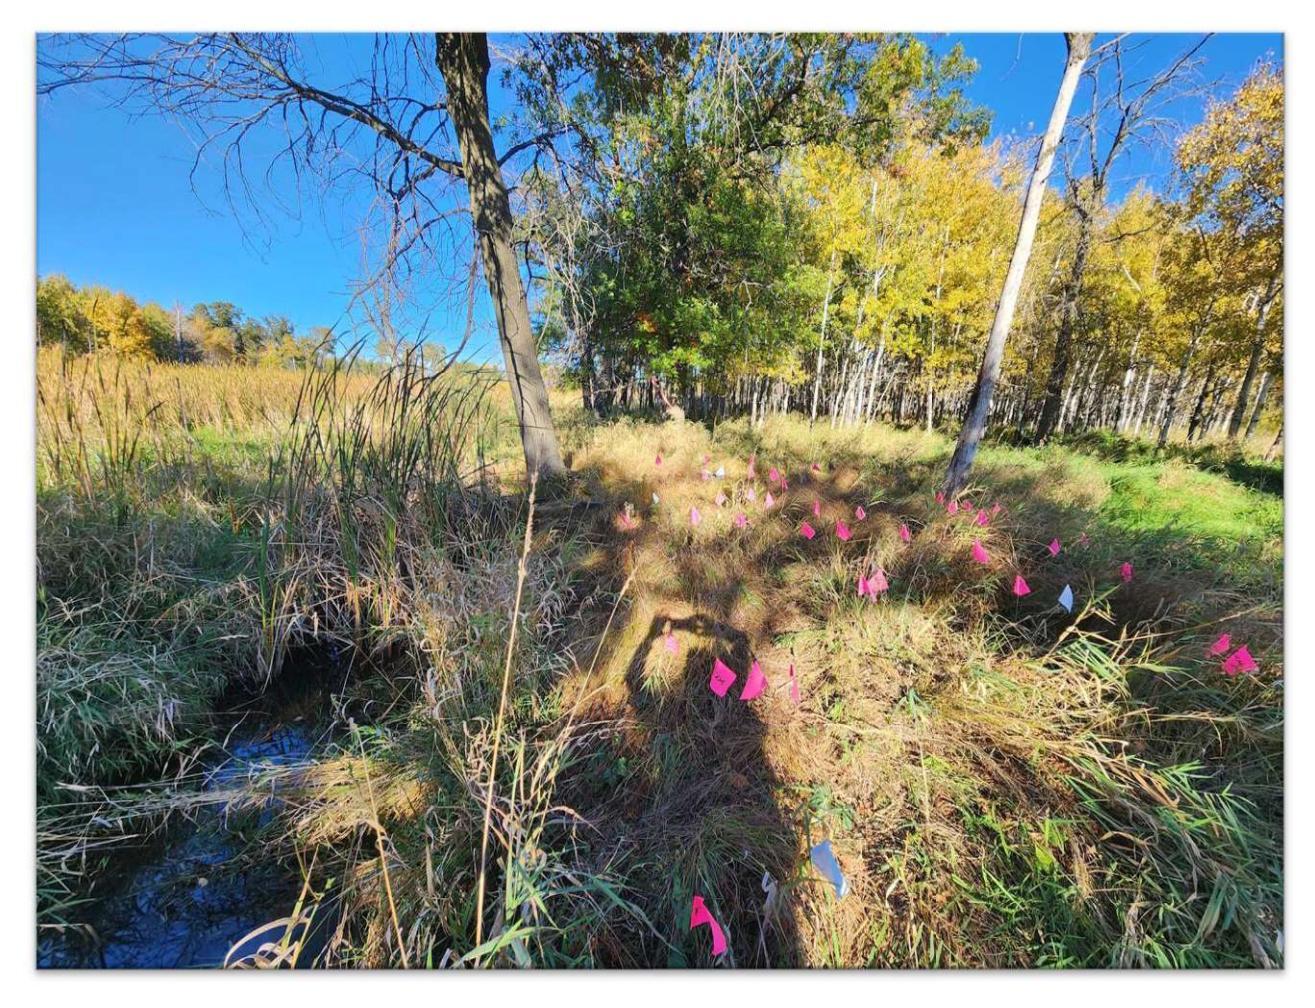
Rubus semisetosus subpopulation RSE-05 along the eastern edge of ACD 53-62 Branch 5

RSE-05 Subpopulation Notes: This subpopulation of *Rubus semisetosus* was comprised of 62 canes, located within a relatively small area immediately adjacent to the ditch and on ditch spoil (250 square feet). Of these canes, most were vegetative primocanes, and very few floricanes were observed producing viable fruit (restricted to sunnier areas). This subpopulation was located on the transition between a southern wet aspen forest (WFs55a) and northern wet meadow openings (WMn82b1) immediately adjacent to the ditch. These swamp blackberries were associated with: *Populus tremuloides, Betula papyrifera, Ulmus americana, Prunus serotina, Salix nigra, Salix* spp., *Rhamnus cathartica, Rubus idaeus, Spiraea alba, Solidago gigantea, Carex lacustris, Calamagrostis canadensis,* and *Phalaris arundinacea.* Soils were saturated to seasonally inundated Isanti sandy Ioams, with a shallow sedge peat organic surface layer. Exposure was partial sun to partial shade. The plants were most densely occurring in the sunnier and more open/exposed portions of the habitat and were stunted in shadier areas among the quaking aspen.

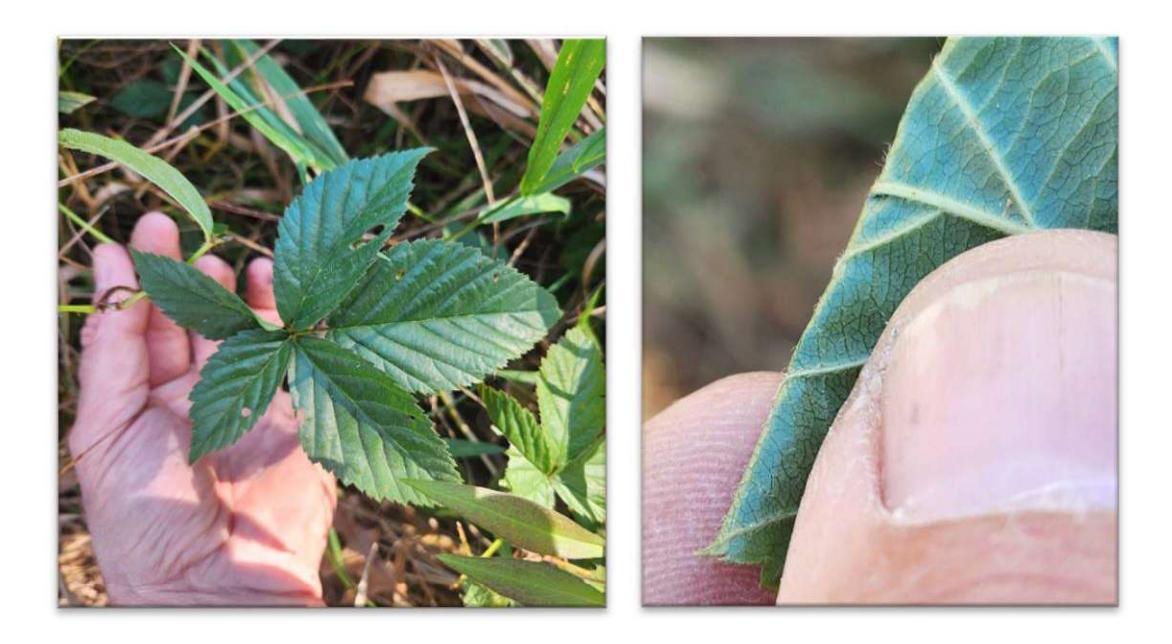
Rubus semisetosus subpopulation RSE-05, primocane leaf and leaf hairs detail

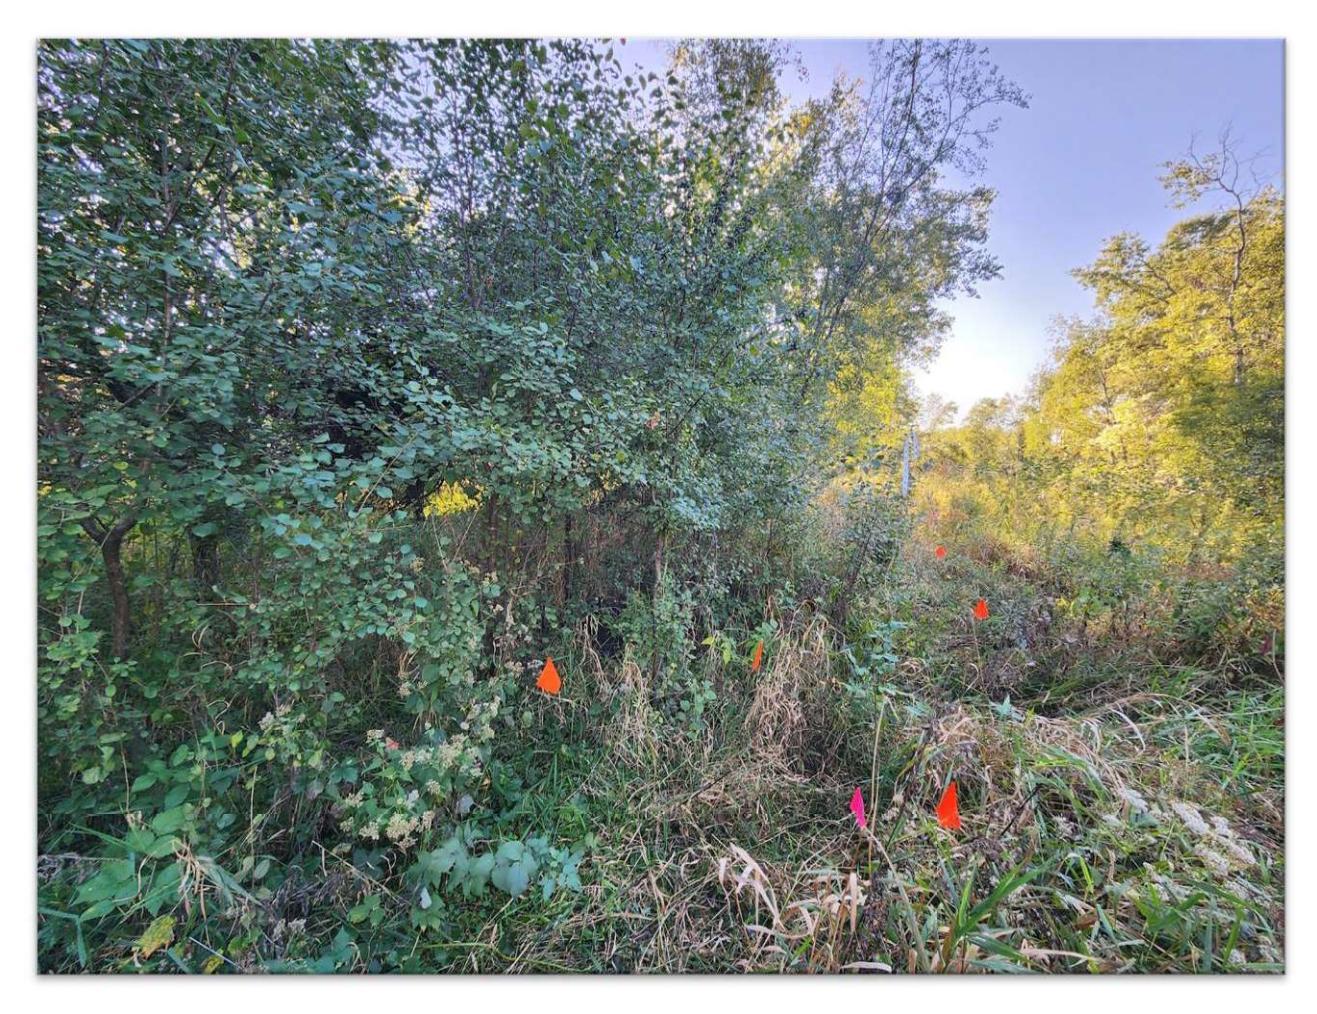
Rubus stipulatus and R. semisetosus habitat at southern end of ACD 53-62 Branch 6

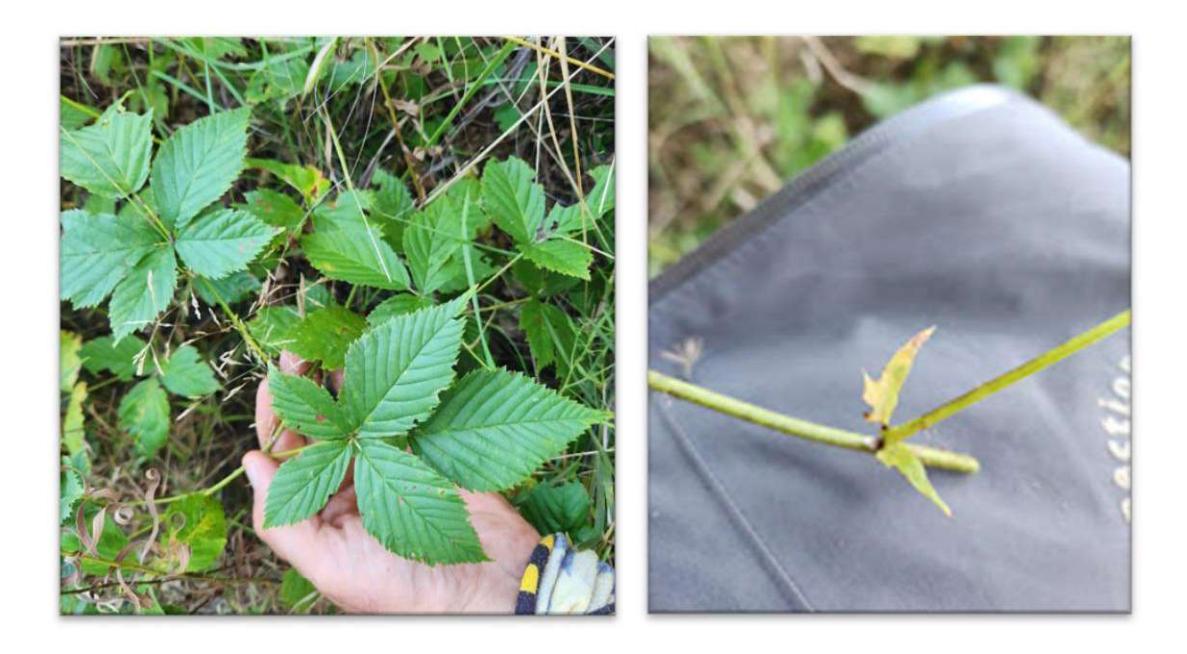
Rubus stipulatus subpopulation RST-06 leaf and diagnostic stipules

RST-06 Subpopulation Notes: This subpopulation of *Rubus stipulatus* was comprised of 16 canes, located within a relatively small area (371 square feet). Of these canes, most were vegetative primocanes, and no floricanes were observed producing viable fruit. This subpopulation was located on the transition between a southern wet aspen forest (WFs55a) and northern wet meadow openings (WMn82b1). These Minnesota Endangered bristle-berries were closely associated and co-occurring with *Rubus semisetosus* (MN Threatened), *Rubus idaeus*, and *Rubus multifer* (MN Special Concern). Other associated species included: *Populus tremuloides, Betula papyrifera, Ulmus americana, Prunus serotina, Salix nigra, Salix* spp., *Rhamnus cathartica, Spiraea alba, Solidago gigantea, Carex lacustris, Calamagrostis canadensis,* and *Phalaris arundinacea*. Soils were earthworm impacted saturated to mesic Isanti sandy loams, with a shallow sedge peat organic surface layer. Exposure was partial shade to shade.

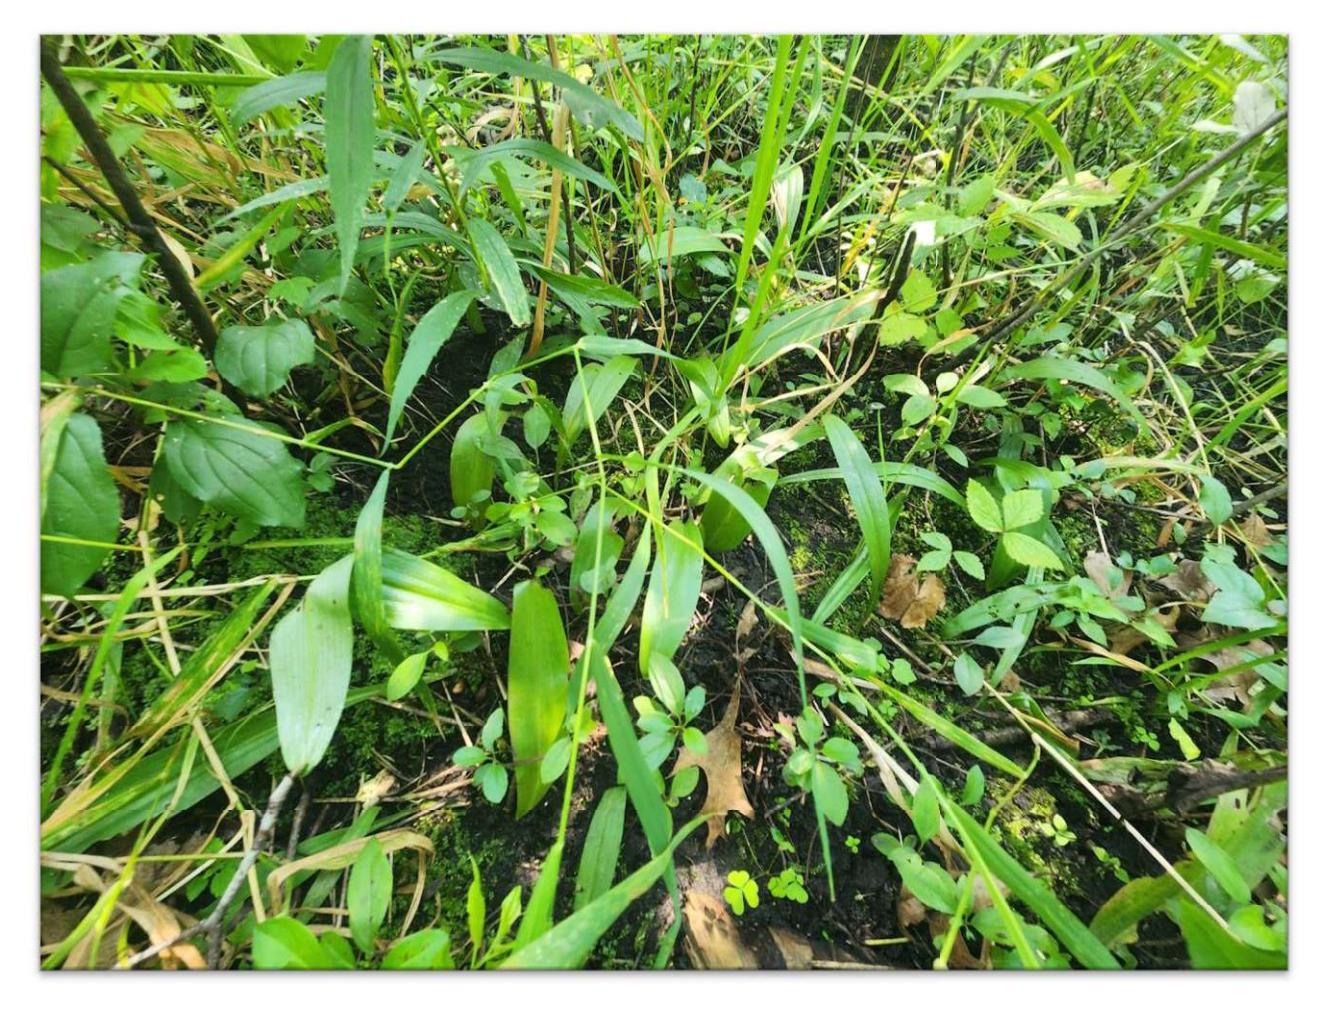
Platanthera flava subpopulation PF-06, cluster of basal leaf plants at ACD 53-62 Branch 6

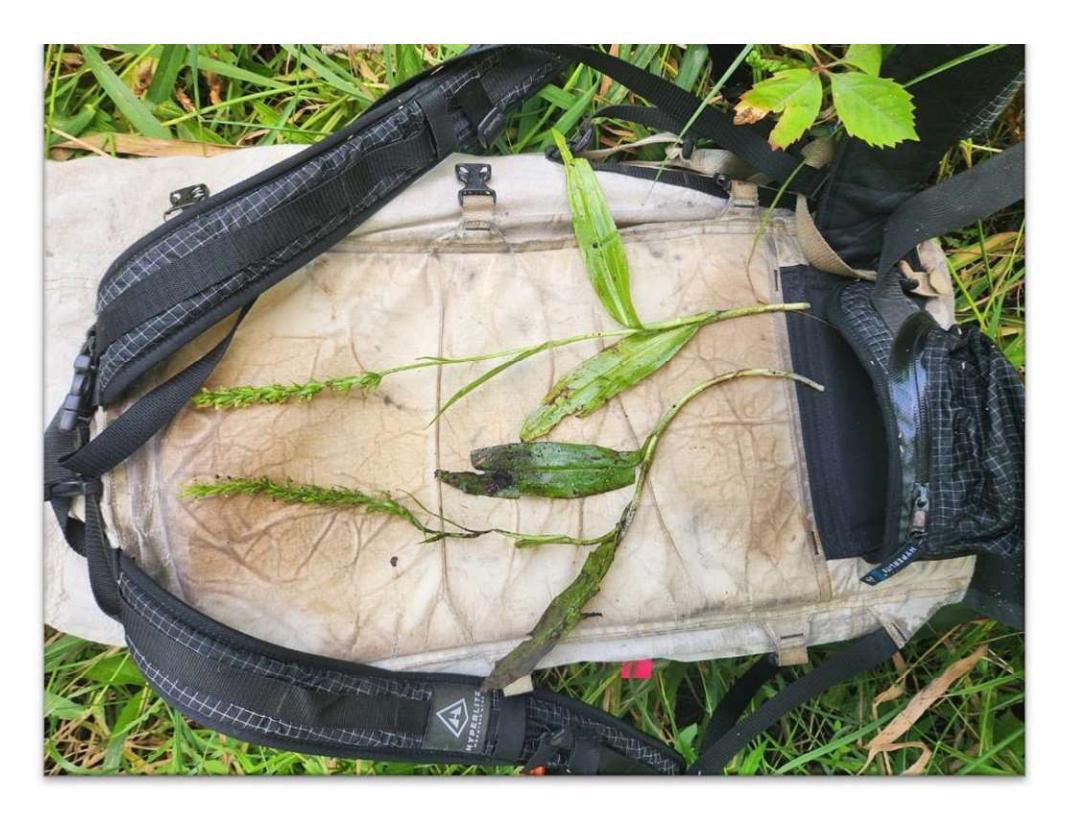
Platanthera flava subpopulation PF-06 voucher specimens of flowering orchids

Voucher specimens for RMU-06 (JJH-2024-144), RSE-06 (JJH-2024-118, 119, 120A/120B), and PF-06 (JJH-2024-114, 115) were collected at the Branch 6 locations. No voucher specimens were collected for RST-06 (*Rubus stipulatus*) because there were too few individuals and these were primarily primocane material, with diagnostic large stipules relatively absent from damping off in high humidity conditions. Photographs of *Rubus stipulatus* primocanes and leaves were collected.

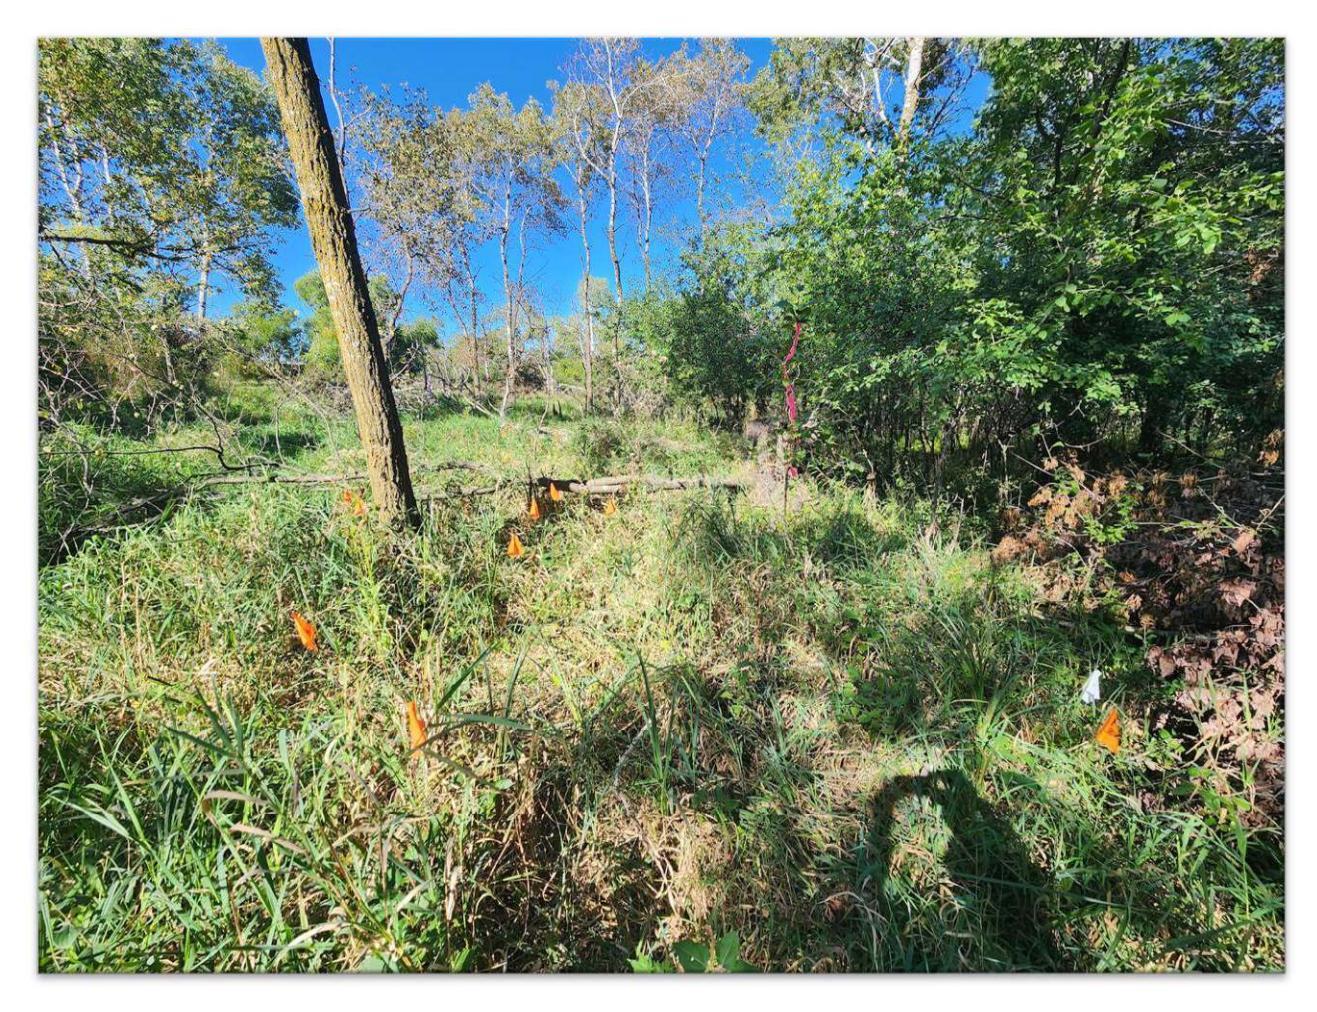
Rubus semisetosus subpopulation RSE-05 along the eastern edge of ACD 53-62 Branch 6

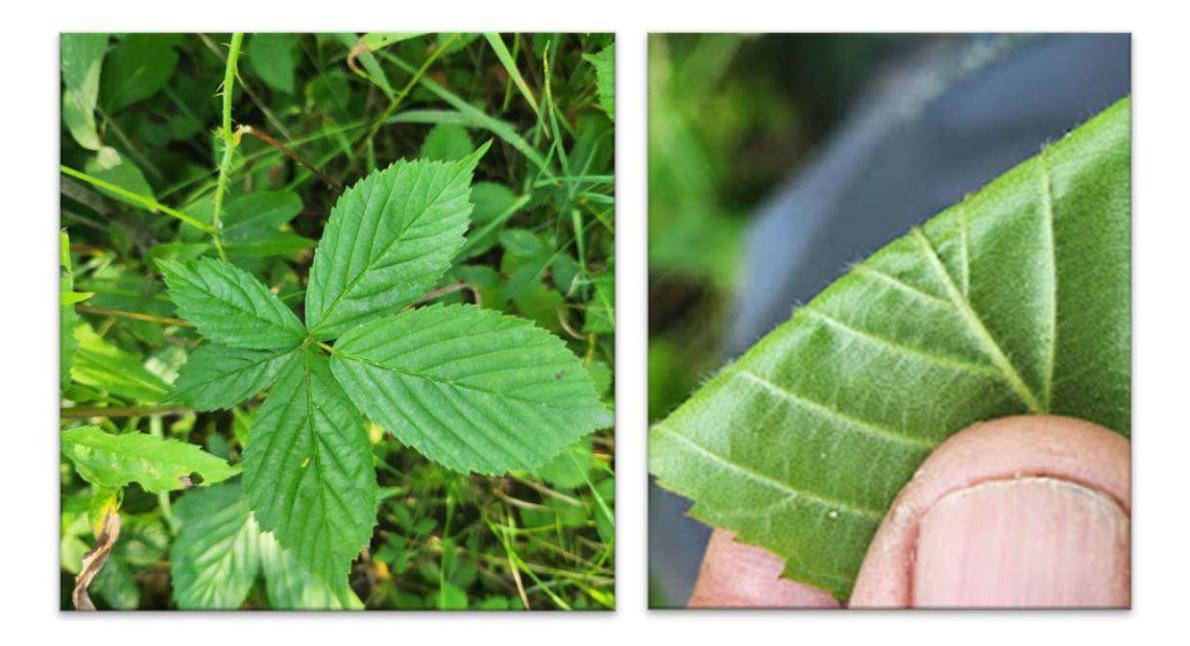
Rubus semisetosus subpopulation RSE-05, primocane leaf, aciculate prickles, and leaf hairs detail
