# ANOKA RAMSEY JUDICIAL DITCH 1 REPAIR REPORT

# ANOKA RAMSEY JUDICIAL DITCH 1 (ARJD 1) REPAIR REPORT

Original issuance date: July 14, 2026

***Amended August 5, 2026***

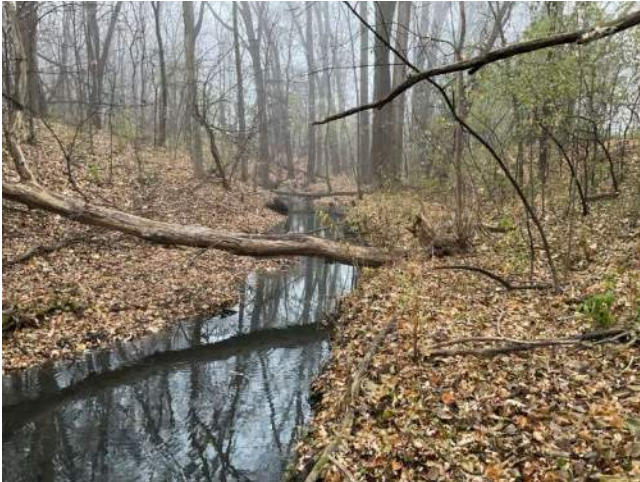
Photo #1: Heavy Vegetation near ditch, Main Trunk  
STA: 31+00

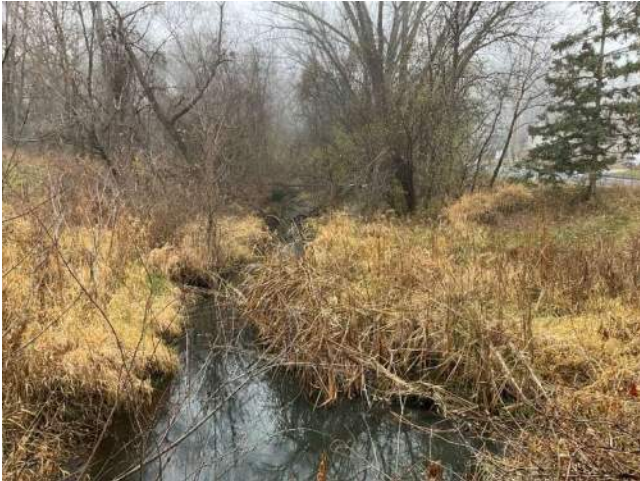
Photo #2: Heavy Vegetation in ditch, Main Trunk STA:  
53+00
